Source: Proponents Environmental Assessment

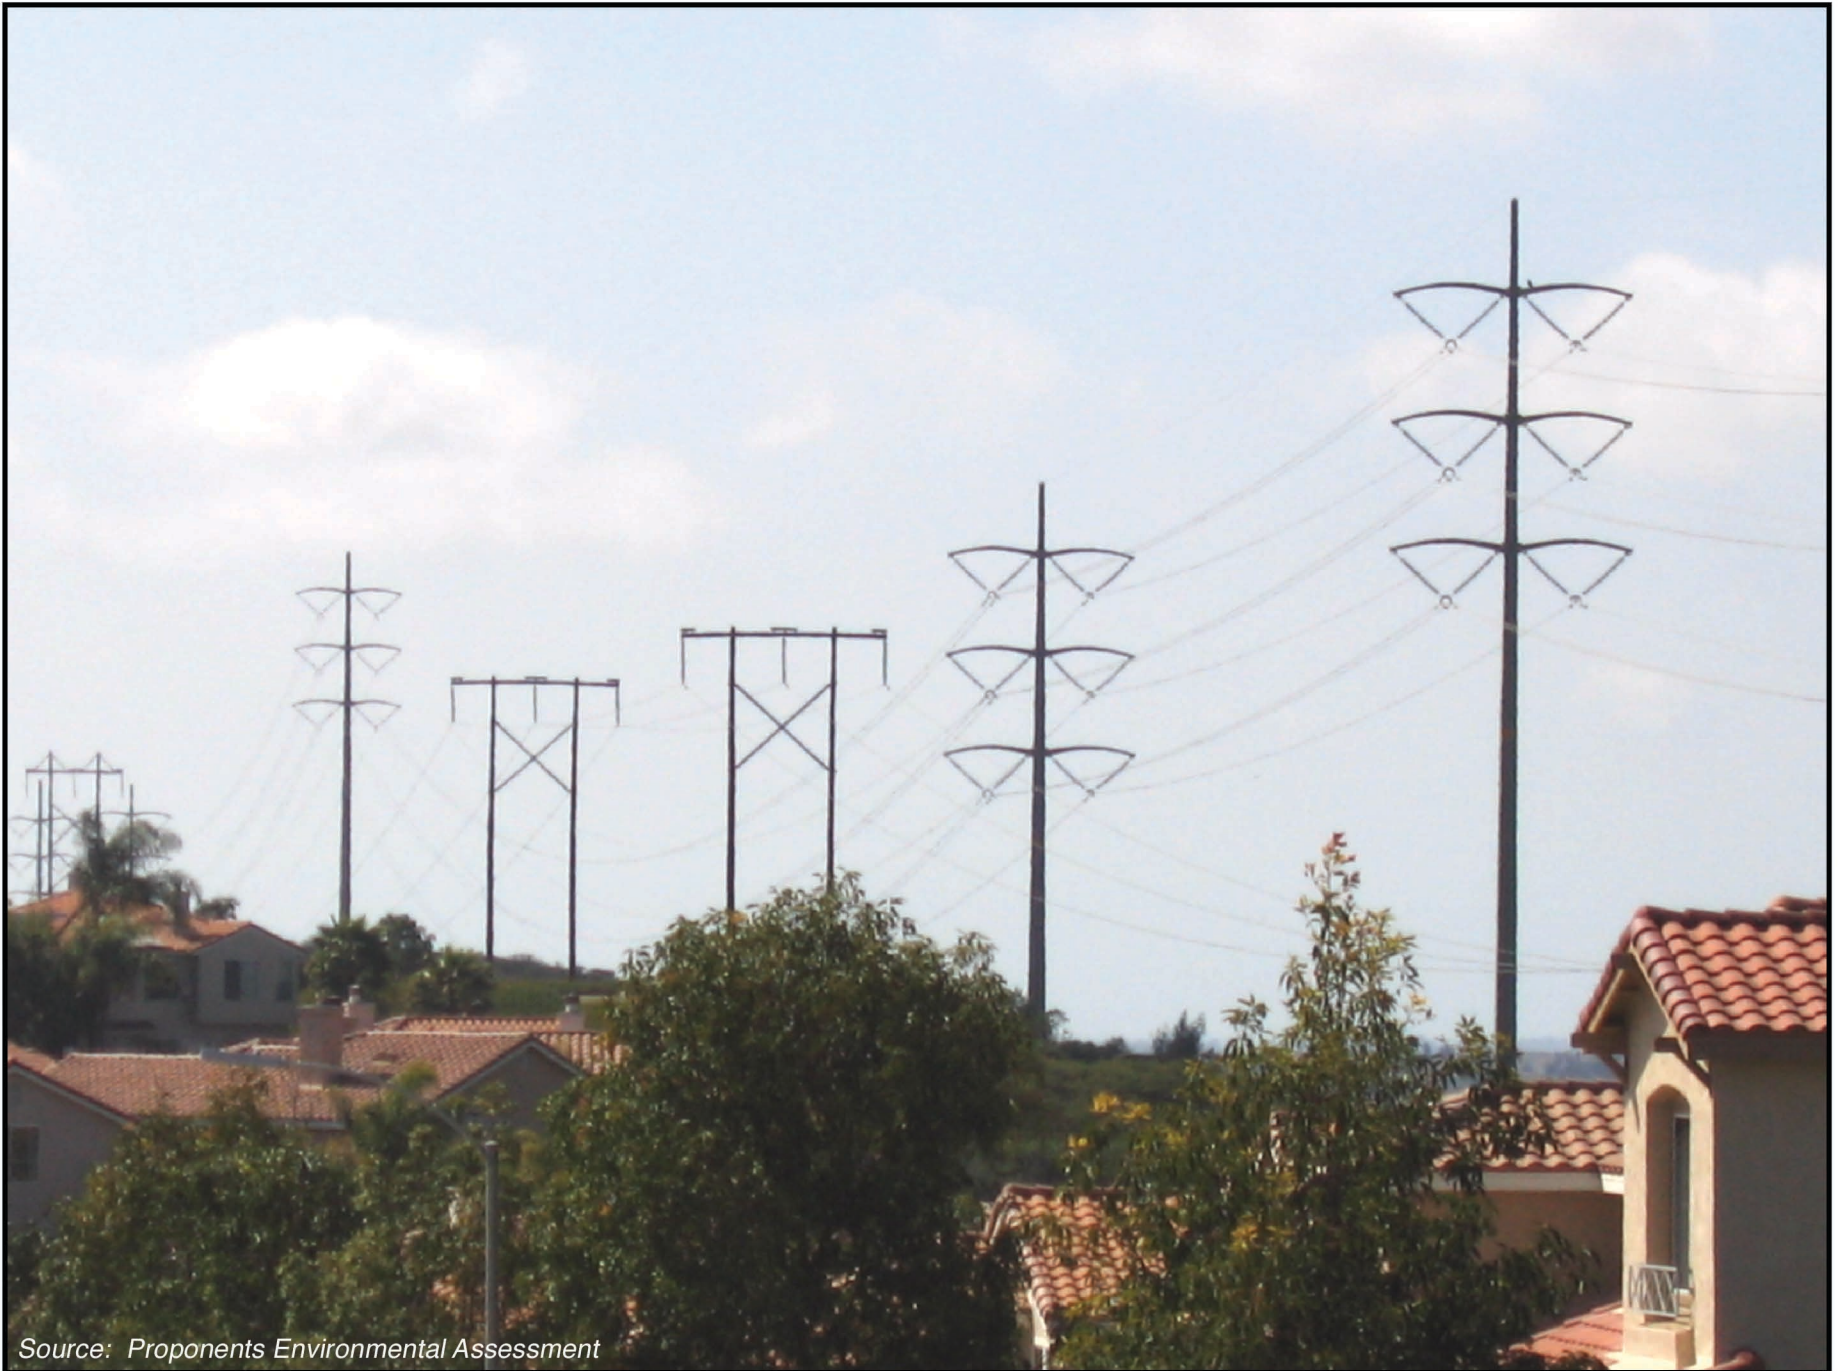
Figure D.3-23A: Existing Condition
 Cypress Canyon Park Drive midway between Cypress Terrace Place and Candy Rose Way. View faces northwest. View shows existing 230 kV and 138 kV transmission lines rising above residences located along south side of ROW.

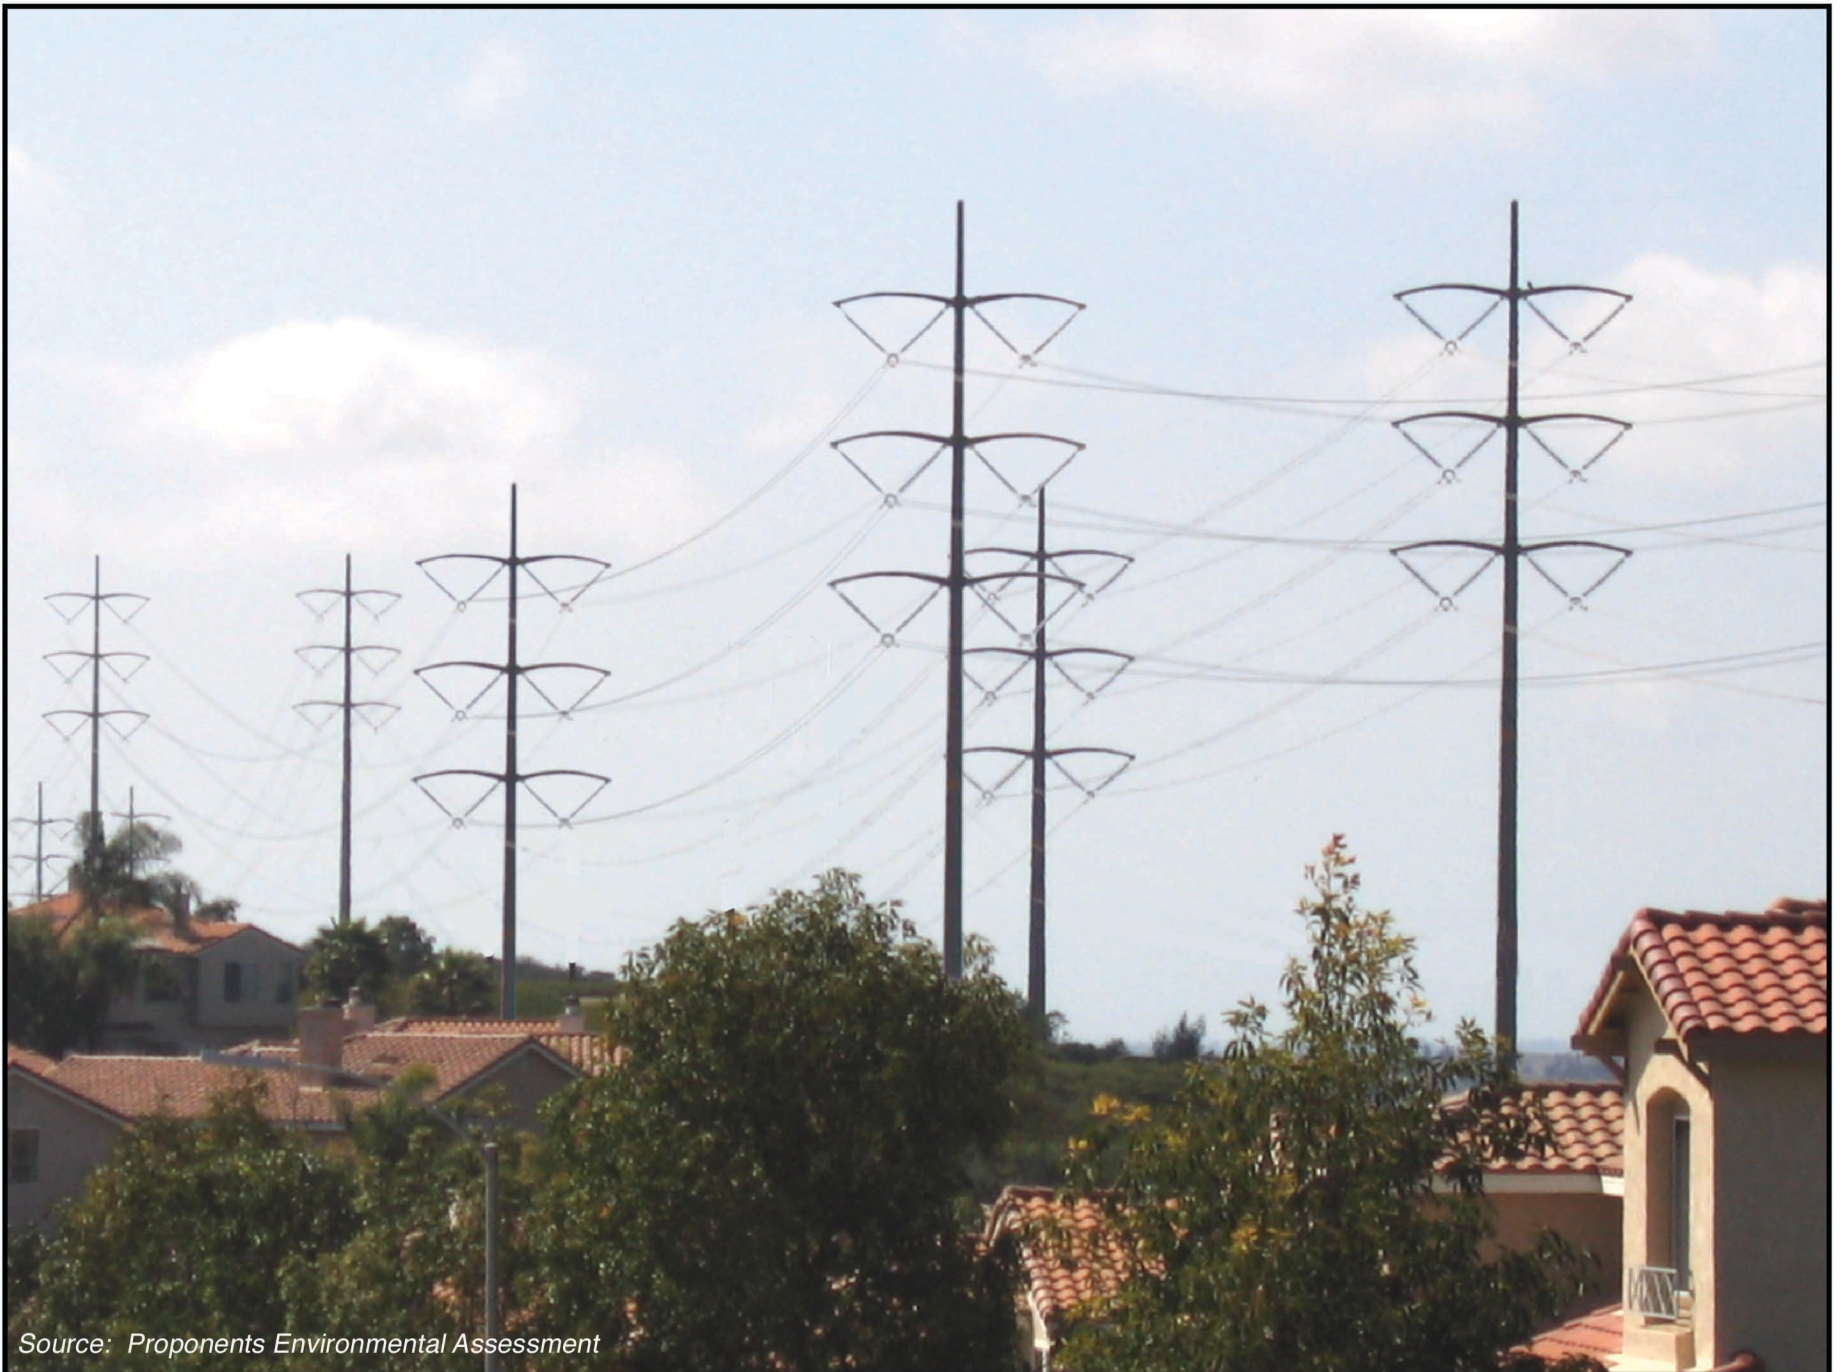
Figure D.3-23B: Photo Simulation
 Simulation of Proposed Project from Cypress Canyon Park Drive midway between Cypress Terrace Place and Candy Rose Way in Miramar Ranch North
