California Public Utilities Commission <i>Mitigation Monitoring, Compliance, and Reporting Program</i>
	Cleveland National Forest Power Line Replacement Projects Compliance Status Report: 015 April 16, 2017

This compliance status report covers construction activities from April 3 through April 16, 2017.

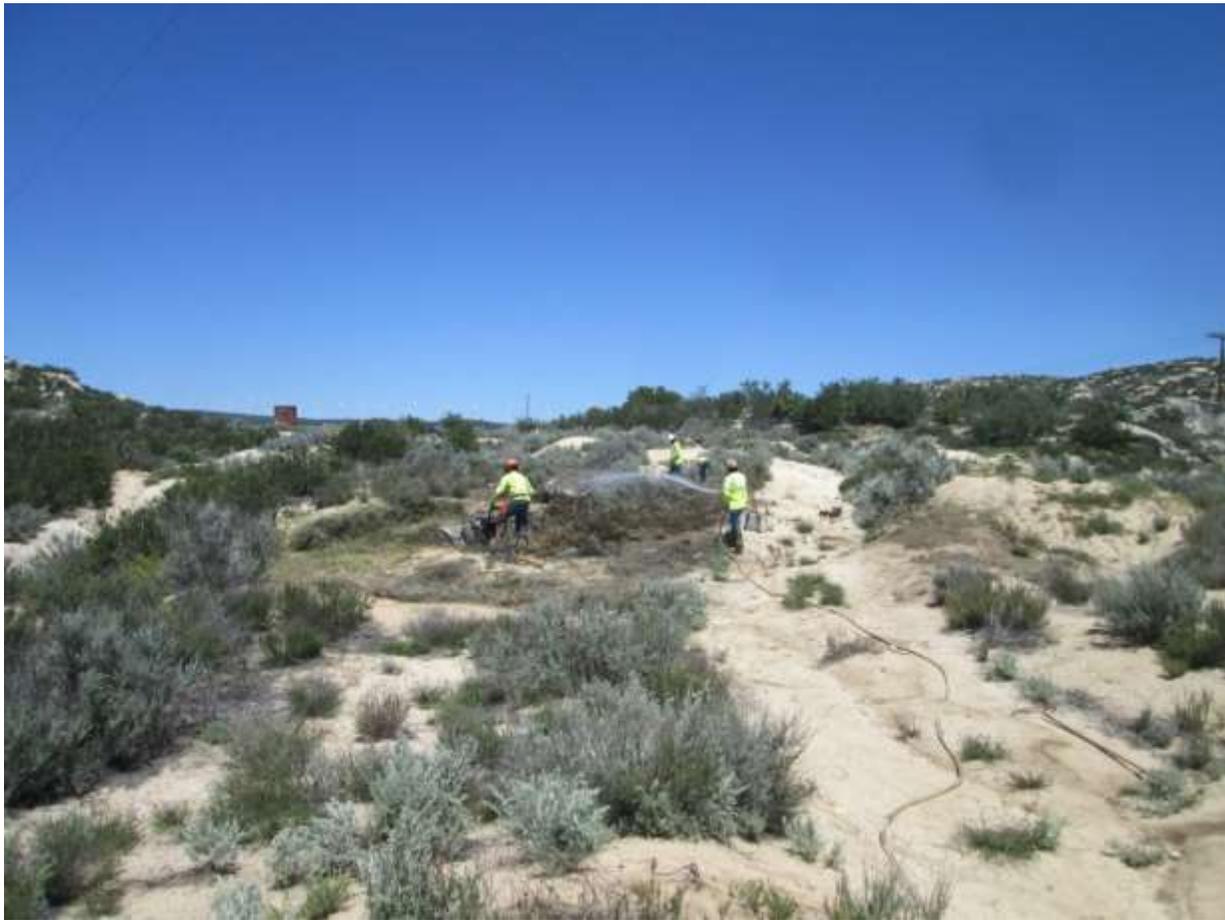
Photo 1: During vegetation clearing at the Pole Z44253 Stringing Site (TL6931), the construction crew pre-watered the work area and staged the prescribed fire tools were within 50 feet in accordance with the CFPPP, MM FF-1, APM HAZ-01, and APM HAZ-04.

During this reporting period, construction crews along TL6931 were observed clearing vegetation within delineated workspaces (See Photo 1—Attachment A), installing erosion control best management practices (BMPs), setting up to drill and drilling (See Photo 2—Attachment A), setting foundation bar,

Construction activities and patrols were observed being conducted in accordance with the Construction Fire Prevention/Protection Plan (CFPPP), MM FF-1, and APM HAZ-01. A construction crew was observed pre-watering the work area prior to vegetation clearing in accordance with the CFPPP Fire Prevention Matrix (off CNF land) (See Photo 1—Attachment A), and prescribed fire tools were observed within 50 feet of work activities in accordance with APM HAZ-04.

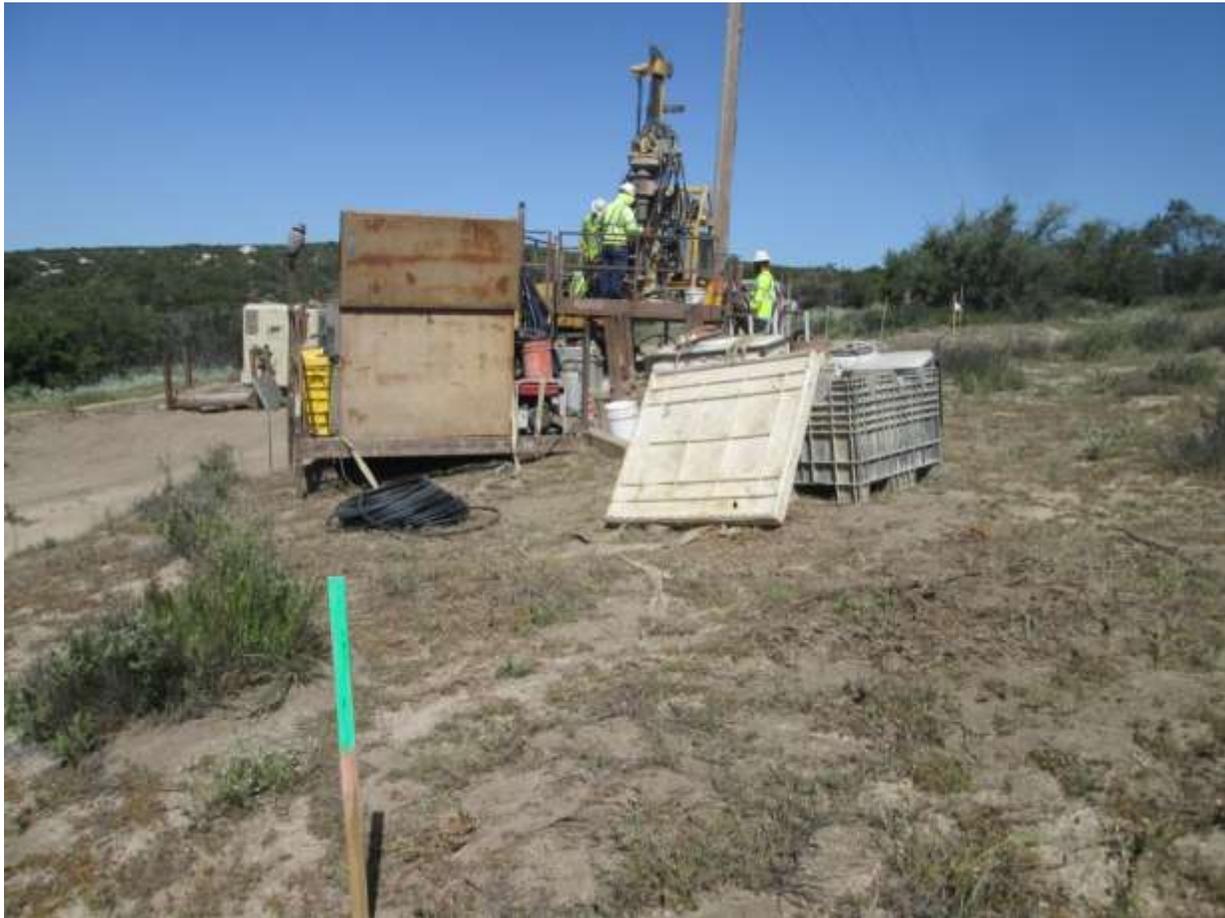
Photo 2: A construction crew observed drilling for a micropile foundation at Pole Z44248 (TL6931). The work activity was restricted to the delineated workspace (marked with green painted stakes) in accordance with MM BIO-1.

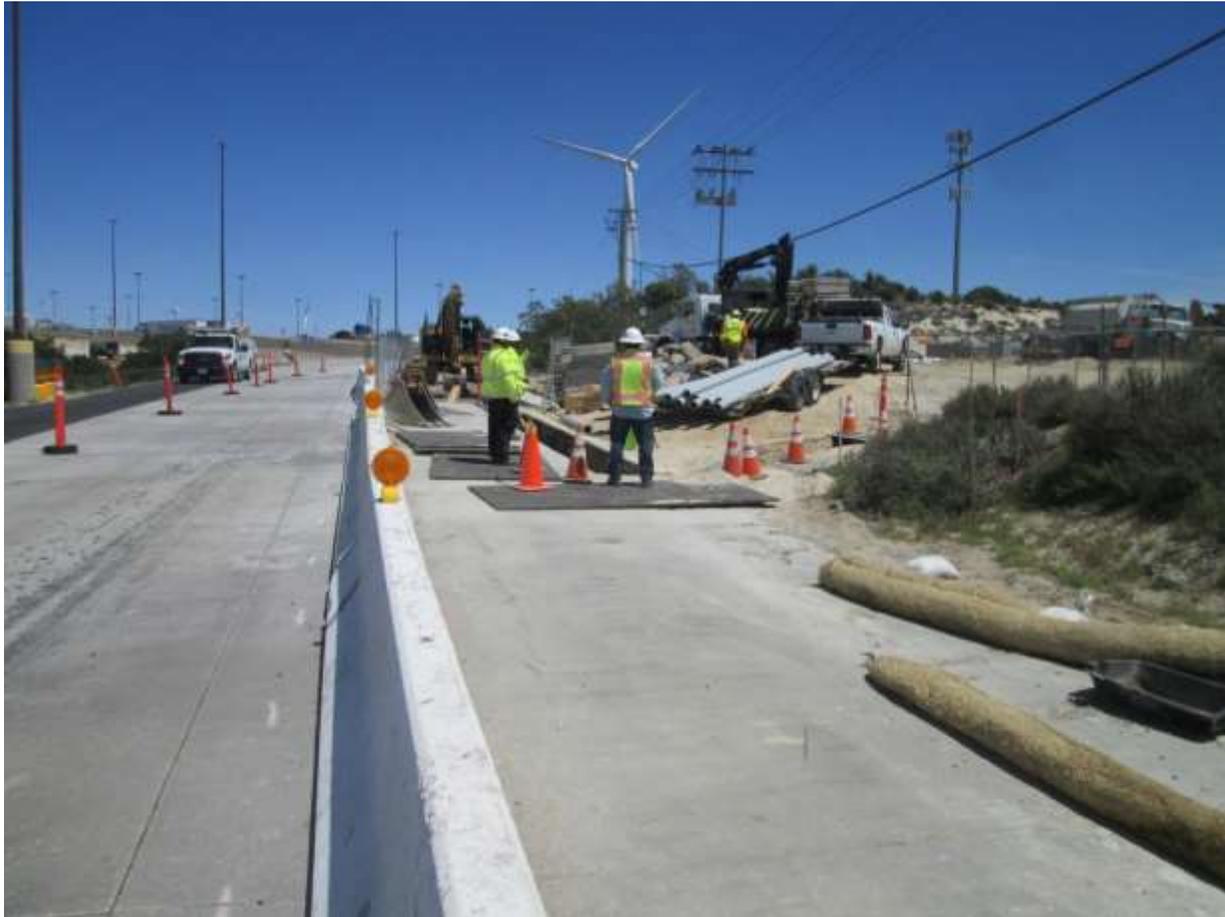
Photo 3: A construction crew observed trenching and laying conduit encasement piping at the Old Highway 80 jack-and-bore crossing (TL629E) near Crestwood Substation.

proof-testing, and capping for micropile foundations, utilizing helicopters to support drilling activities, and spreading and transferring wire. At TL629E, a crew was observed trenching and laying conduit encasement piping at the Old Highway 80 jack-and-bore crossing (See Photo 3—Attachment A). Along TL625B, crews were observed framing and preparing to set replacement poles (See Photo 4—Attachment A), and installing grounding wire.

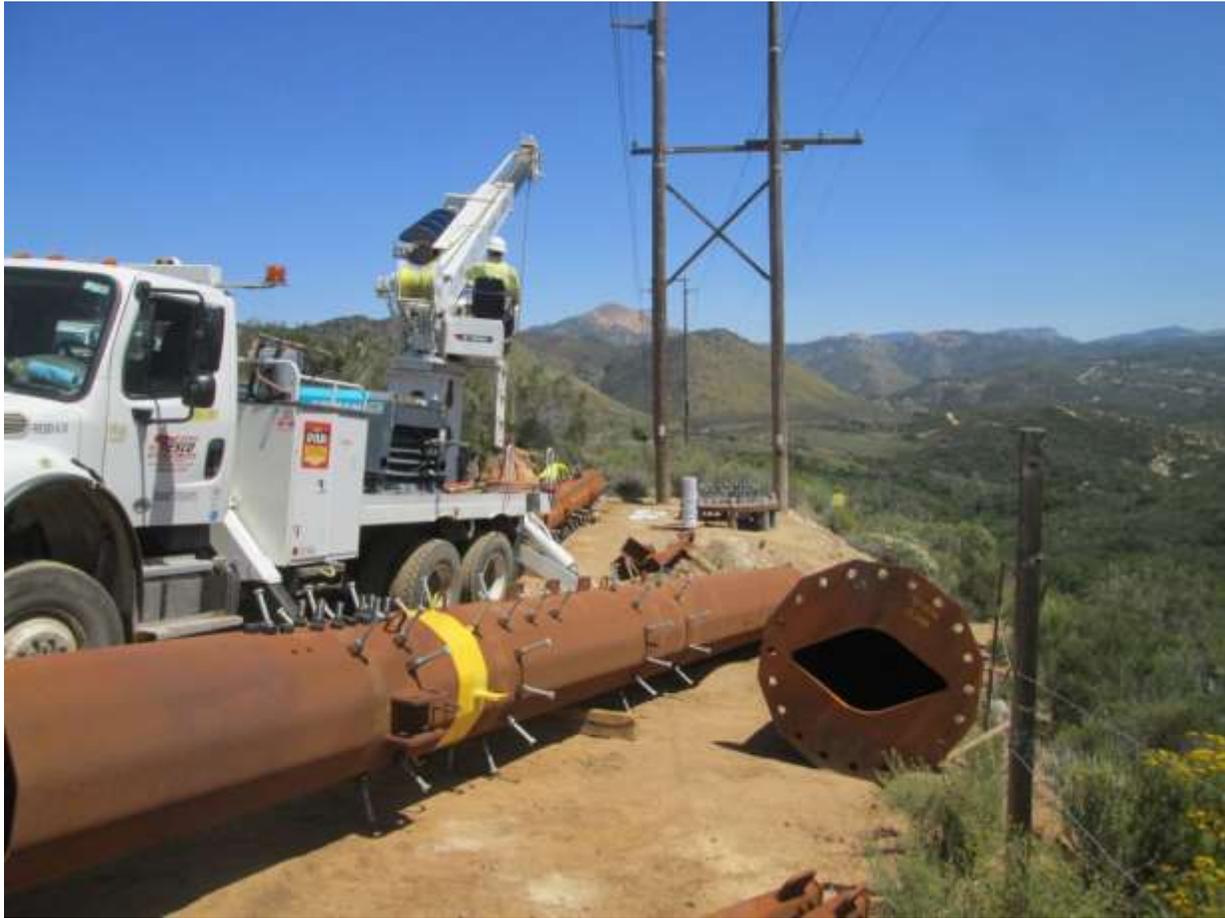
Photo 4: A construction crew observed framing steel replacement poles and preparing to set them at Pole Z272852 (TL625B).

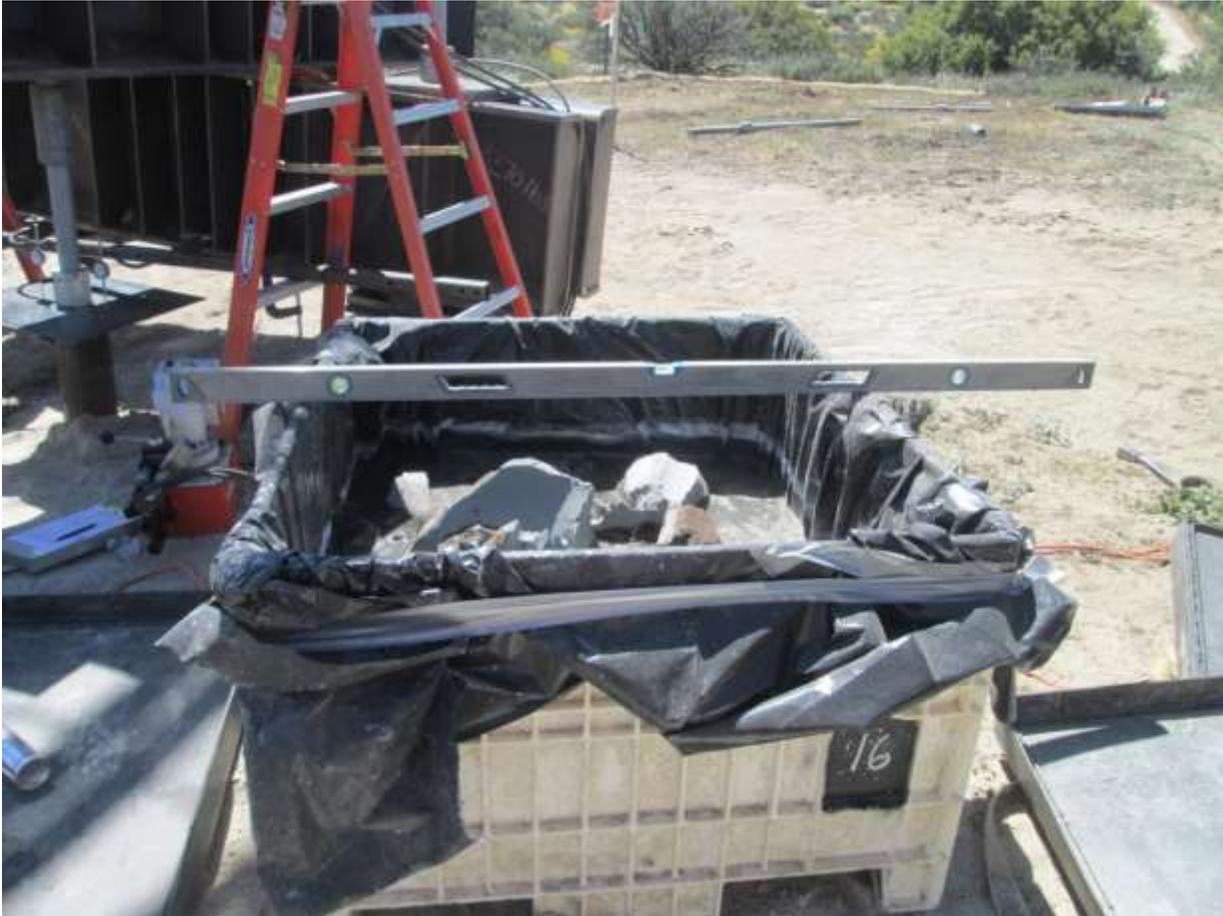
Photo 5: In accordance with APM HYD-1, concrete waste generated during micropile foundation construction at Pole Z44271 (TL6931) was cleaned up and disposed of in accordance with approved procedures.

cleaning up and disposing of concrete waste in accordance with APM HYD-1 (See Photo 5—Attachment A).

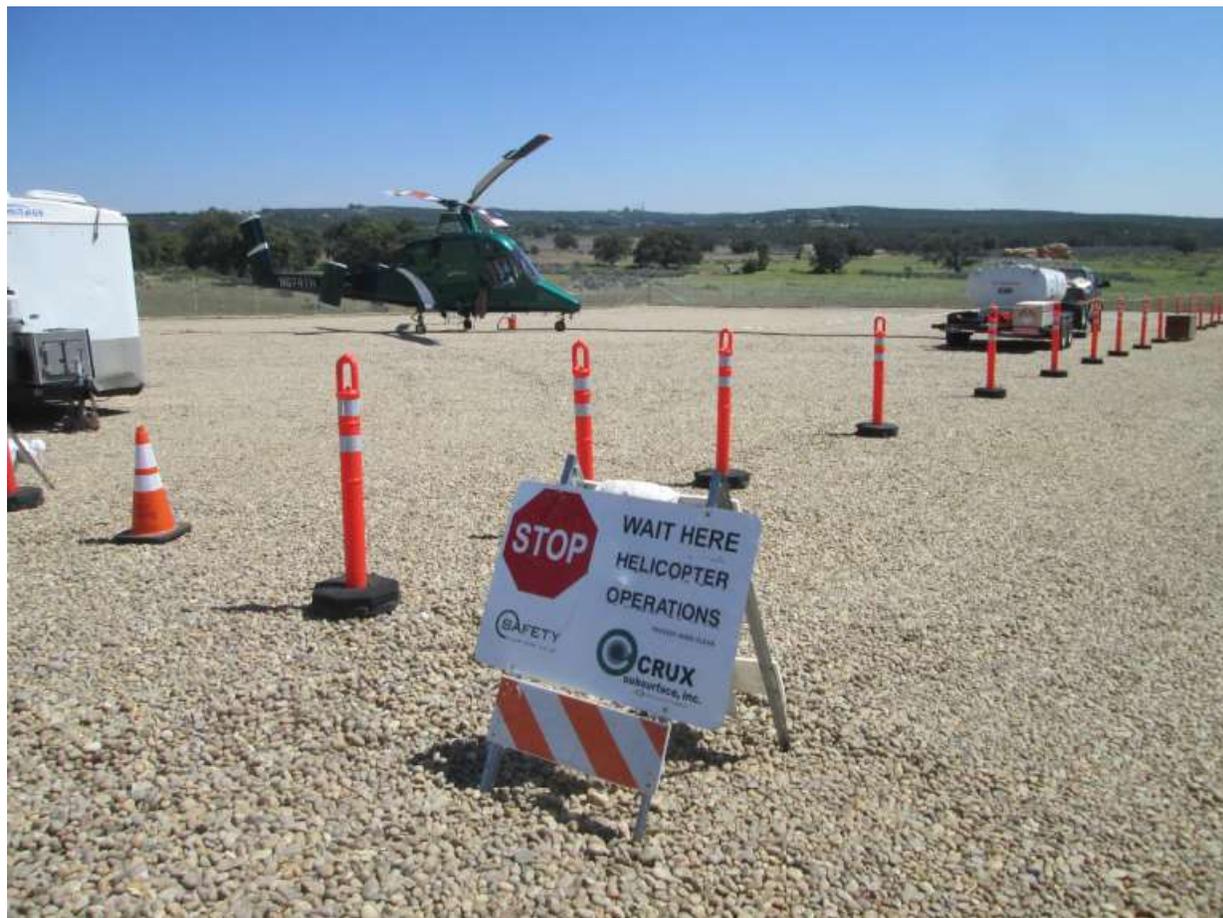
Photo 6: Designated landing areas were observed at the Live Oak Staging Yard (MM PHS-05).

Helicopter utilization in support of construction activities were in conducted in accordance with MM PHS-05, the Aviation Safety Plan, and Helicopter Lift Plan, and included the use of designated landing areas, and the designation of ground personnel responsible for the safety of helicopter operations was observed at established staging yards and implemented at the Live Oak Staging Yard this reporting period (See Photo 6—Attachment A) .
