**CALIFORNIA PUBLIC UTILITIES COMMISSION**  
**Safety and Enforcement Division**  
**Utilities Safety and Reliability Branch**

**Incident Investigation Report**

**Incident Number:** E20160919-03

**Utility:** Pacific Gas & Electric (PG&E)

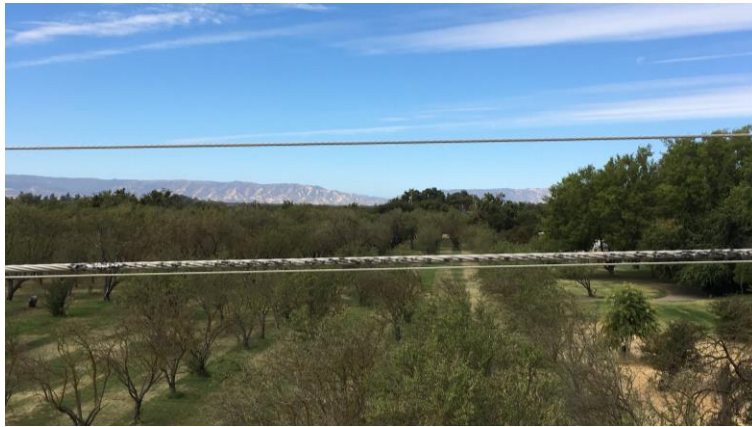
While I observed [REDACTED], PG&E Troublemaker, taking measurements of the point of contact, we found evidence of arcing on the conductor (see Figure 1 below).

**Figure 1.** Arcing marks found on the conductor of Davis-1107, 12 kV circuit.

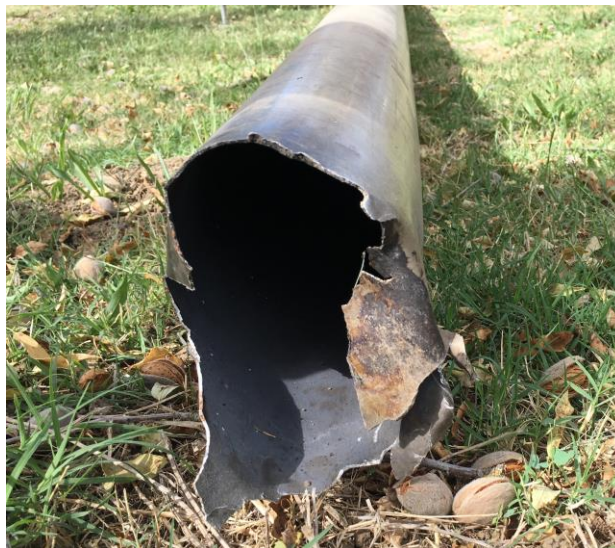
The remaining 26' section of aluminum irrigation pipe was left at the scene (see Figure 2 below). The charring on the pipe is also evidence of high voltage arcing.

**Figure 2.** Remaining 26' section of irrigation pipe severed by electric contact.
