CONSUMER PROTECTION AND SAFETY DIVISION
CALIFORNIA PUBLIC UTILITIES COMMISSION

REVISED
REPORT AND TESTIMONY OF MARGARET FELTS

I.11-02-016

San Francisco, California
March 16, 2012

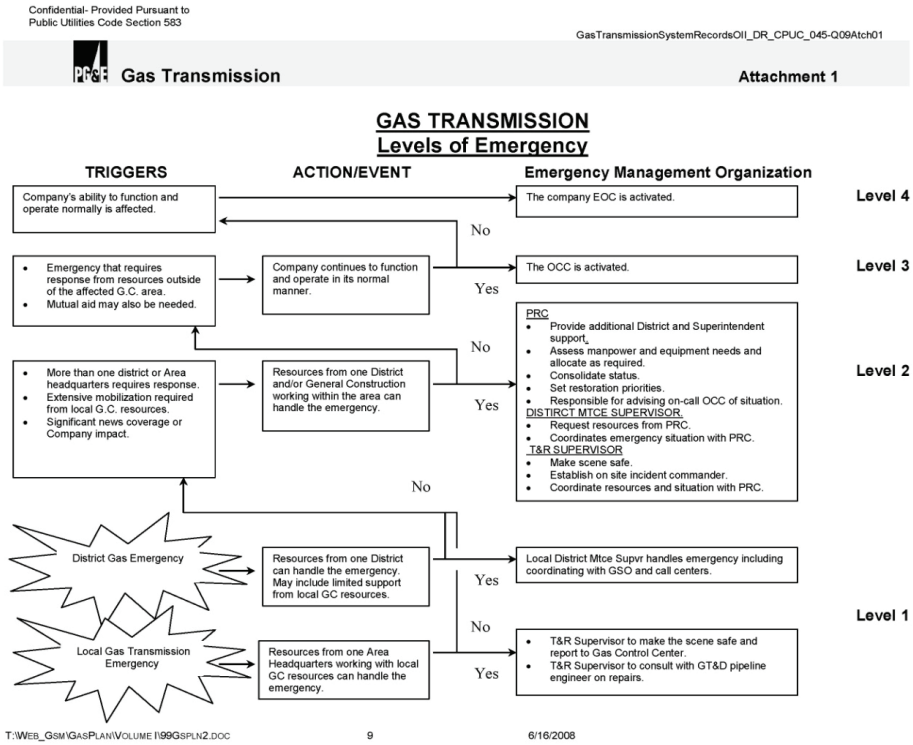
Figure 1

On the transcript of the audio recording made in the San Francisco Control Room during the emergency, it is clear that there was confusion about the emergency response plan.[56] Studying Figure 1, which is supposed to be the short-hand guide to responding to an emergency, confirms that the confusion was warranted. For example, it is not clear who in PG&E was supposed to be in charge of the response to the San Bruno incident, a level 4 emergency.[57]

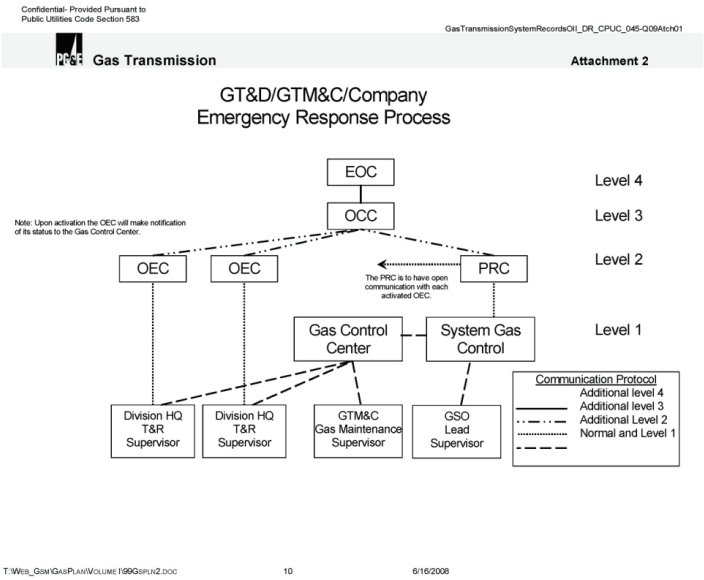
Figure 2

provides to its employees.[58] (Figure 2) Each center referenced is opened by a predefined manager within PG&E.[59] "EOC" is the Corporate Emergency Operations Center. "OOC" is the Operations Coordination Center. "OEC" is the Operations Emergency Center and "PRC" is the Pipeline Restoration Center. Not shown on the diagram, but referenced in the Company-wide Gas Emergency Response Plan is the "CCECC," or Call Center Emergency Coordination Center.[60]

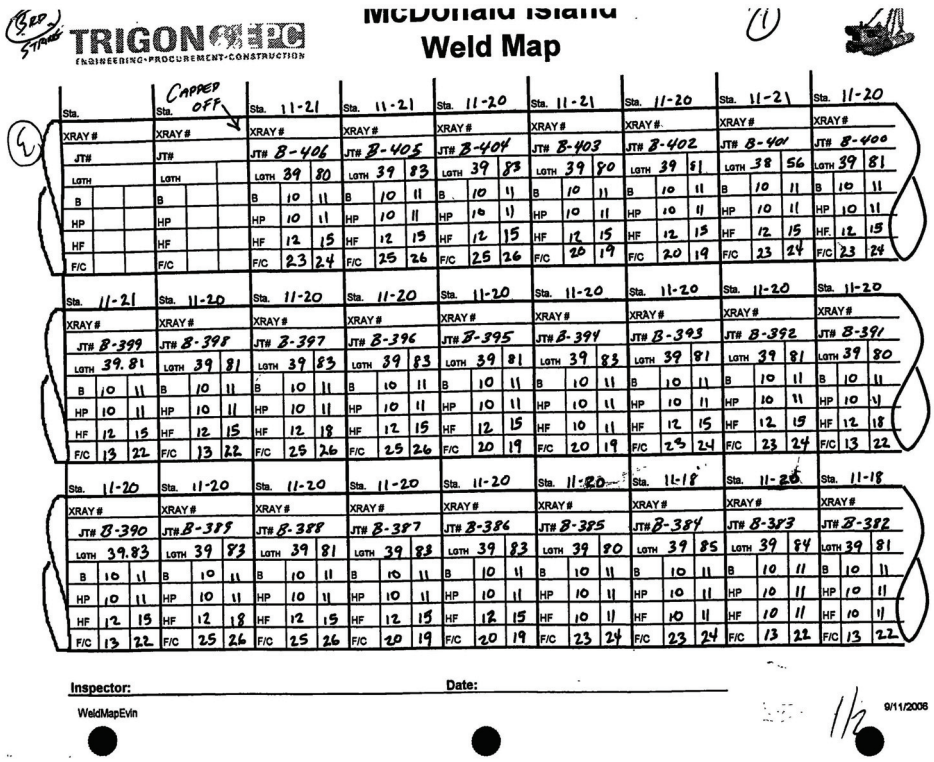
Figure 4[145]

Weld maps and inspection records for PG&E's transmission pipelines, which would normally be a source of key pipeline data for the integrity management risk assessment model, are mostly missing.[142]

The maps generated during a construction project that show the location and orientation of welds on a pipeline are called Mainline and Tie-in Weld Maps.[143] A thorough review of many job files in PG&E's new Enterprise Compliance Tracking System database revealed very few such weld maps, even though they should have been retained in the master Job File according to PG&E' policies.[144] These missing weld maps would provide invaluable information to PG&E in its current efforts to locate and evaluate welds.

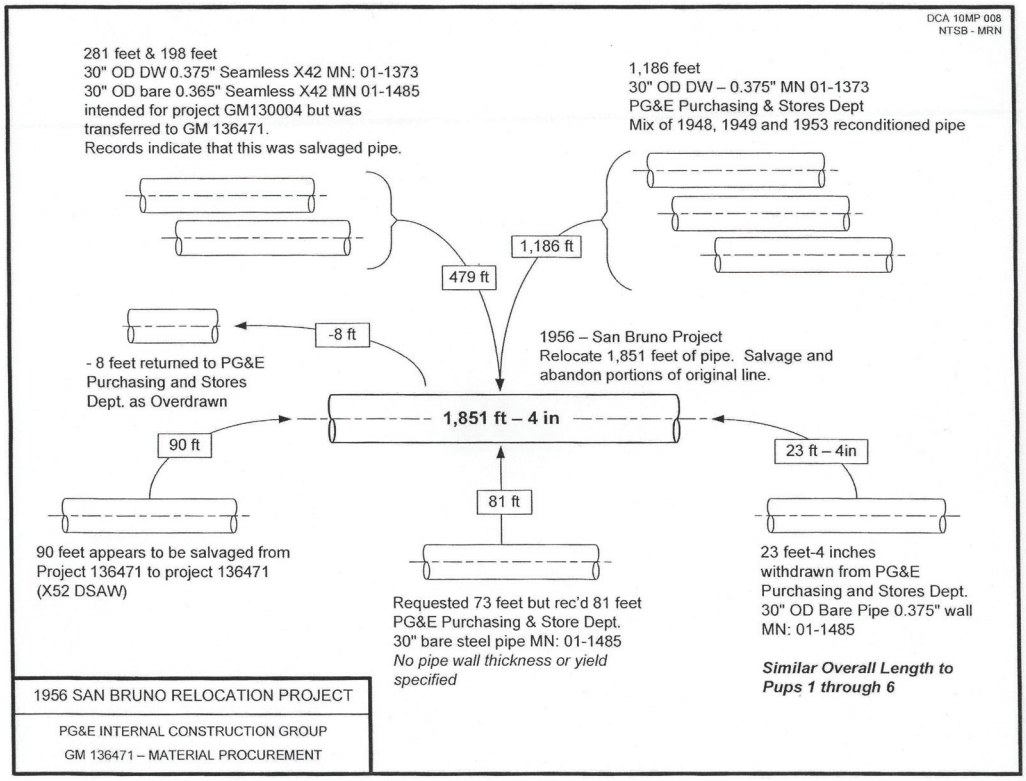
Figure 5[183]

In 1979, in what appears to be an intentional effort to eliminate records that show the use of salvaged pipe, PG&E's drafting instructions in Mapping Standards 410.21-1, section II.3, states "salvaged and abandoned mains – to be removed from plat sheets." The instructions offered no additional explanation as to why the information should be removed.[184] Generally, based on reviewing thousands of documents in the Enterprise Compliance Tracking System (ECTS) database, it appears that sometime in the 1980's PG&E lost the ability to track salvaged pipe.
