CPUC Audit Findings of Maverick Solar & BESS

GA2026-01MW

Corrective Actions and Planned Actions

EDF power solutions Services, Inc.

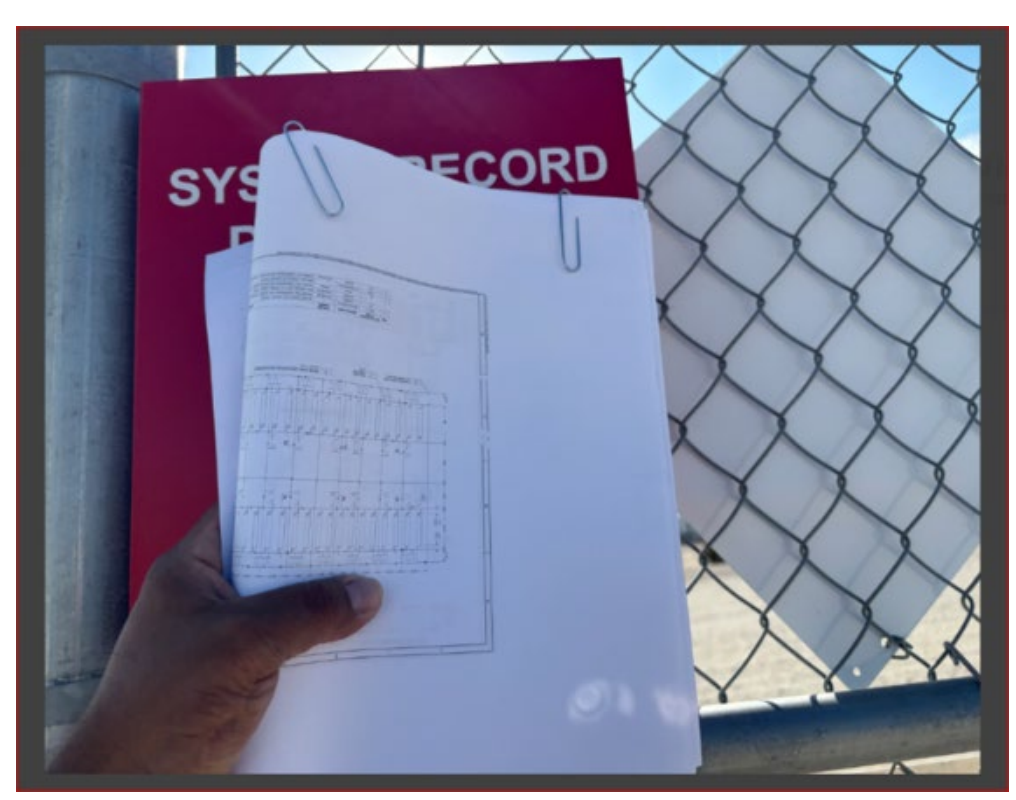
Finding 13; Page 1

<u>Finding 13:</u> First responder documentation cabinet not installed at the BESS entrance

Finding Evidence	Proposed Planned Action/Implemented Corrective Action by EDFps Services
BESS area does not have first responder documentation cabinet installed at the entrance.	- Implemented: First responder documentation cabinet has been installed at the BESS entrance and contains ERP, site map, and emergency contact info. Photographic evidence provided below.
