CALIFORNIA PUBLIC UTILITIES COMMISSION
Safety and Enforcement Division
Wildfire Safety and Enforcement Division

Incident Investigation Report

Incident Number: E20220602-03

Regulated Utility Involved: Pacific Gas and Electric Company

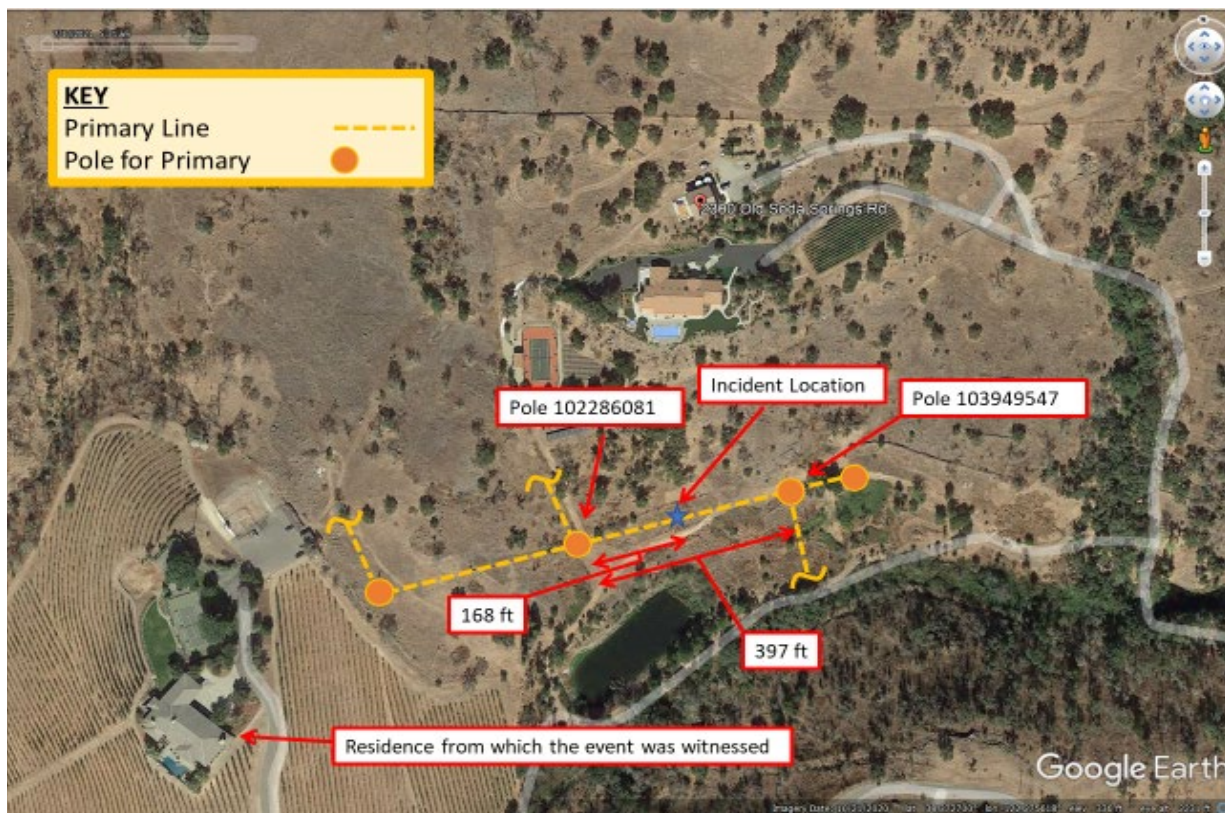
Figure 1 below shows a sketch of the Incident Location including the pole numbers, and the residence from which the witness saw the dust devil.

Figure 1: Sketch of Incident Location. Primary Line refers to the Subject Circuit conductors.

CAL FIRE reported that an eyewitness saw a dust devil near the middle of a span of the Pueblo 1105 (12kV) circuit. At the Incident Location, the circuit comprises of three conductors. The eyewitness reportedly saw a flash that appeared to emanate from the conductors and then saw a bush ignite. Figure 1 earlier in this report shows a map of the Incident Location and residence of the eyewitness. While SED was on site, SED observed a small dust devil as well.

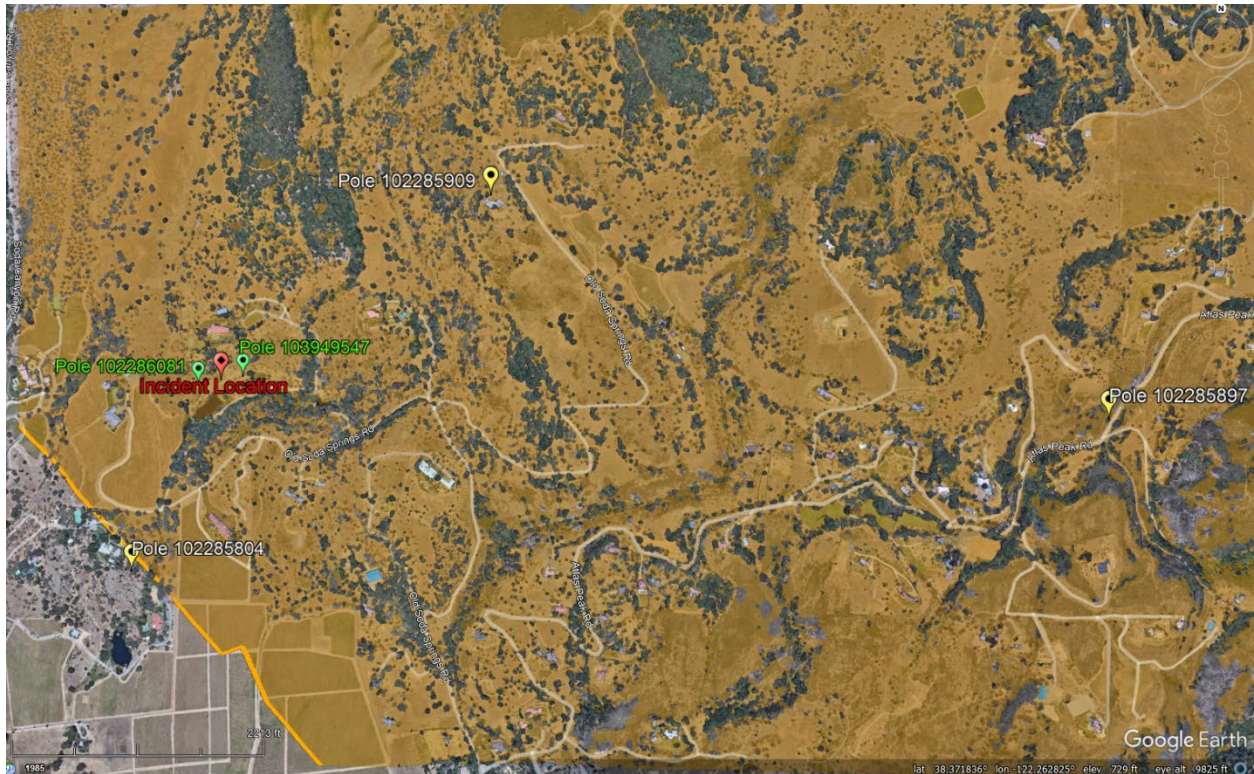
In 2016, PG&E observed that a number of poles in the vicinity of the Incident Location were missing high voltage signs.⁶³ Figure 15 below shows a map of a number of these poles in relation to the Incident Location. Missing high voltage signs is one of the exceptions to the requirements of GO 95 Rule 18, as stated in Appendix J of the GO, however, PG&E noted additional higher priority maintenance issues during Field Safety Reassessments (FSRs) of three poles in the vicinity of the Incident Location: Pole 102285897, Pole 102285909, and Pole 102285804. These higher priority issues fell into the Level 2 priority category and have a due date of 12 months within a Tier 2 HFTD per GO 95 Rule 18.

Figure 15: Map of Poles with Late Work Orders Near Incident Location. Orange overlay indicates Tier 2 HFTD.

This pole is located at the boundary of the Tier 2 HFTD as shown in Figure 15. Failure of this pole has the potential to ignite a fire that could easily burn into a Tier 2 HFTD. GO 95 Appendix I lists damaged poles as a Level 2 issue, and the potential for the pole to fail poses a risk that could ignite a fire in a Tier 2 HFTD. Therefore, Rule 18 requires PG&E to address this issue within 12 months. PG&E set an April 6, 2022 deadline to correct the issue, but PG&E had not resolved the issue as of August 25, 2022.⁷⁷
