Appendix F

ANALYSIS FROM AVAILABLE TECHNICAL INFORMATION ON PIPELINE RUPTURE

By Dr. Robert E. Nickell

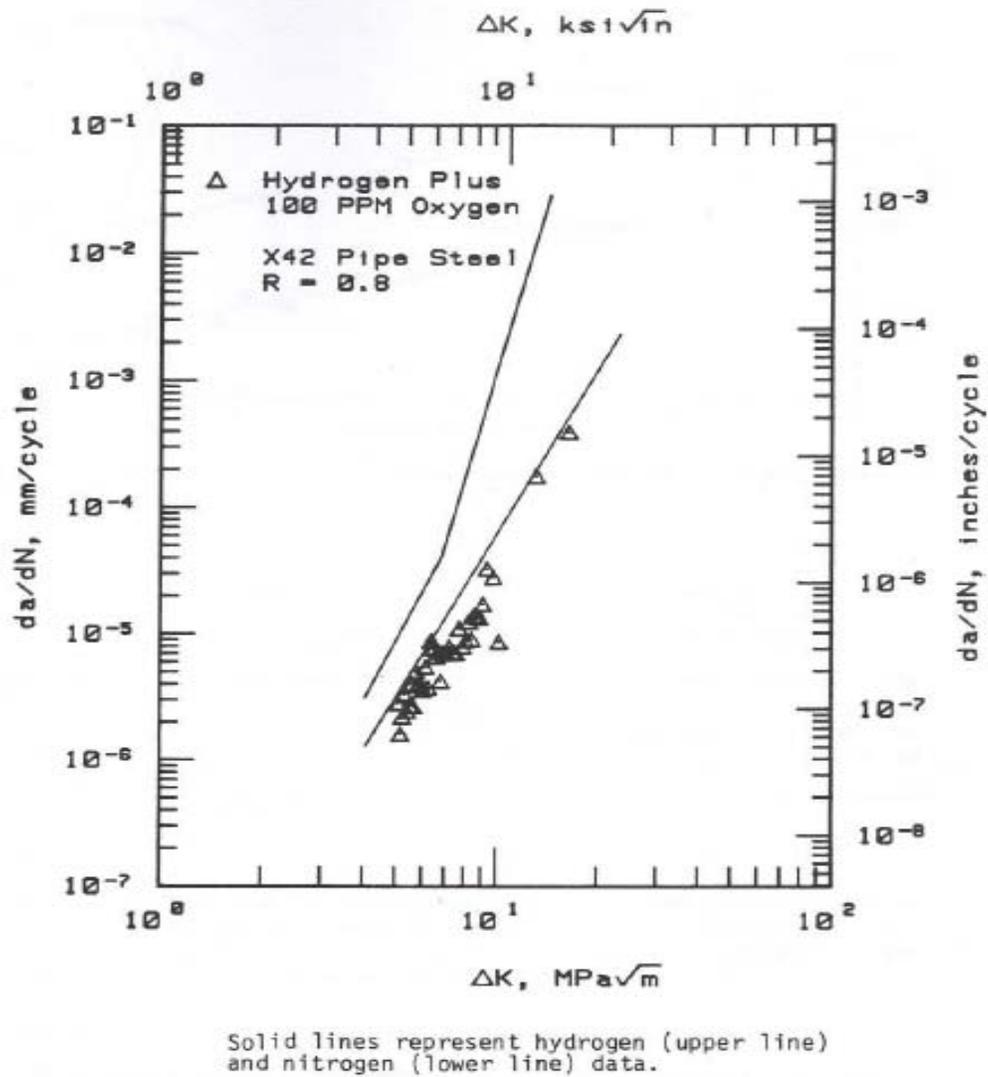
Figure F5

In this case, for ΔK of $35 \text{ ksi}\sqrt{\text{in}}$ (a full pressurization and complete depressurization cycle), the amount of defect growth for one cycle per year and 60 years of operation would be about 0.006 inches. For ΔK of $7 \text{ ksi}\sqrt{\text{in}}$, the growth for a daily cycle for 60 years would be about 0.018 inches. The combination of cycles could take a defect that is 55% through wall (0.206 inches deep in a 0.375-inch-thick wall) to a defect that is still less than 65% through wall.

Therefore, even assuming annual start-up/shut-down cycles and thousands or hundreds of thousands of modest pressure fluctuation cycles, the amount of stable propagation of the initial defect in the radial direction could possibly lead to a critical and unstable defect in PUP 1 only if the fracture toughness in the longitudinal seam weld and its heat-affected zone were of the order of $35 \text{ ksi}\sqrt{\text{in}}$. Such a scenario is certainly plausible, but no clear evidence of such growth is available from the NTSB metallurgical evidence.
