# LA Metro Safety Issues at the Blue Line-Expo Line Rail Junction

**Daren Gilbert**

***Program Manager, Rail Transit and Crossings Branch***

September 13, 2012

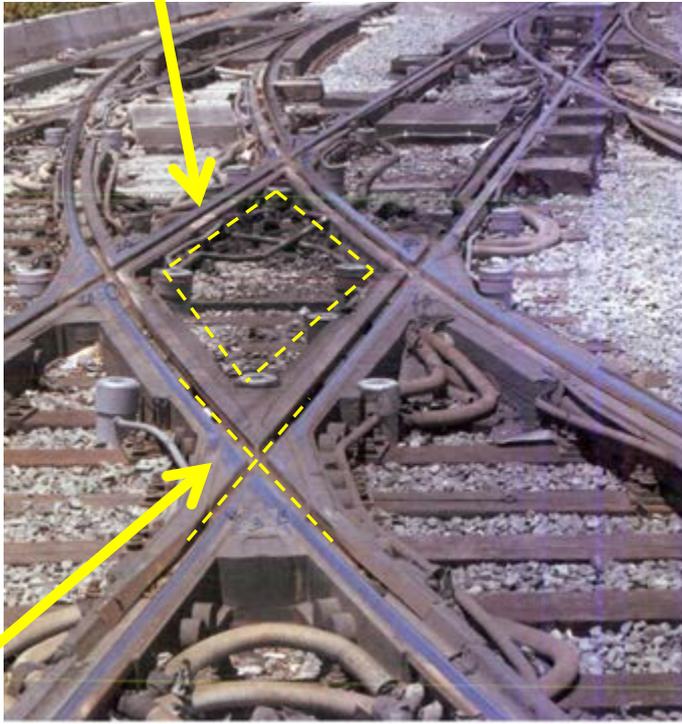
- The junction is also known as the “diamond” due to the resulting shape of the intersecting tracks.
- The support structure where the rails intersect is called a “frog,” and provides a gap for a wheel flange to cross through an intersecting rail.
- There are four frogs in the diamond, and two more in the distance.

diamond

frog
