**CALIFORNIA PUBLIC UTILITIES COMMISSION**  
**Safety and Enforcement Division**  
**Wildfire Safety and Enforcement Branch**

**Incident Investigation Report**

**Incident Number:** E20220908-02 (Mosquito Fire)

**Regulated Utility Facilities Involved:** PG&E's Middle Fork #1, Oxbow Tap and Weimar #1 60 kV transmission circuits

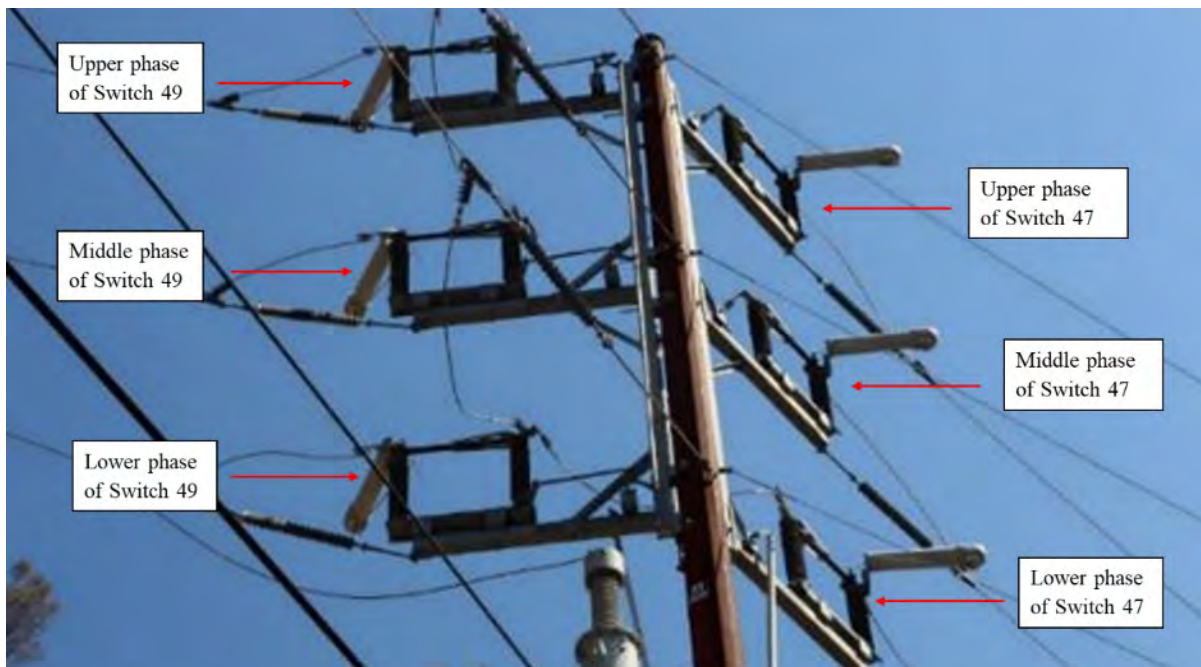
Figure 4: Switches 47 and 49 on Oxbow Junction Pole<sup>33</sup>

PG&E staff informed SED investigators that Switch 47 controls the connection of the Middle Fork #1 60 kV circuit to the Oxbow Junction Pole and is normally open, preventing the flow of power between this circuit and the pole.<sup>32</sup> Switch 49 controlling the Weimar #1 circuit is normally closed. Both switches can be opened and closed either manually or remotely. Each circuit and switch includes three phases (i.e. top, middle, and lower phase based on the respective location on the pole) for a total of six phases between the two switches as shown below in Figure 4.

All phases for both Switches 47 and 49 appeared closed, meaning that the end of the blade that rotates touched the jaws and closed that connection as shown in Figure 5 below.

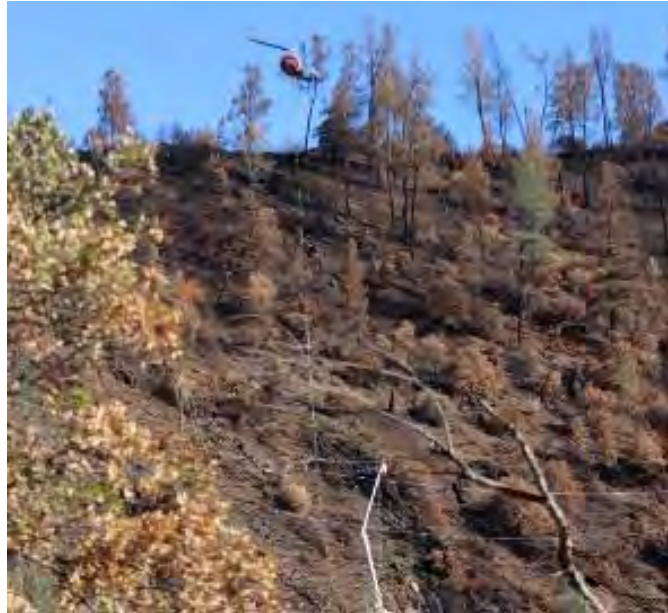
**Figure 14: Conductor collection by helicopter and bucket truck<sup>48</sup>**

The condition of the conductors prior to collection appeared unchanged from the September 30, 2022, site visit. The ends of the Weimar circuit #1 conductors that were previously connected to the Oxbow Junction Pole lay on the ground. The conductor serving Middle Fork #1 circuit was spliced together in the air with conductor serving the Oxbow Tap.<sup>49</sup>

PG&E collected conductor sections, as shown in Figure 14 above, using two helicopters and a bucket truck. PG&E's contractor then inspected and collected the conductors as evidence.

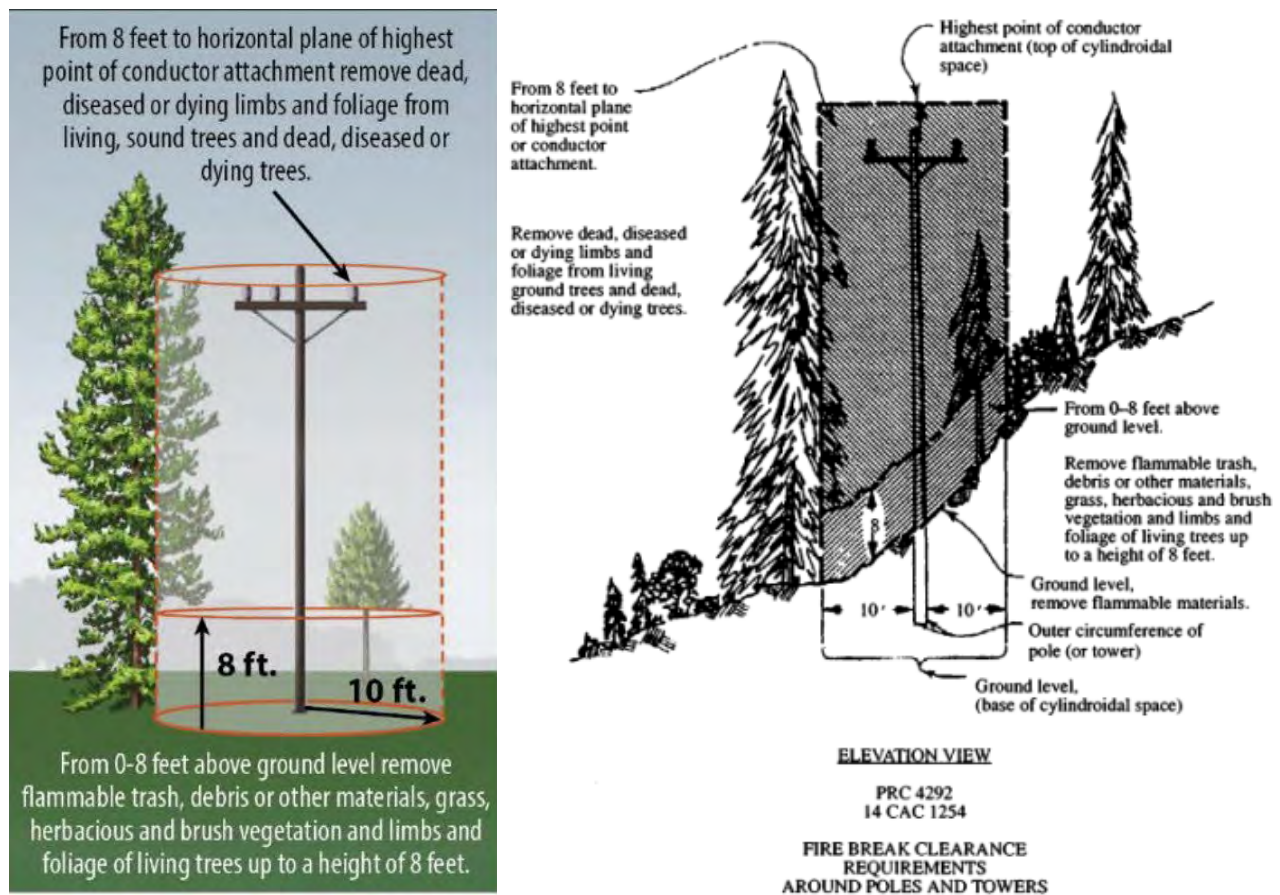
Figure 28 below (left image) below illustrates the requirements including clearing the ground within a 10-foot radius of the pole and to a height of eight feet above ground level.<sup>105</sup> Figure 28 (right image) shows the requirement to clear a cylinder up to eight feet above ground for a sloped surface.

**Figure 28: Pole clearance requirements for level ground (left)<sup>106</sup> and sloped ground (right).<sup>107</sup>**

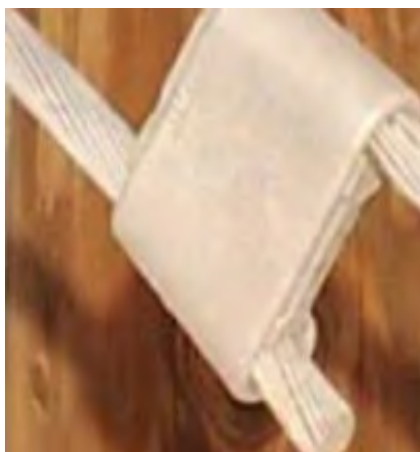
Figure 40: Photo of fully inserted wedge from PG&E manual<sup>174</sup>

PG&E’s May 27, 2022, Transmission Notification inspection summary for Pole 014/187 shows that a PG&E inspector and a PG&E SME agreed to recommend repairs for "4 jumper connectors not shot or seated" as shown in Figure 39 below.<sup>172</sup> PG&E inspection manuals show that the wedge connector is normally fully inserted, as shown for example in Figure 40 below.<sup>173</sup> In contrast, the partially inserted wedges at Pole 014/187 are not normal.

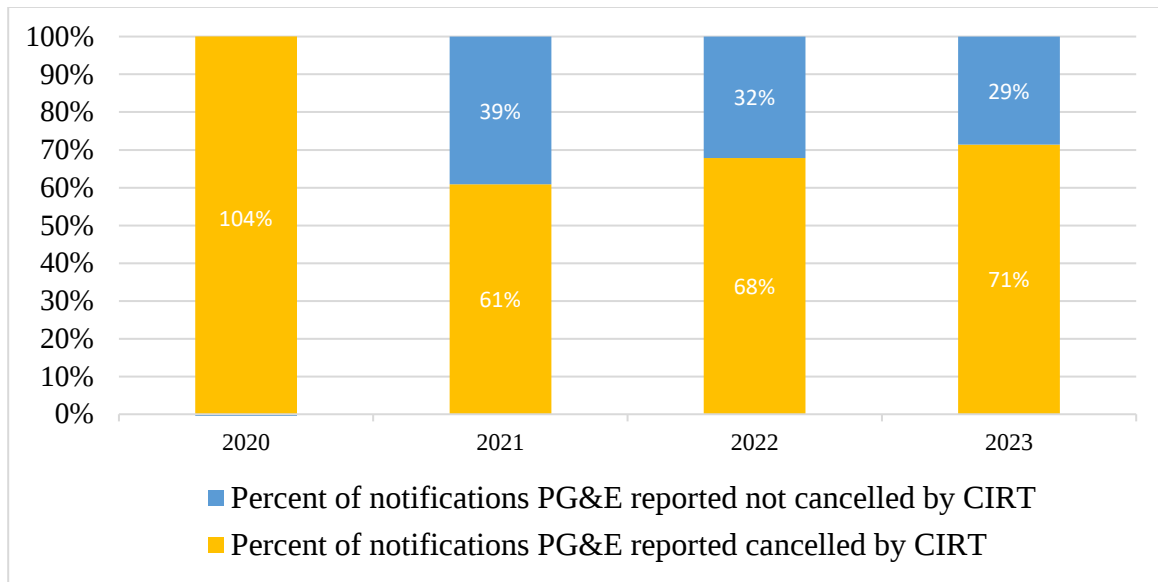
During this period, CIRT canceled the majority of repairs recommended in transmission inspection reports created by PG&E inspection staff and approved by a PG&E SME. Specifically, SED found that CIRT reviewed 447,365 recommendations and cancelled approximately 314,000 of the 447,365 recommendations reviewed, as shown in in Figure 44 below.<sup>197</sup>

Figure 44: CIRT rate of notification cancellation  
(PG&E data for CIRT notification cancellations in 2020 is approximate and exceeds PG&E data for number of 2020 notifications reviewed by 4%).<sup>198</sup>
