CALIFORNIA PUBLIC UTILITIES COMMISSION
Safety and Enforcement Division
Wildfire Safety and Enforcement Branch

Incident Investigation Report

Incident Number: E20220905-03 (Fairview Fire)

Regulated Utility Involved: Southern California Edison Company (SCE)

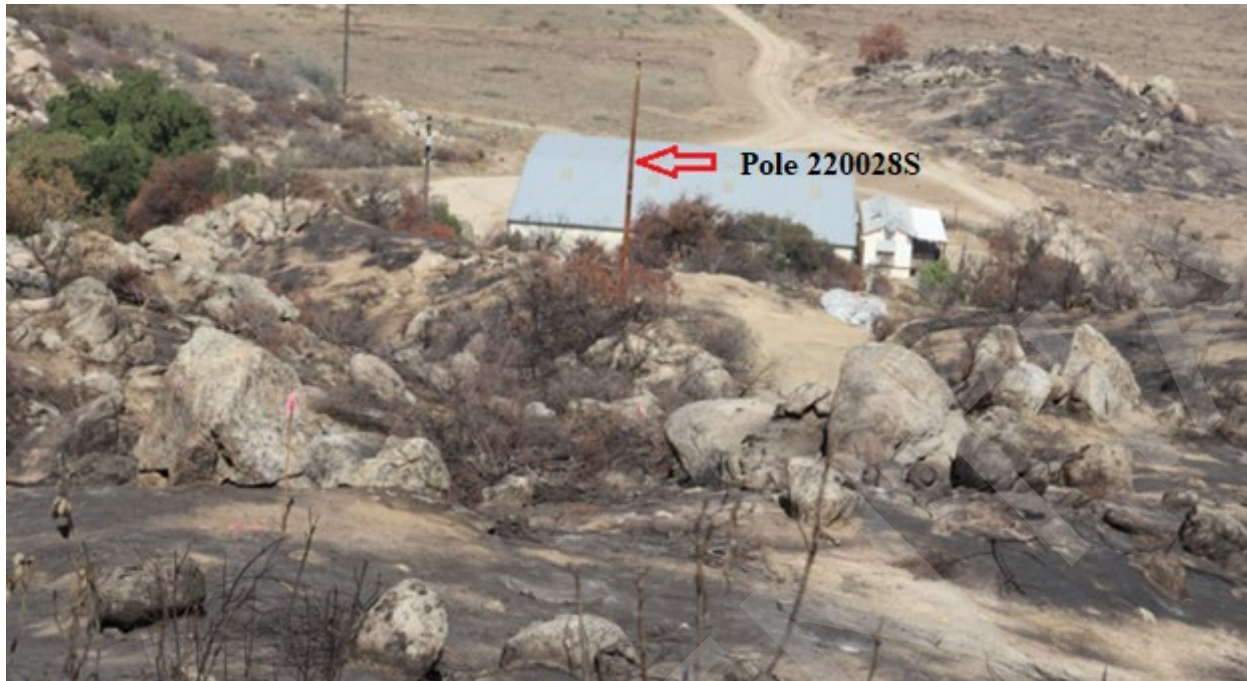
Figure 7: View of Incident Span between Incident Pole 220029S at the top of hill (behind the camera) and Pole 220028S (brown pole in front of barn).

SED investigators used a range finder to estimate the distance between Incident Pole 220029S (See Figure 8) and Pole 220028S (See Figure 9) to be approximately 480 feet from the base of Pole 220028S to the top of Incident Pole 220029S. Prior to the site visit, SED was informed by CAL FIRE that it collected approximately 400 feet of conductor as evidence, which would match the entire span between the poles.

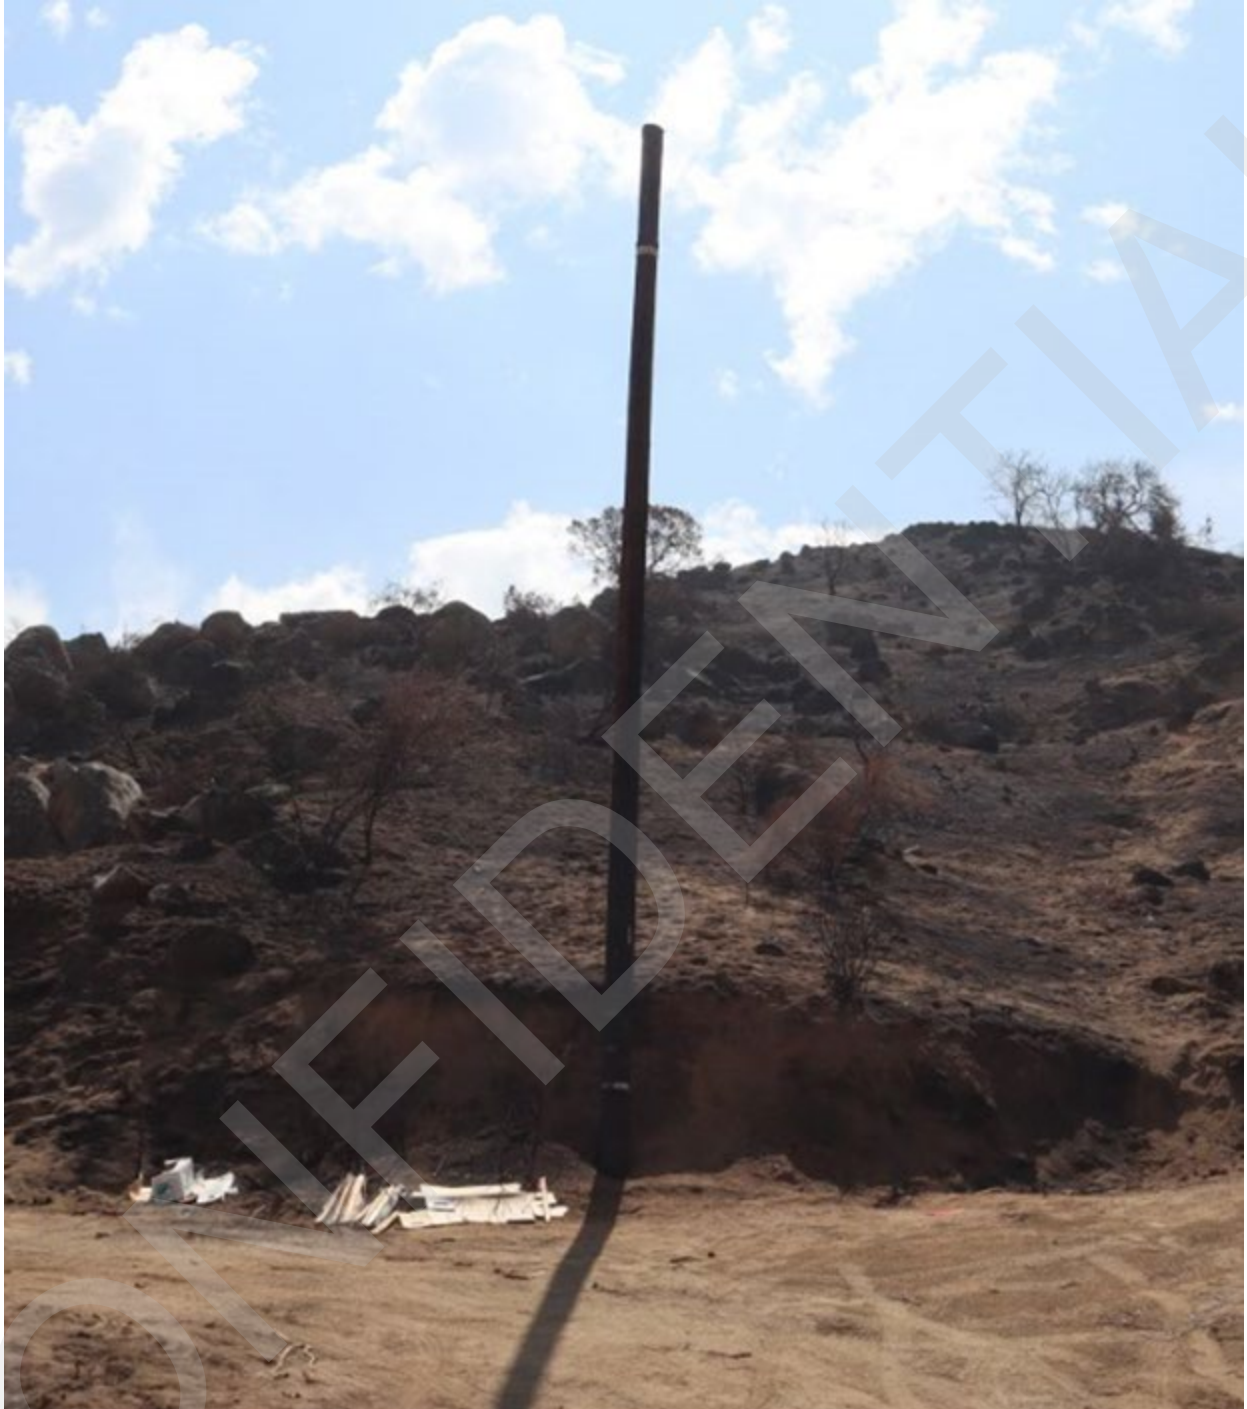
Figure 8: Incident Pole 220029S without the crossarms, conductor lines, and telecommunication lines which were removed and collected by CAL FIRE.

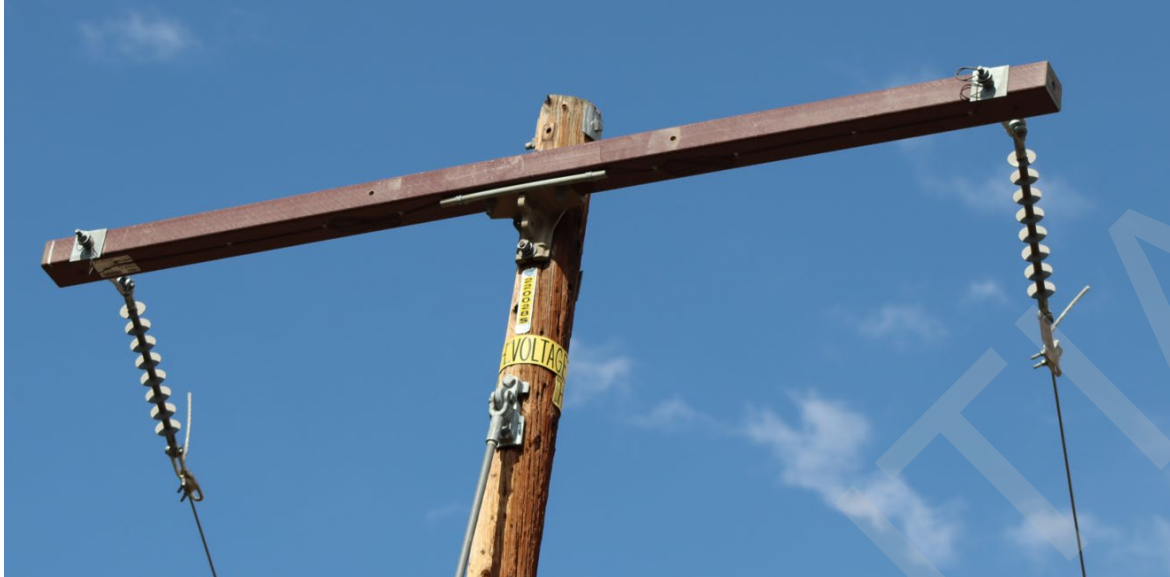
Figure 9: Close up view of Pole 220028S at the bottom of the Incident Span with conductor lines and communication lines collected by CAL FIRE.

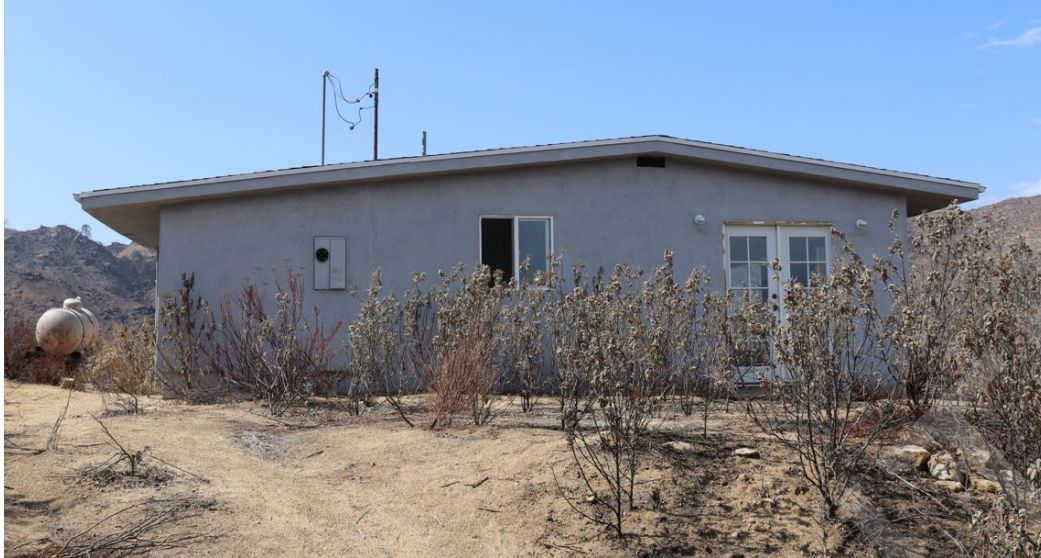
SED investigators asked SCE staff about the unoccupied structure (See Figure 12) to the west of Incident Pole 220029S, and SCE staff stated that the structure had been disconnected from the Subject Distribution Circuit branch line before the Fairview Fire incident but did not know the exact date of the disconnection and would need to look through internal records in order to determine this information. In addition, SCE staff stated that they believe the property owner did not have proper permits for the structure to be a dwelling unit and that may be the reason why the structure was disconnected from service. Lastly, SCE staff stated that the dead-end Incident Pole 220029S did not have a transformer installed, and that the Incident Span was energized during the incident but did not serve any equipment.

Figure 12: Unoccupied structure on the top of the hill, which was unconnected to the dead-end Incident Pole 220029S.

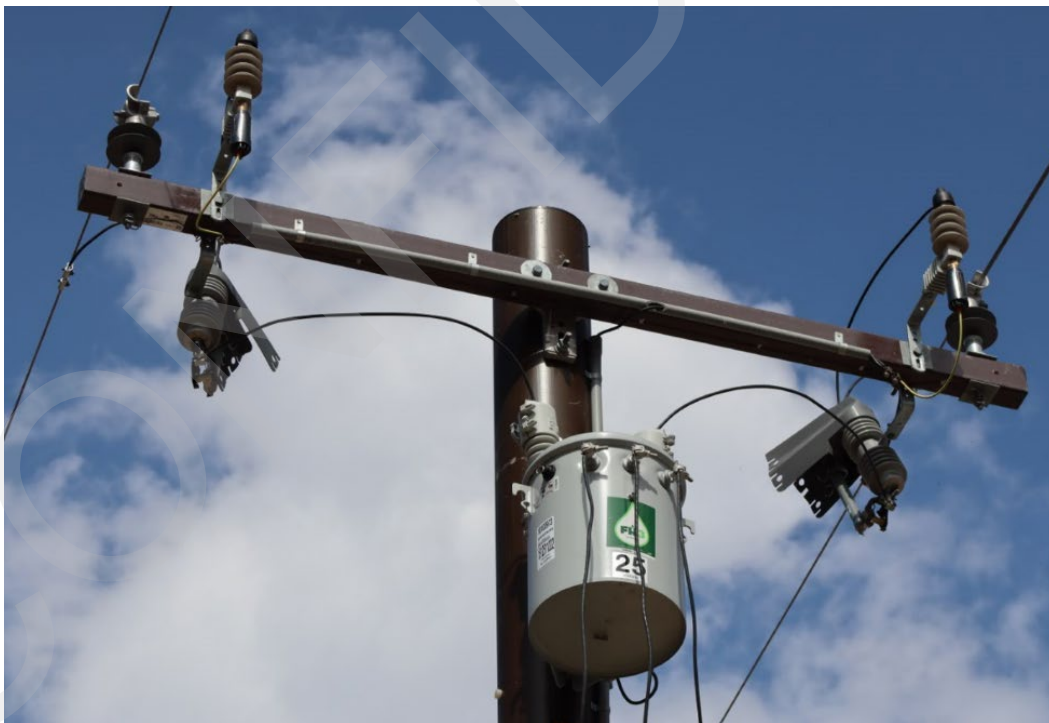
After walking the Incident Span, SED investigators arrived back at the private barn and Pole 4943353E (See Figure 13). SED investigators asked SCE staff to explain why the fuses at Pole 4943353E serving the barn did not blow and SCE staff explained that the fuses at this location are current limiting fuses which protect the circuit line from the transformer rather than to protect the transformer from the line. In addition, SCE staff explained that these types of current limiting fuses do not activate when there is a fault on the distribution primary circuit.

Figure 13: Pole 4943353E with a transformer and the current limiting fuses serving the private barn.

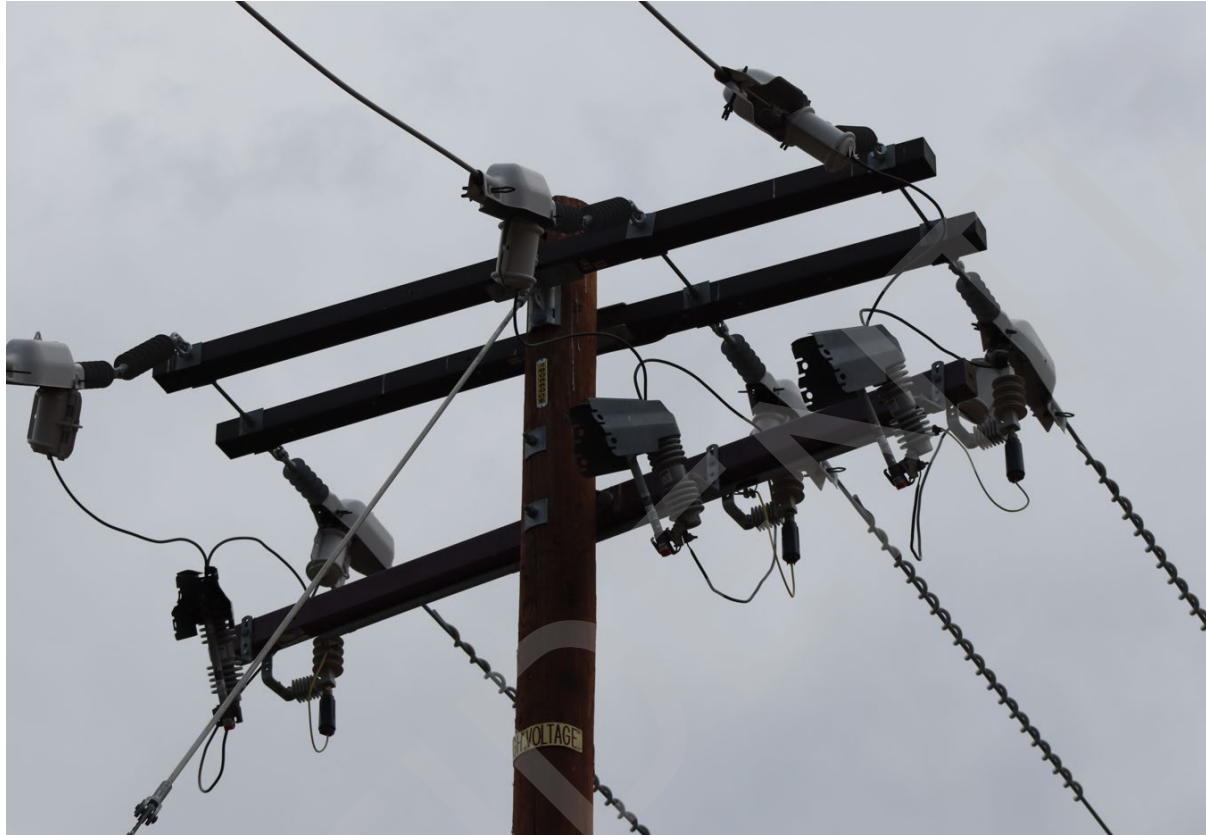
SED investigators drove with SCE staff to Pole 4905500E. This pole is located just inside the private gate and supported the three power fuses that SCE collected, including the East phase fuse that blew eight minutes before the Fairview Fire reportedly started. Pole 4905500E had new fuses installed at the time of the site visit and is shown in Figure 14.

Figure 14: Pole 4905500E serving a branch line of the Subject Distribution Circuit into private farmland.

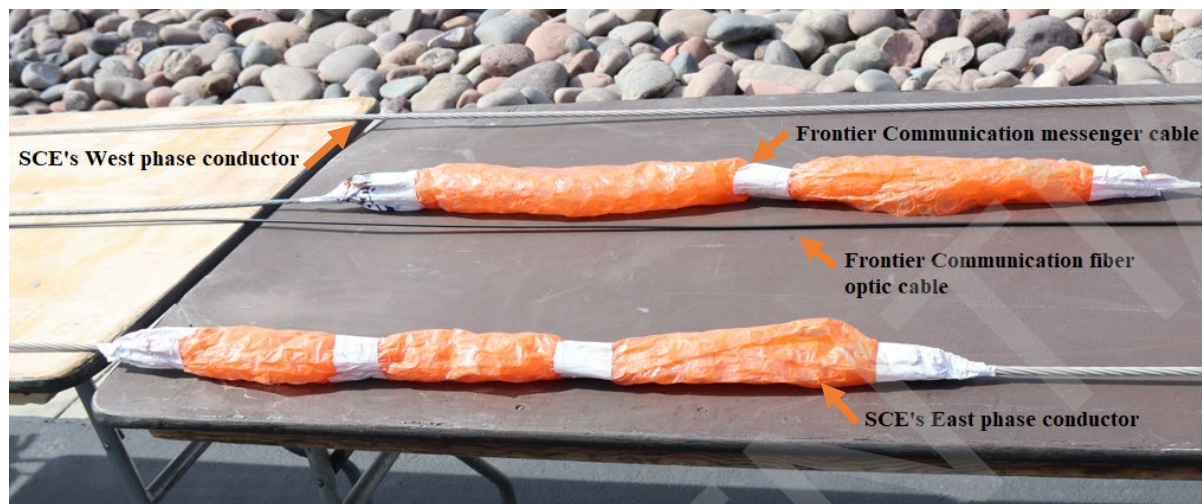
As shown in Figure 16 below, CAL FIRE bubble wrapped areas of interest on the Frontier Communications messenger cable and SCE's East phase conductor.

Figure 16: SCE's East and West phase conductors and Frontier Communications' fiber optic cable and messenger cable.

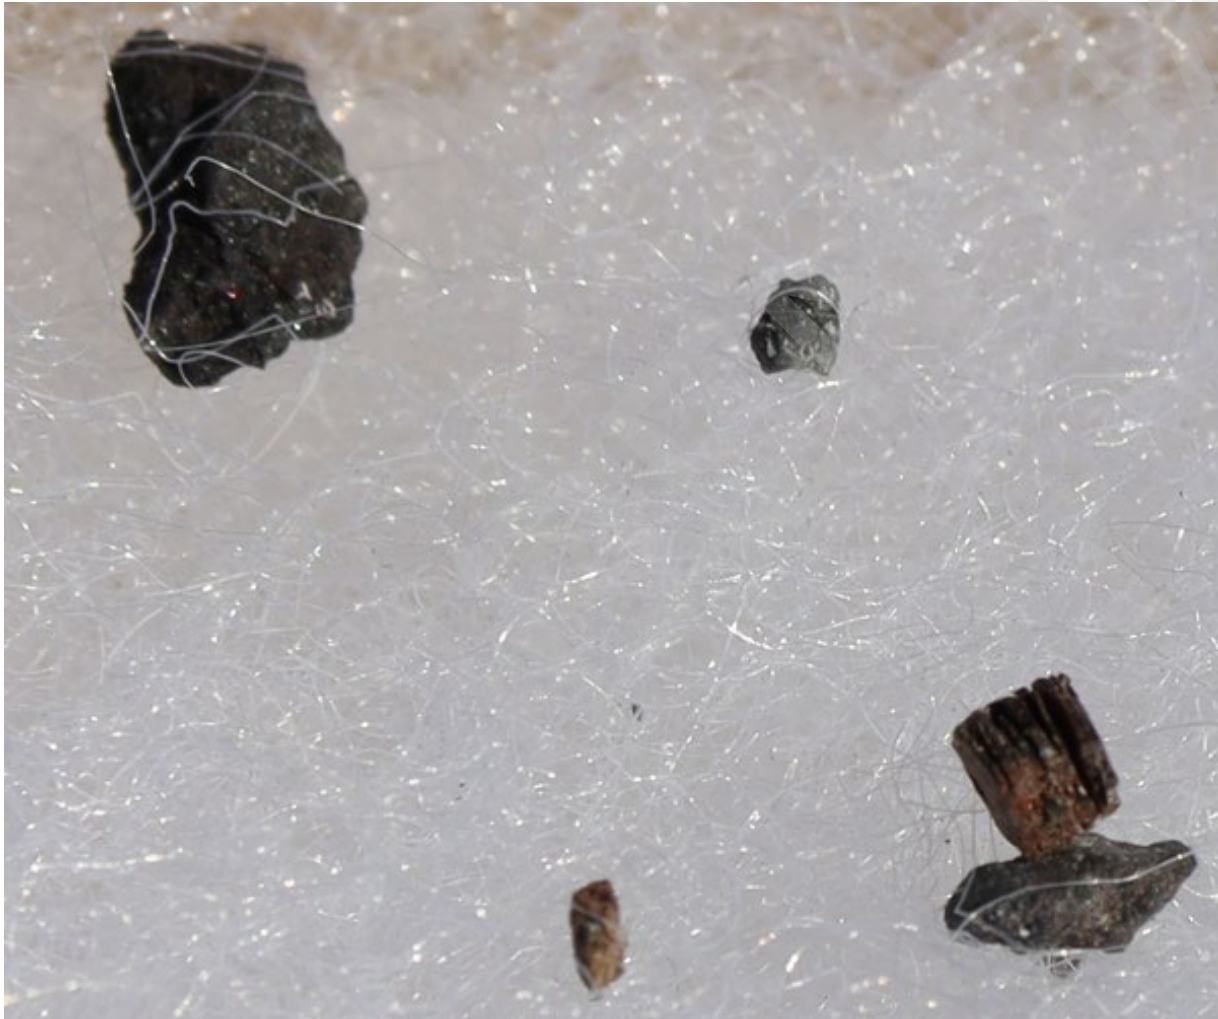
CAL FIRE staff opened and displayed several metallic fragments collected by CAL FIRE investigators at the Incident Location on September 8, 2022. As seen in Figure 20 below, the metallic fragments appear to have broken off or separated from a larger metal structure. SED investigators were unable to verify if the metallic fragments melted off of SCE's East phase conductor or the Frontier Communications messenger cable.

Figure 20: Miscellaneous metal pieces/fragments recovered by CAL FIRE at the Incident Location.

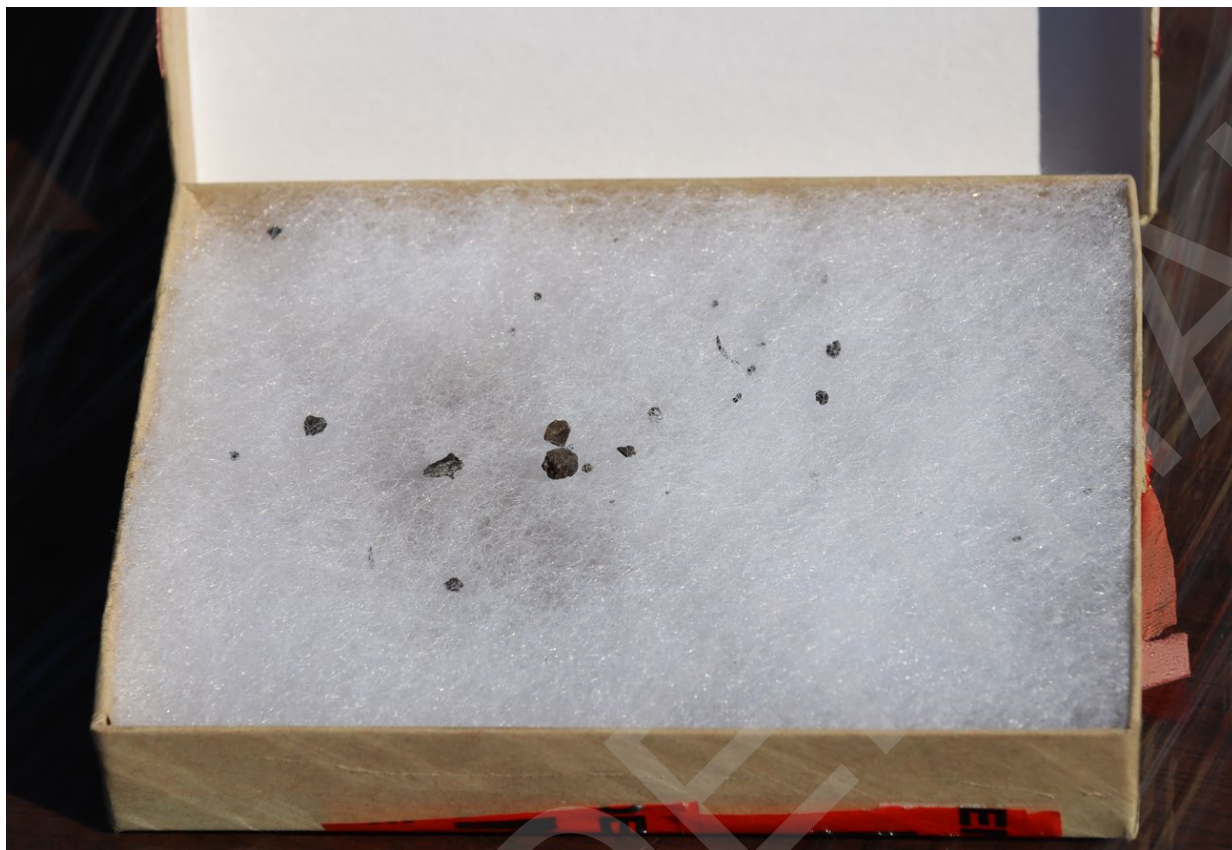
In addition, CAL FIRE staff displayed several pieces of fire debris collected at the Incident Location using a magnet on September 10, 2022. The fire debris is shown in Figure 21 below.

Figure 21: Fire debris collected by CAL FIRE using a magnet.

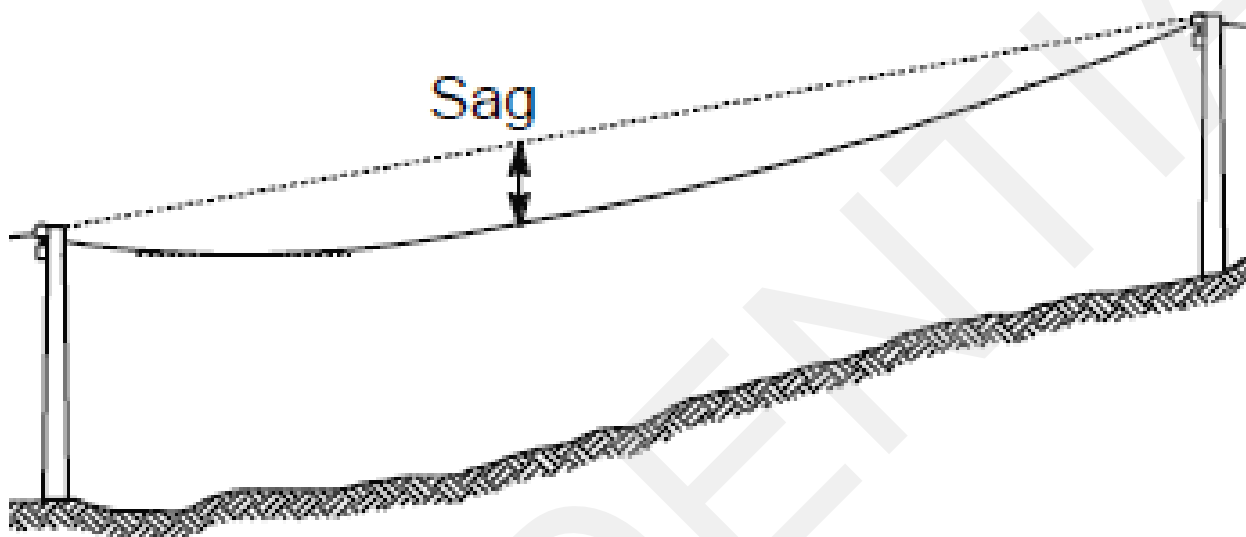
explanation or identify a specific reason why the phase 1A and phase 1B conductors in the Incident Span were sagging below SCE's allowable limit as far back as June 2, 2020.⁴⁴

GO 95, Rule 23.3(b) defines the apparent conductor sag as the maximum distance measured vertically in a given span from a straight line between the two points of support of the span at uneven ground.⁴⁵ Thus, per Rule 23.3(b), the sag measurements of the phase 1A and phase 1B conductors are shown in Figure 25 below.

Figure 25: Profile drawing of conductor sag measurements, as defined by GO 95, Rule 23.3(b).

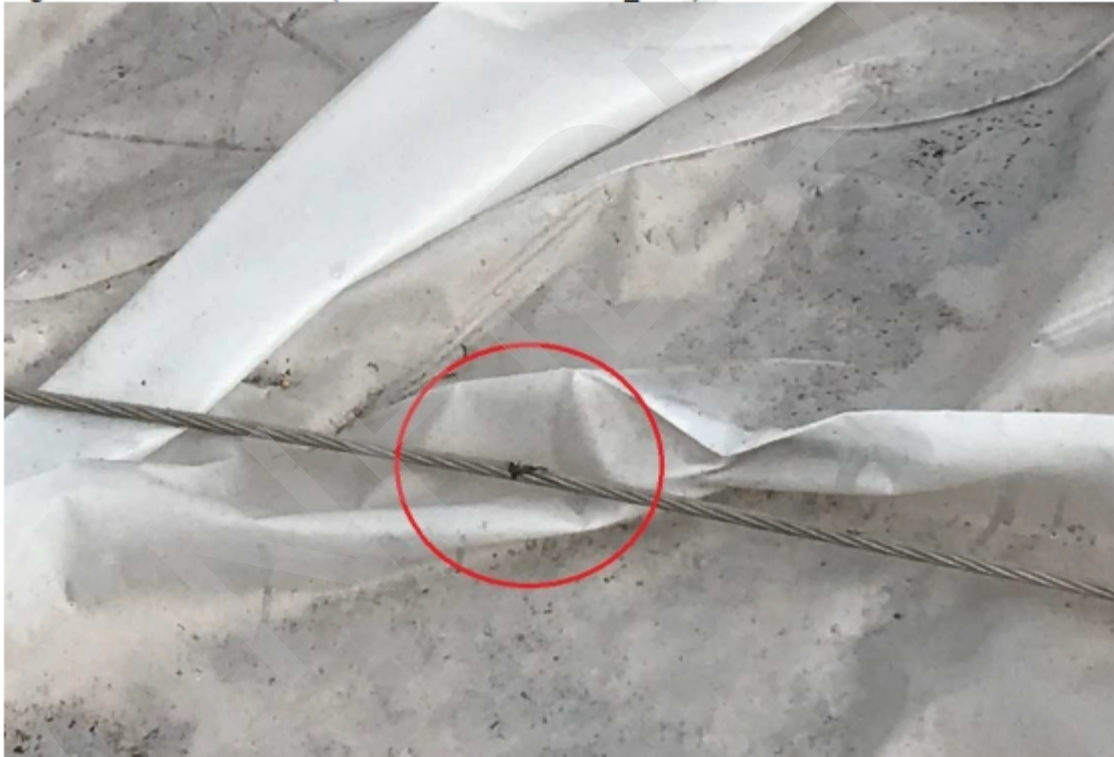
Figure 4: Conductor Phase (source: SCE-CPUC-IMG_3590)

In response to DR-01 Question 39, submitted on 04/28/2023, SCE provided photos taken on 09/12/2022. Reference Figure 4 below and:

- a. Identify if the conductor shown in Figure 4 is A Phase (1A)
- b. Identify the location where the picture in Figure 4 was taken.
- c. Confirm if the encircled area in Figure 4 is consistent with damage from electrical arcing.

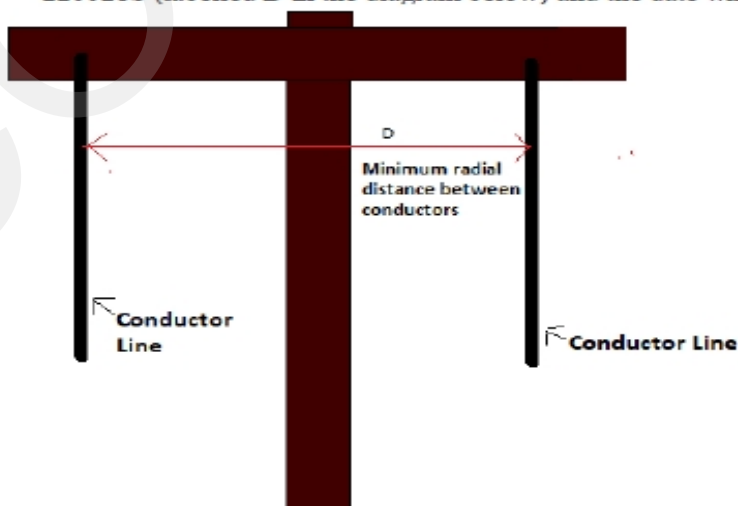
- c. Provide the minimum radial distance between the conductor lines on Pole 220029S and Pole 220028S (labelled D in the diagram below) and the date when this measurement was taken.

SCE interprets this Request to call for the interpretation of the most recent pre-fire LiDAR and not to call for the interpretation of post-fire LiDAR taken by SCE's litigation experts. LiDAR for structures/spans from 220029S to 20678S and 220028S to 220029S was collected on October 13, 2020, and December, 22, 2020 respectively for responses 8.a. – 8.c.
