Incident Number: 24CAAEU0018665

PACIFIC GAS AND ELECTRIC COMPANY
PG&E Reference Number: EI240706A
Electric Incident - 20 Day Report

PACIFIC GAS AND ELECTRIC COMPANY
PG&E Ref. DRU14826-Electric Incident-EI240706A-Placerville-Property Damage-
2024 Pay Fire
Data Request CPUC ESRB-SED
Requester DR No. SED-02-PAY FIRE

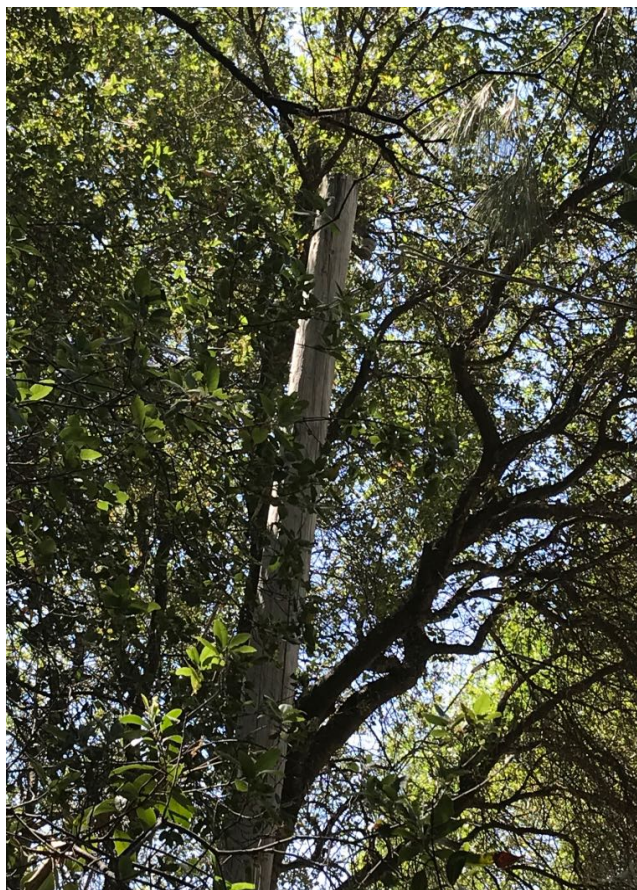
Attach Photo of the top 1/3 of the pole

Conductor	
Does this structure have PG&E owned conductor?	Yes
Conductor Issues	<ul style="list-style-type: none"> • No Conductor damage or compelling abnormal conditions to report
Equipment	
Does this structure have equipment?	No
Anchor & Guys	
Does or should this location have a Guy?	No
Hardware Framing	
Is Hardware Framing present on this structure?	Yes
Hardware Framing Issues	<ul style="list-style-type: none"> • No Hardware Framing damage or compelling abnormal conditions to report
Vegetation	
Does this structure have vegetation present?	Yes
Vegetation - EC Specific Tags	<ul style="list-style-type: none"> • Tree causing strain or abrasion to secondary or service (only 1 service)
Vegetation - Vegetation Specific Tags	<ul style="list-style-type: none"> • No vegetation issues or compelling abnormal conditions to report for the EC in accordance with GO95, PRC 4292, PRC 4293
Non-Time-Dependent Issues	
Non-Time-Dependent Issues	<ul style="list-style-type: none"> • No non-time dependent or compelling abnormal conditions to report

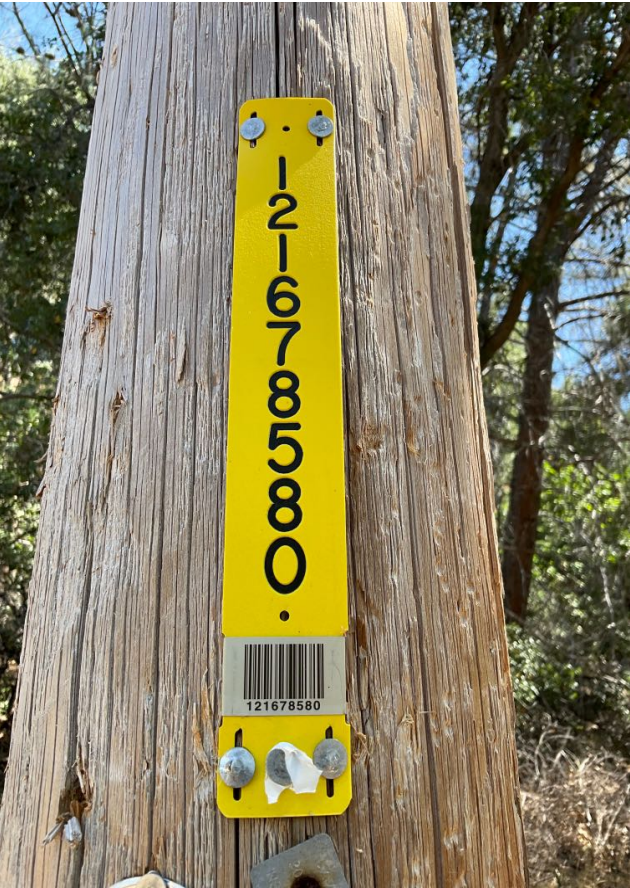
Attach photo of pole number

Structure (Distribution Pole)	• No structure damage or compelling abnormal conditions to report
-------------------------------	---
