JOB# J-045679

SCN RESOLUTION & PHOTO

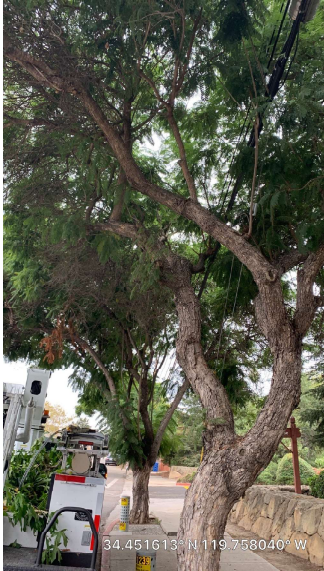
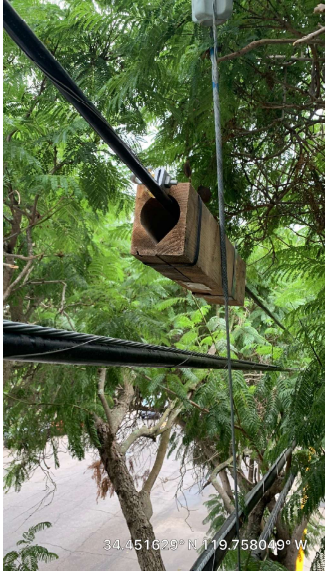
Before Photo #2 (If Necessary)	After Photo #2 (If Necessary)

Crown Castle communications conductor supported on Pole number 1081714E was touching a third-party communication down guy wire
1061 Foothill Rd Santa Barbara, Ca 93110

Placed Box Guard
Trimmed Tree 100'

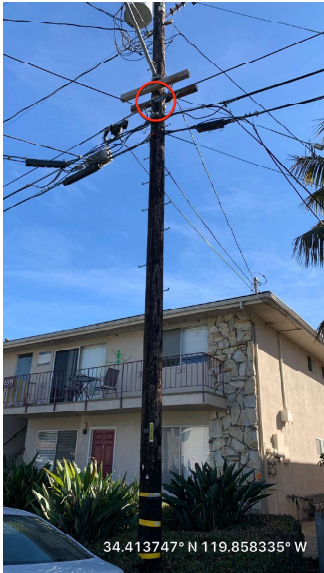
Before Photo #2 (If Necessary)	After Photo #2 (If Necessary)

The ground moulding attached to each of the following poles was damaged
EMBARCADERO DEL MAR P/P 330 W 920 N/O TRIGO RD

Placed Molding Stick, Fiber Tag and Guy Guard on Down Guy

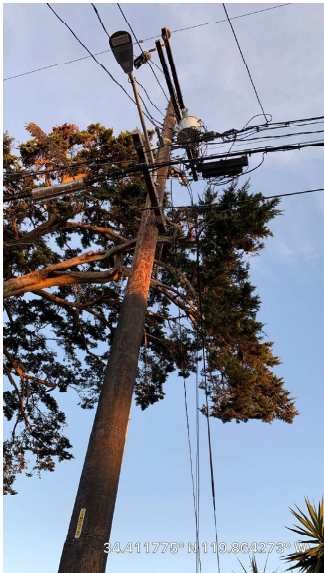
Before Photo #3 (If Necessary)	After Photo #3 (If Necessary)

Crown Castle communications conductor was touching a third-party communications service drop.
PASADA RD N/S 470' W/O CAMINO DEL SUR

Fixed Box Guard and Spec Hardware
Re-tension span
Removed Drops from Lead and Placed Fiber Tag

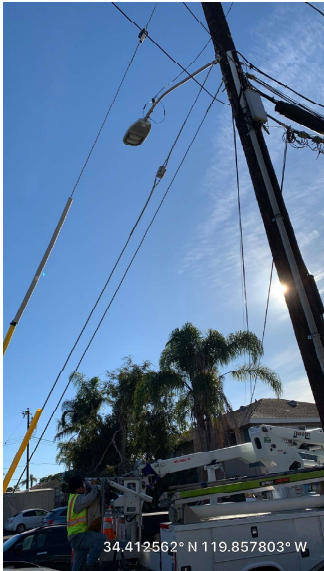
Before Photo #2 (If Necessary)	After Photo #2 (If Necessary)

The Crown Castle down guy wire supporting Pole 1256346E was not taut
CAMINO PESCADERO P/P 260' E 1' S/O SL/O SUENO RD EXTD

No Work Needed

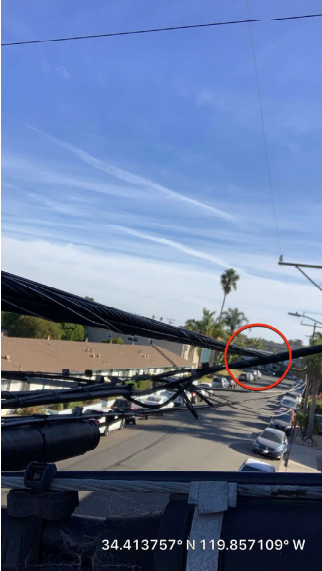
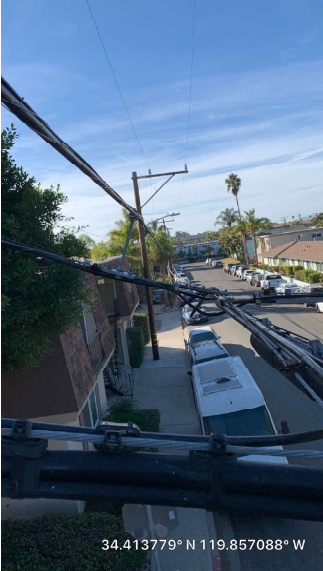
Before Photo #2 (If Necessary)	After Photo #2 (If Necessary)
<div>

Crown Castle communications conductor was touching a third-party communications conductor.
EMBARCADERO DEL MAR W/S 910' N/O TRIGO RD

Placed Spreader Bolt

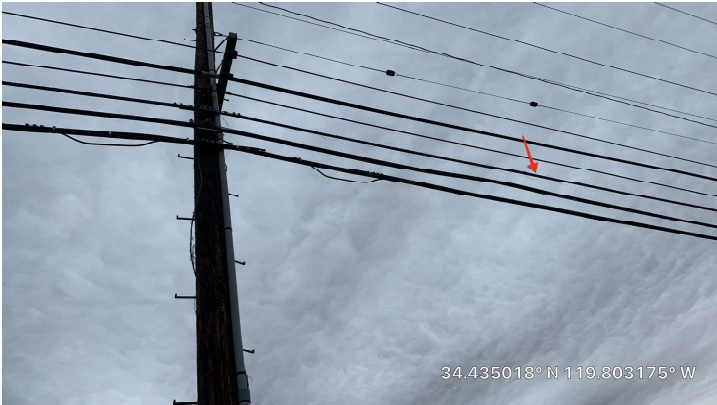
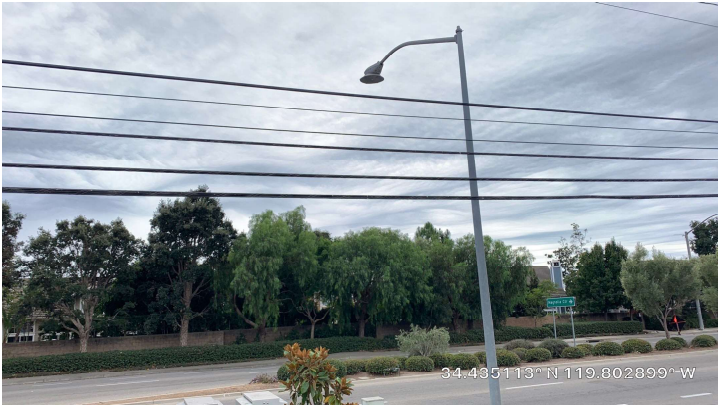
Before Photo #2 (If Necessary)	After Photo #2 (If Necessary)

Crown Castle lashing wire was broken

Placed Fiber Tag
Repaired Lashing Wire

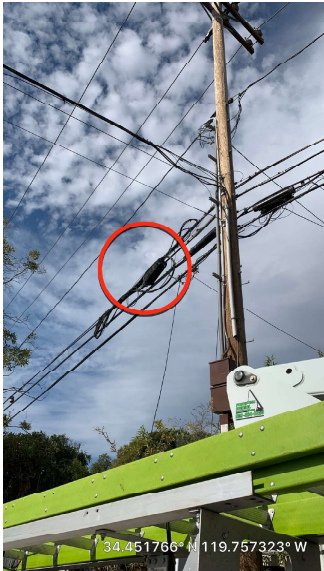
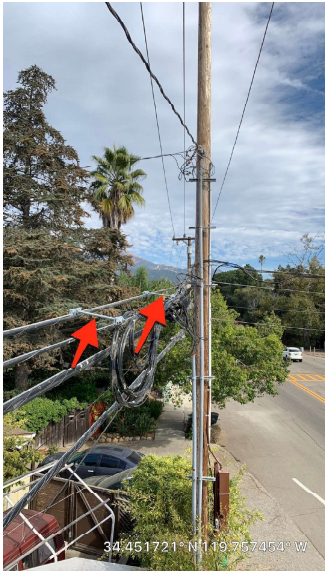
Before Photo #2 (If Necessary)	After Photo #2 (If Necessary)

Crown Castle communications conductor had less than 12 inches of vertical separation from a third-party communications conductor.

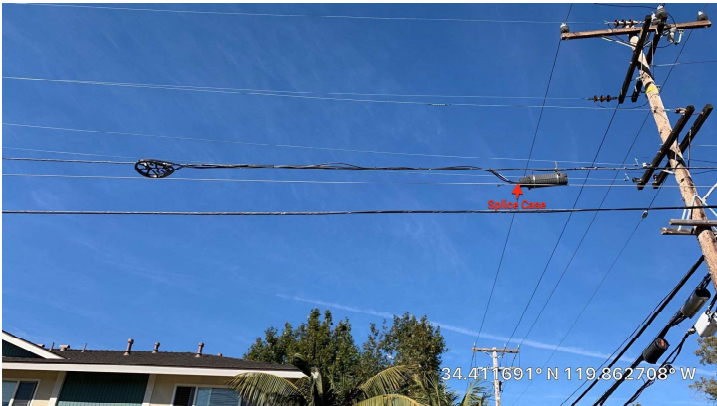
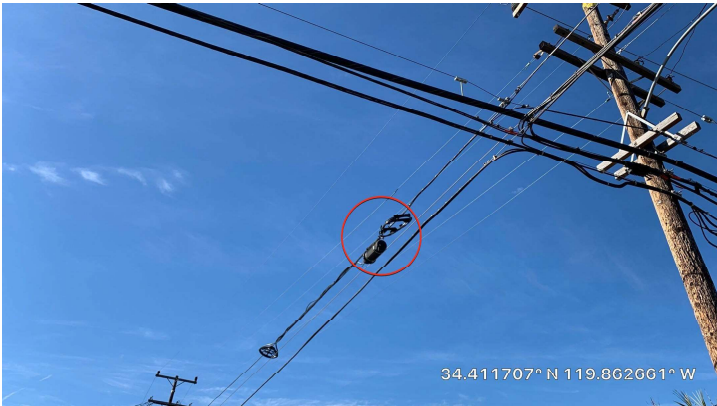
Before Photo #2 (If Necessary)

A Crown Castle splice box was loose and not secured to the pole.
CAMINO DEL SUR N/W COR/O PASADO RD
