Re: Electric Substation Audit of PG&E Martin Headquarters (HQ)

IV. Field Inspection – Violations List

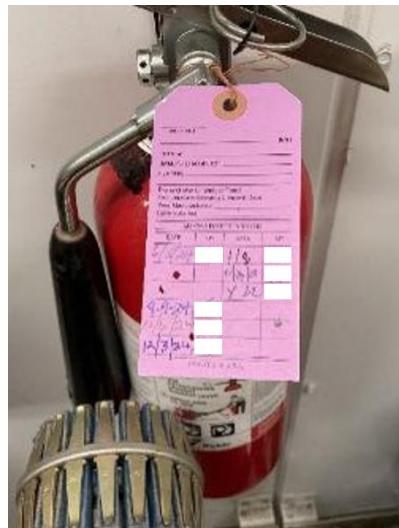
1.8. Fire extinguisher is missing the 7/2024, 8/2024, 10/2024, and 3/2025 monthly inspections and another fire extinguisher is missing the 3/2025 monthly inspection in the 12 kV Section E Control Room.

We acknowledge that fire extinguishers located in the 12 kV Section E Control Room are missing multiple monthly sign-offs. While these inspections are conducted monthly, we recognize the importance of ensuring that all inspection activities are properly recorded and will reinforce the requirement to document monthly inspections with the local supervisor.

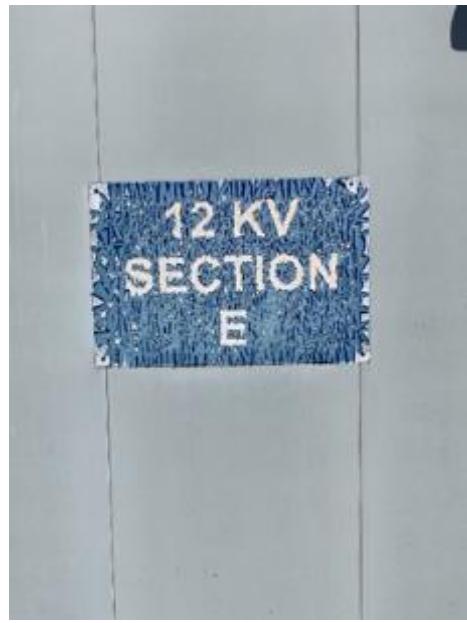
1.9. Deteriorated signage at the 12 kV Section E Building. PG&E has an open LC 131234687 to replace the signage.

Pre-existing LC Notification 131234687 was established in our system of record, SAP, prior to the field audit to address the deteriorated signage at the 12 kV Section E Building at Martin Substation. This LC notification was carried out in accordance with our maintenance procedures. It was completed on time on June 17, 2025, and therefore we disagree that the condition is a violation of GO 174, Rule 12.

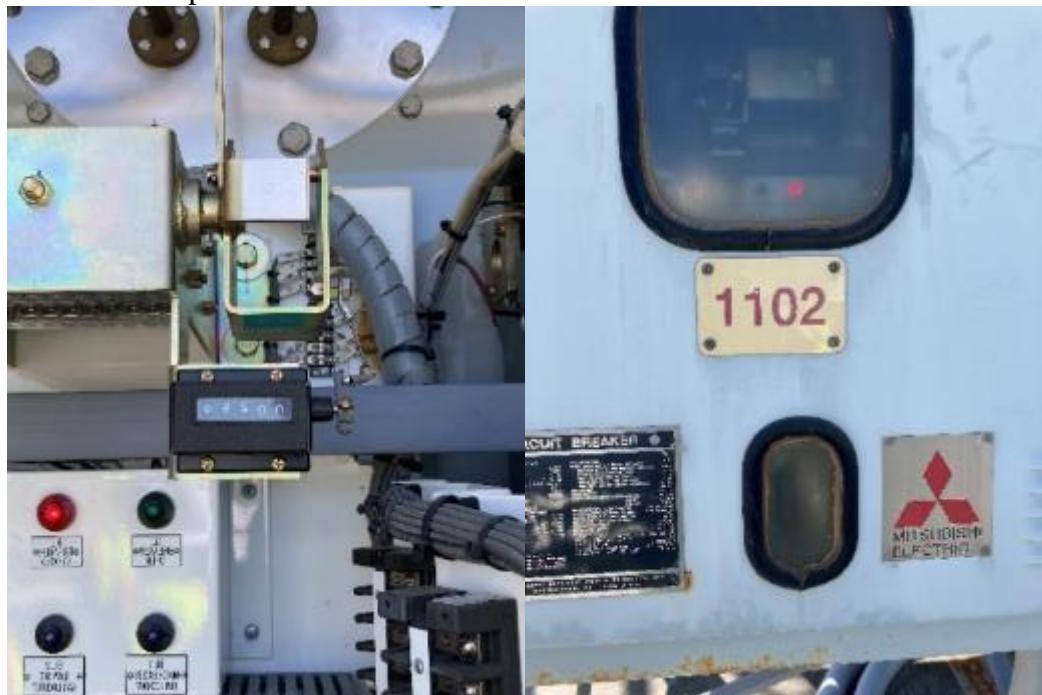
1.11. CB 1102 closed semaphore is faded.

We created LC notification 131385201 to address ESRB's finding regarding the faded closed semaphore on CB1102 at Martin Substation, added it to the workplan, and completed it on September 14, 2025.

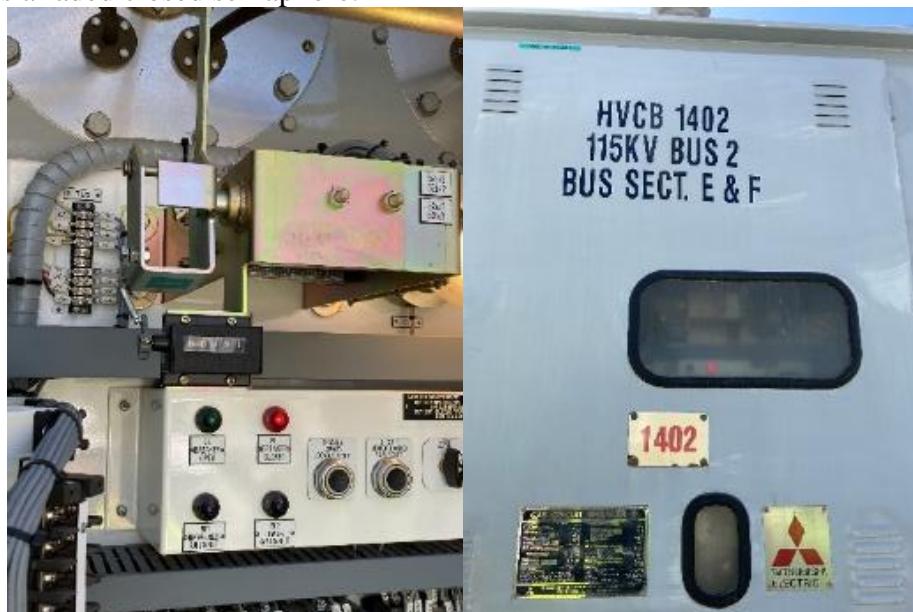
1.14. CB 1402 has a faded closed semaphore.

We created LC notification 131385202 to address ESRB's finding regarding the faded closed semaphore on CB1402 at Martin Substation, added it to the workplan, and completed it on September 14, 2025.

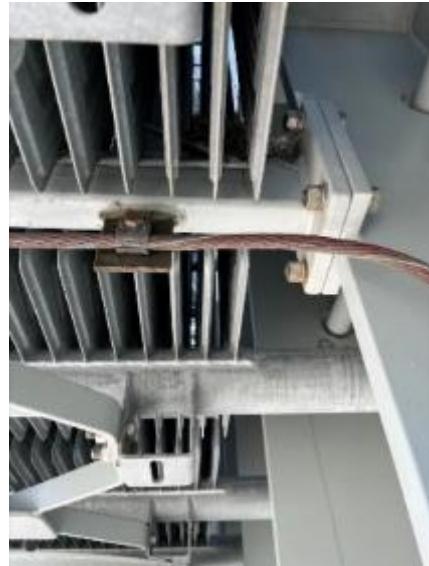
1.16. Bird nest at TX Bank 7.

We created LC Notification 131385203 to address ESRB's finding regarding the bird's nest in Transformer Bank 7 at Martin Substation, added it to the workplan, and completed it on July 13, 2025.

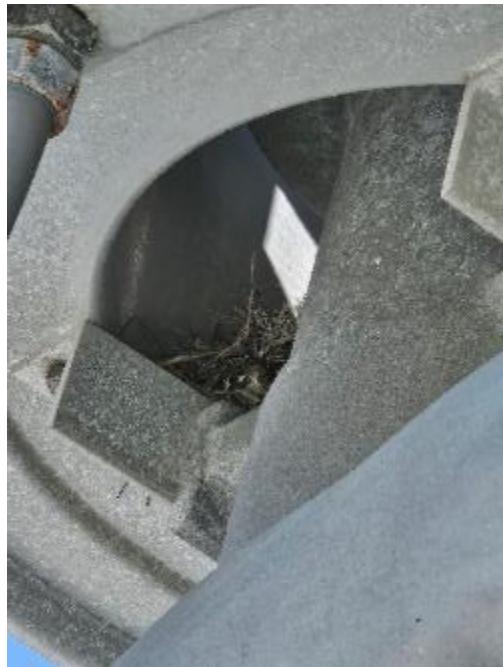
3.1. Bird nest at CB 142.

We created LC Notification 131417561 to address ESRB's finding regarding the identified bird's nest on CB 142 at Millbrae Substation, added it to the workplan, and completed it on July 20, 2025.

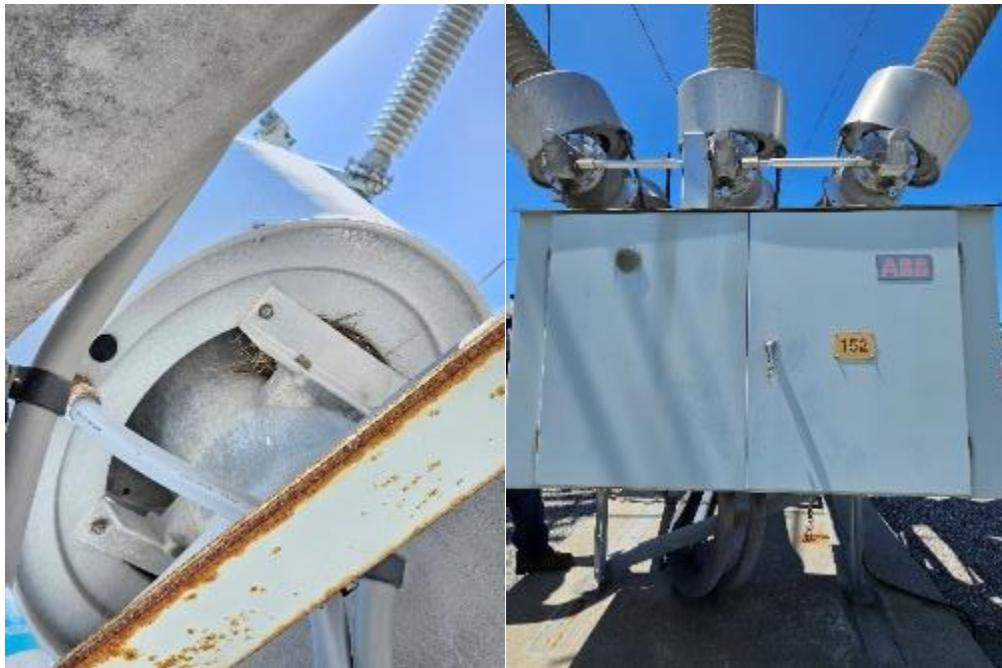
3.7. Bird nest at CB 152.

We created LC Notification 131417634 to address ESRB's finding regarding the bird's nest, added it to the workplan, and completed it on July 20, 2025.

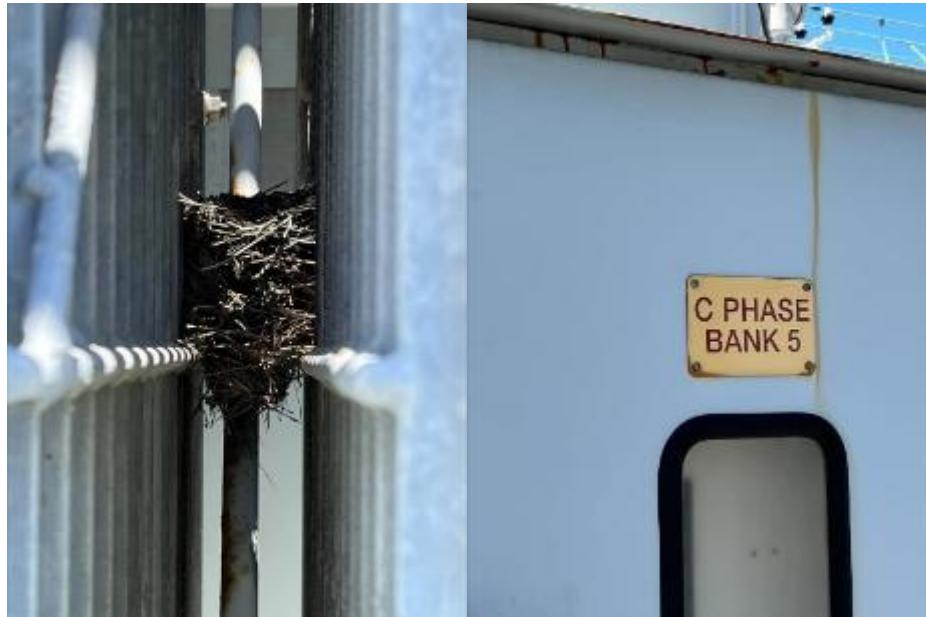
3.11. Bird nest at C Phase TX Bank 5.

We created LC Notification 131419495 to address ESRB's finding regarding the bird's nest, added it to the workplan, and completed it on July 20, 2025.

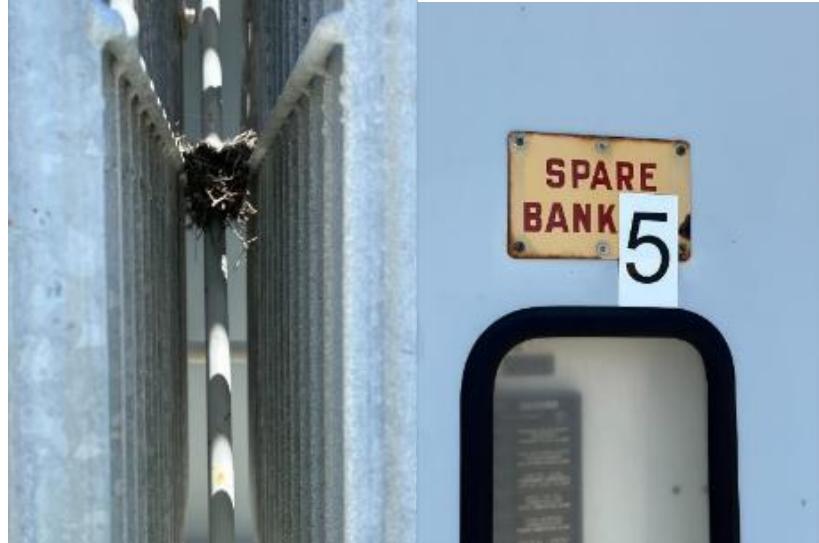
3.12. Bird nest at Spare TX Bank 5.

We created LC Notification 131419496 to address ESRB's finding regarding the bird's nest, added it to the workplan, and completed it on July 20, 2025.

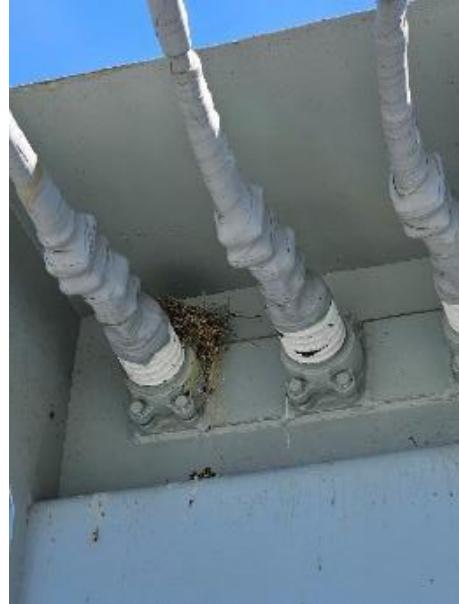
4.3. Bird nest at low side insulator bushing of Bank 1.

We created LC Notification 131419589 to address ESRB's finding regarding the bird's nest, added it to our work plan, and completed it on September 15, 2025.

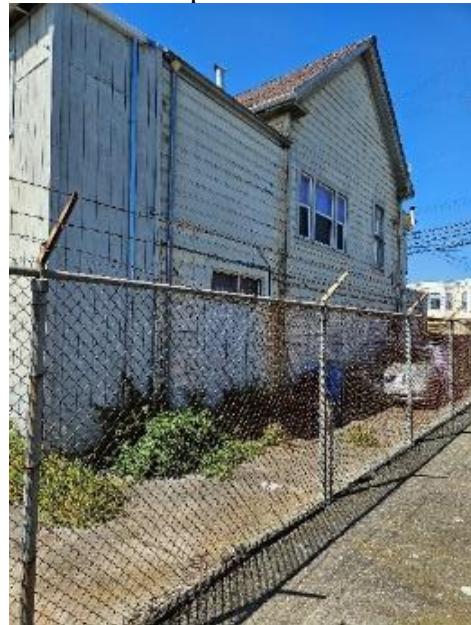
8.1. Damaged barbed wire. PG&E has an open LC 129315835 to repair the barbed wire.

Pre-existing LC Notification 129315835 was established in our system of record, SAP, prior to the field audit to address the damaged barbed wire at Plymouth Substation. We disagree that this finding qualifies as a violation of GO 174, Rule 12, since the LC notification was worked in accordance with our maintenance procedures and completed on time on June 04, 2025.

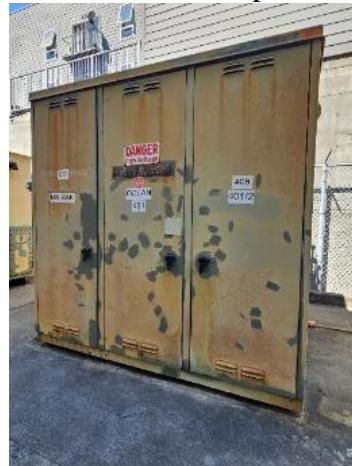
9.1. Bank 1 (401) has moderate rust. PG&E has an open LC 129315928 to repaint it.

Pre-existing LC notification 129315928 was established in our system of record, SAP, prior to the field audit to address the rust on Bank 1 (401) at Ocean Avenue Substation. We disagree that this finding qualifies as a violation of GO 174, Rule 12 since this LC notification will be completed based on current work prioritization and material availability and is not past due.

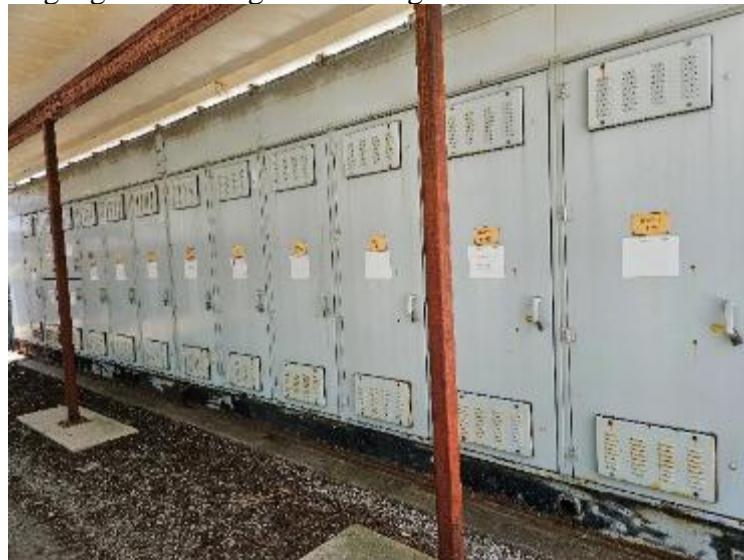
10.3. Faded Danger signage at Switchgear Building.

We created LC Notification 131420158 to address ESRB's finding regarding the faded signage on the switchgear building, added it to the workplan, and it will be completed based on current work prioritization and material availability.

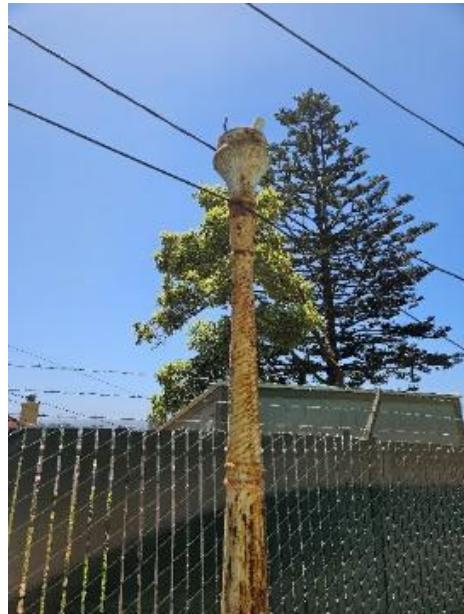
10.5. Third party comms line touching abandoned streetlight.

We disagree that this condition qualifies as a violation of GO 174, Rule 12, as the line is owned and maintained by a third party and does not impact the safety or reliability of substation operations. Third-party Notifications 131795281 and 131795283 have been created, and resolution will proceed in accordance with established third-party protocols.

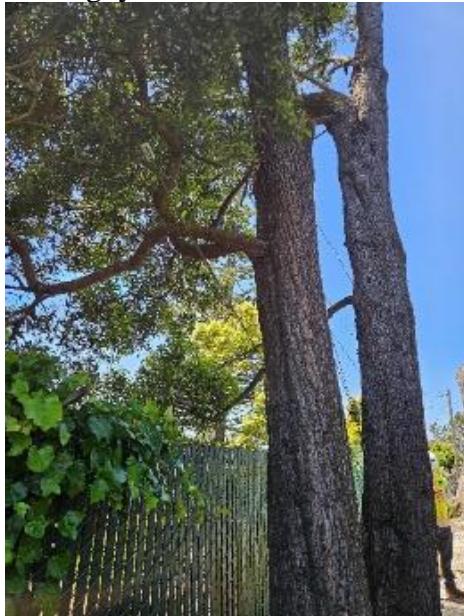
10.6. Tree pushing down on comms guy in Substation.

We disagree that this condition qualifies as a violation of GO 174, Rule 12, as the line is owned and maintained by a third party and does not impact the safety or reliability of

substation operations. Third-party Notifications 131795310 and 131795318 have been created, and resolution will proceed in accordance with established third-party protocols.

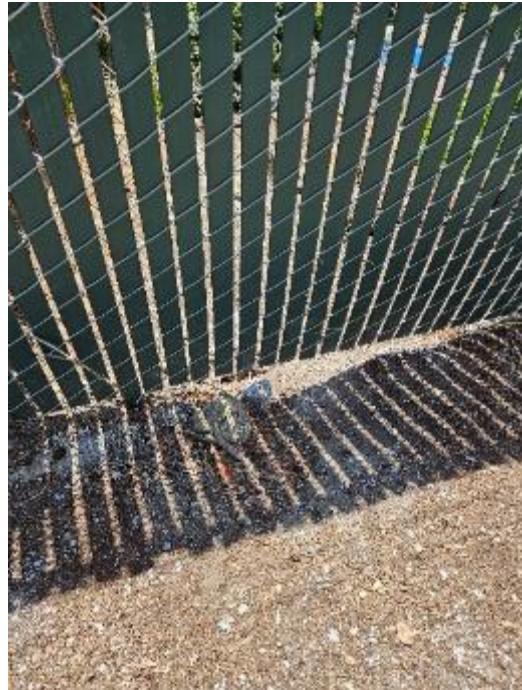
10.7. Minor soil erosion at fence.

We created LC Notification 131796160 to address ESRB's finding regarding the minor soil erosion at San Fran L Substation, added it to the workplan, and it will be completed based on current work prioritization.

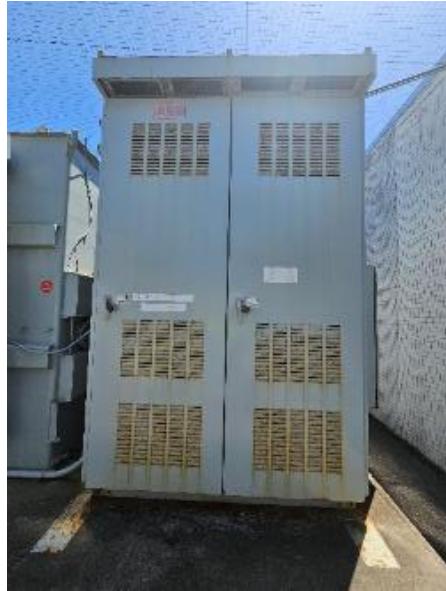
11.3. Faded identification signage and Danger signage at Bank 2 Unit 402.

We created LC Notification 131579009 to address ESRB's finding regarding the faded signage on Bank 2 Unit 402 Noriega Substation, added it to our work plan, and it will be completed based on current work prioritization.

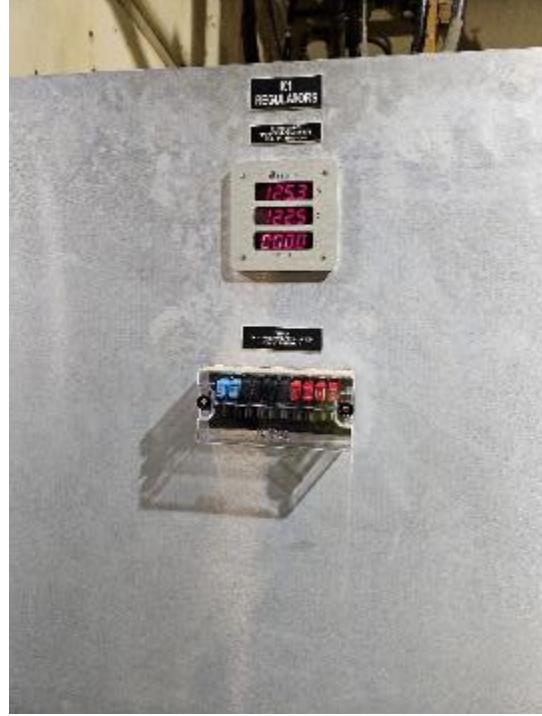
13.3. K-1 C phase Regulator voltmeter not working showing 0 Volts.

We created LC Notification 131417052 to address ESRB's finding regarding the voltmeter not working, added it to the workplan, and completed it on August 03, 2025.

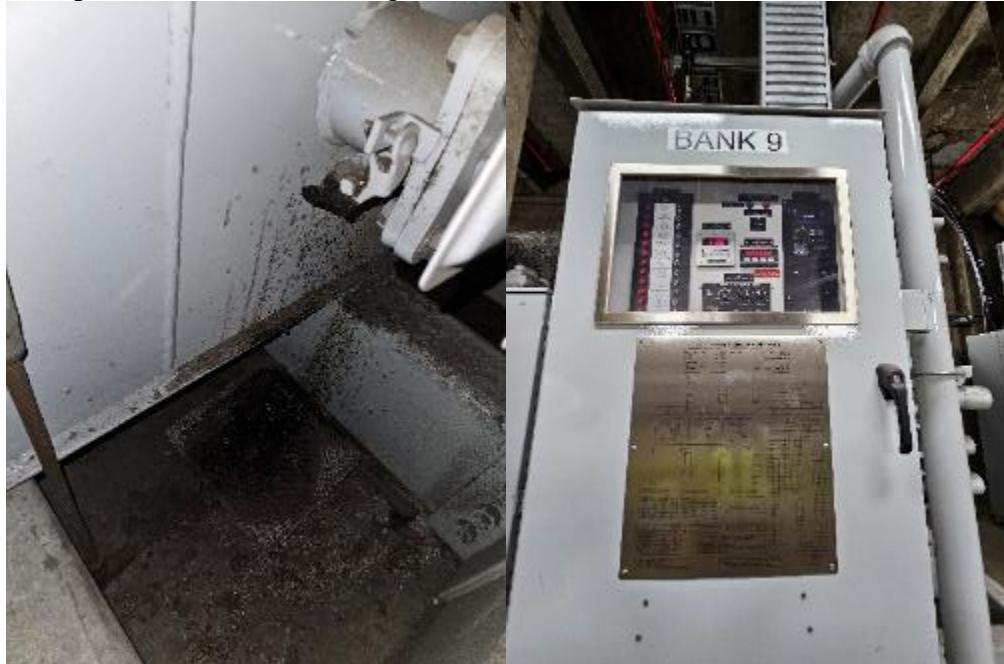
17.1. Oil weep at Bank 9 radiator flange.

We created LC Notification 131417243 to address the ESRB finding regarding the oil weep at Bank 9 radiator flange at San Francisco X (Mission) Substation, added it to the workplan and completed it on July 18, 2025.

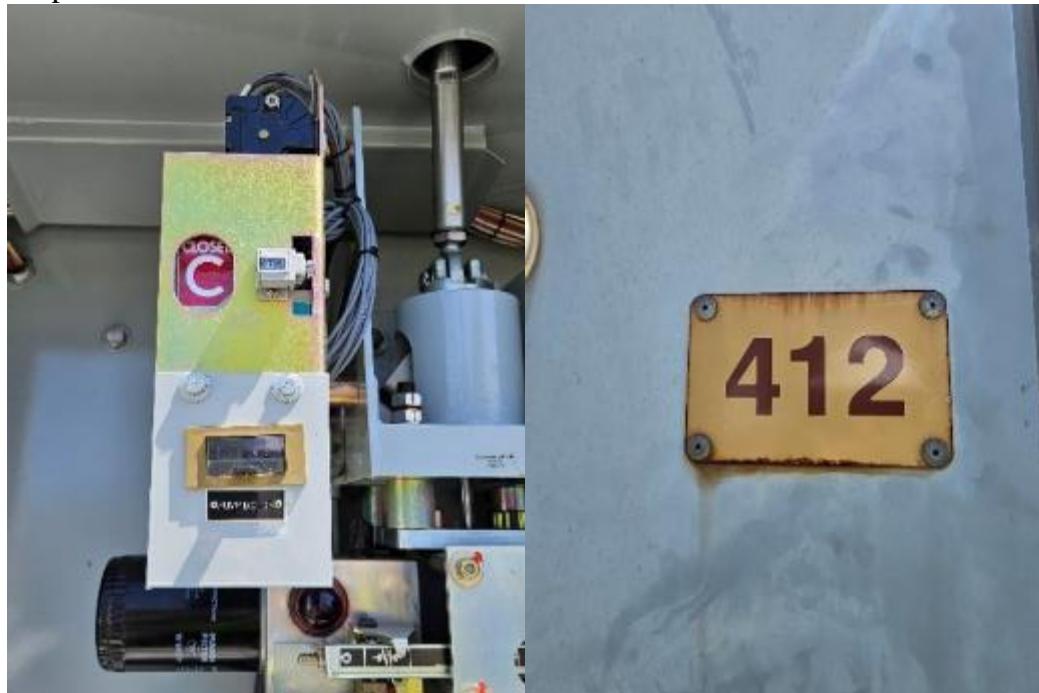
18.8. Pump motor counter faded at CB 412.

We created LC Notification 131322394 to address the ESRB finding of the faded pump motor counter in CB 412 at San Francisco A (Potrero), added it to the workplan, and completed it on September 13, 2025.
