PUBLIC UTILITIES COMMISSION

SA2025-1423

SUBJECT: Electric Substation Audit of PG&E Concord Headquarters

CPUC SUBSTATION AUDIT FINDINGS
PG&E Concord Headquarters
November 3 – 7, 2025

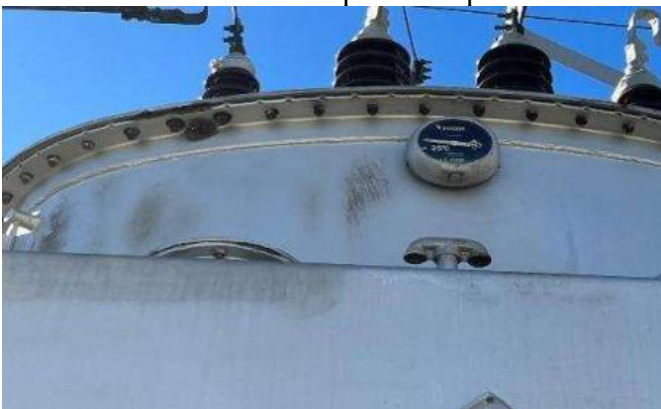
2.5 Transformer Bank 1C Wasp Nest Top Front – Fixed in Field

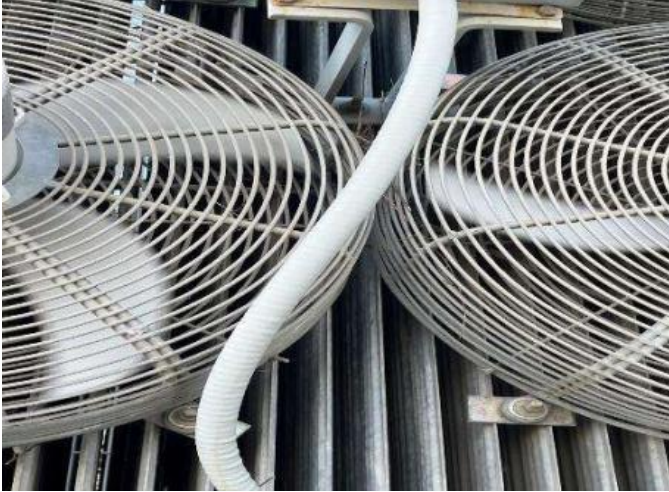
5.12 Transformer Bank 8 Bird Nest Starting in Radiator - Fixed in Field

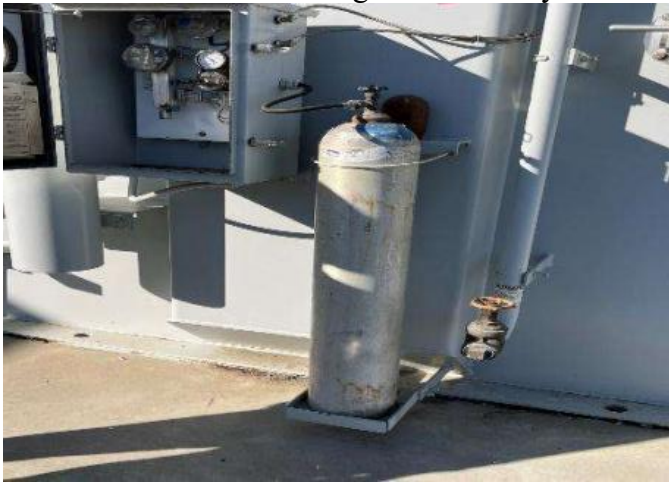
5.13 Transformer Bank 8 Nitrogen Bottle Only One Strap

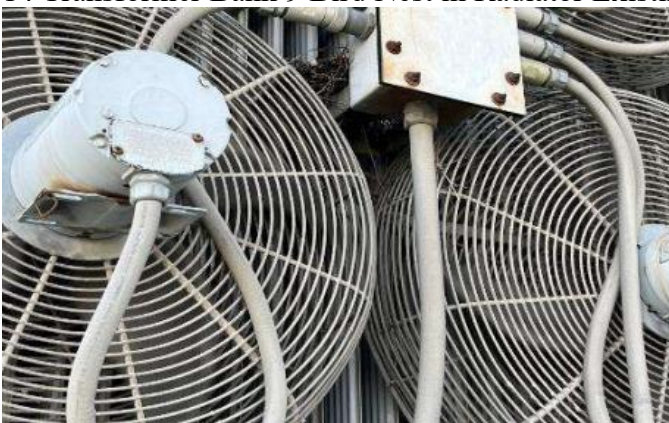
5.14 Transformer Bank 9 Bird Nest in Radiator Existing LC Tag#130927057

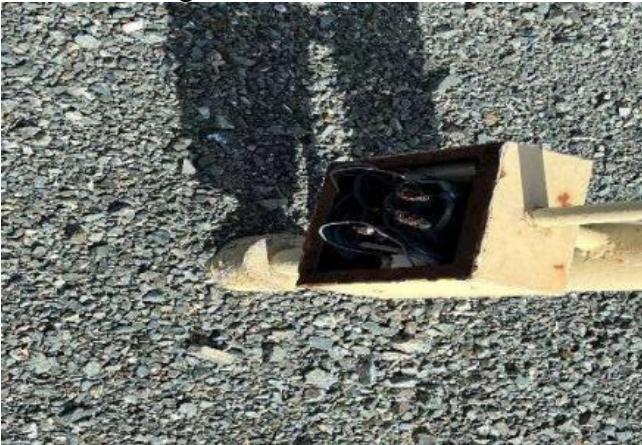
5.17 Substation Yard Light has Exposed Electrical Junction Box Between Transformer Banks 2 and 3 LC Tag#131966285

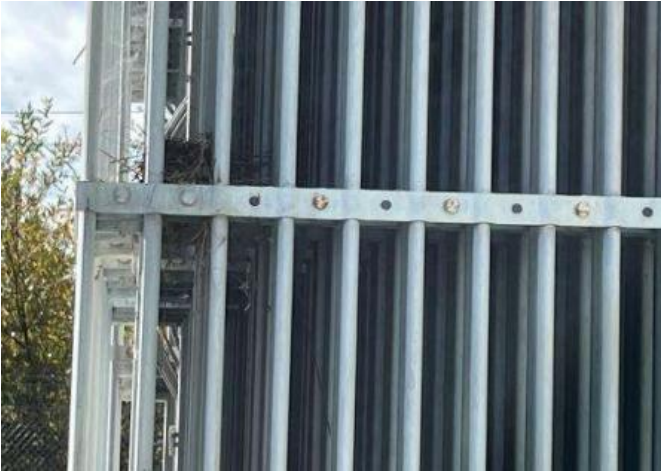
9.5 Transformer Bank 3 Birds Nest In Radiator Existing LC Tag#131966340

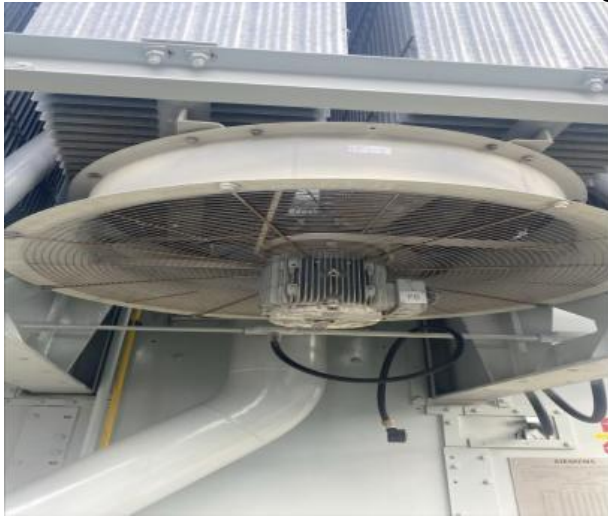
13.5 Transformer Bank 1 One Fan Not Working Existing LC Tag#131702282

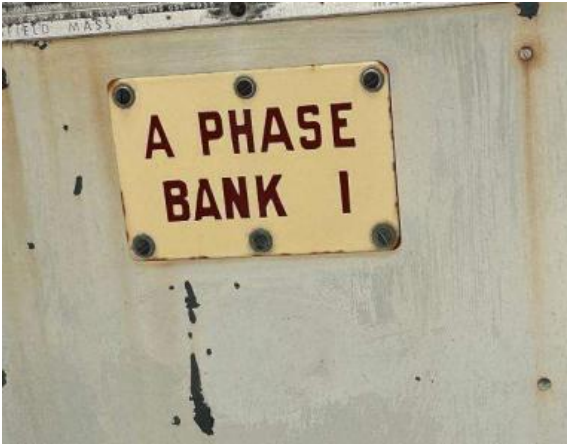
14.4 Transformer Bank 1 A Phase Status: Out of Service, Never to be Operated Again, Spare Will be Operated in Place of Phase A

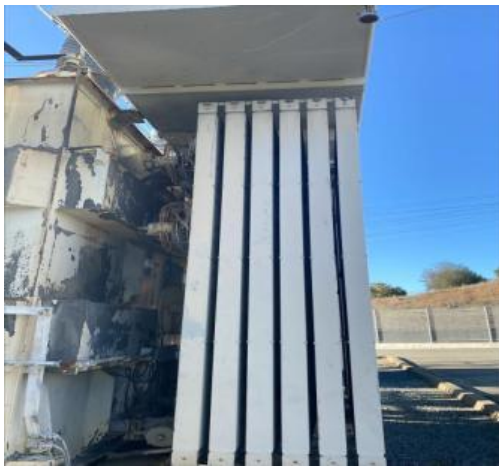
14.5 Transformer Bank 1 B Phase Birds Nest Existing LC Tag#131966301

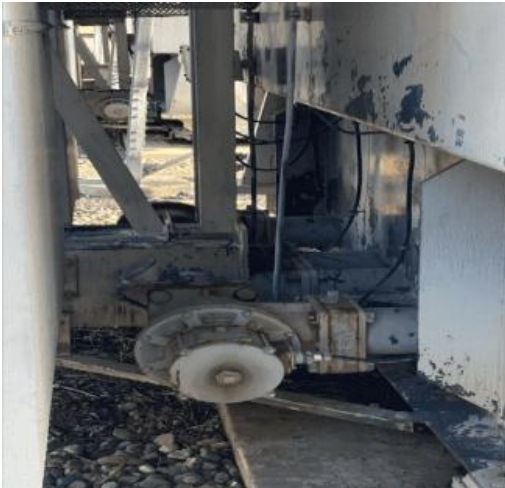
14.6 Transformer Bank 1 C Phase Fans and Oil Pump Not Working Existing LC Tag#13187150

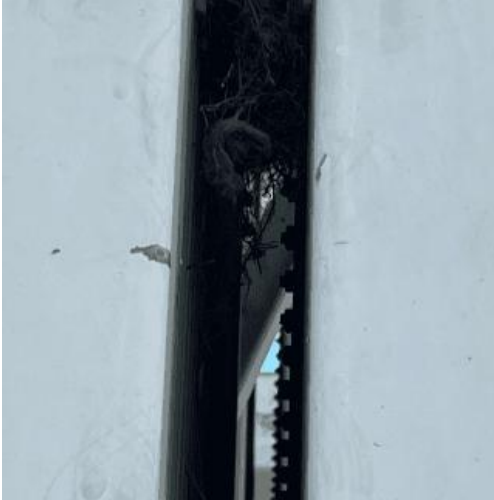
14.7 Transformer Bank 1 Spare Birds Nest in Radiator Existing LC Tag#131984277, Oil Mitigation LC 131966305, Fans Not Working LC 131987155

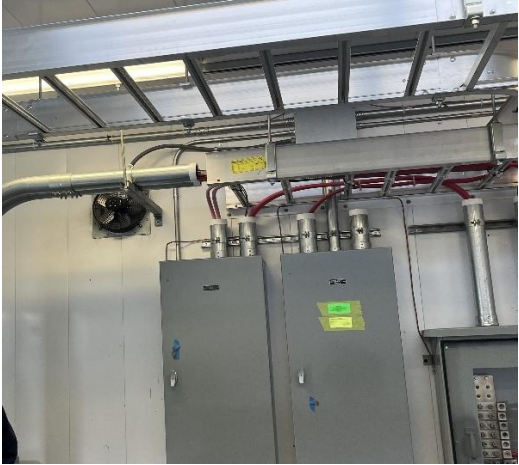
15.1 Battery Room - Need to Demonstrate Exhaust Fan is Operational New LC Tag#131989888

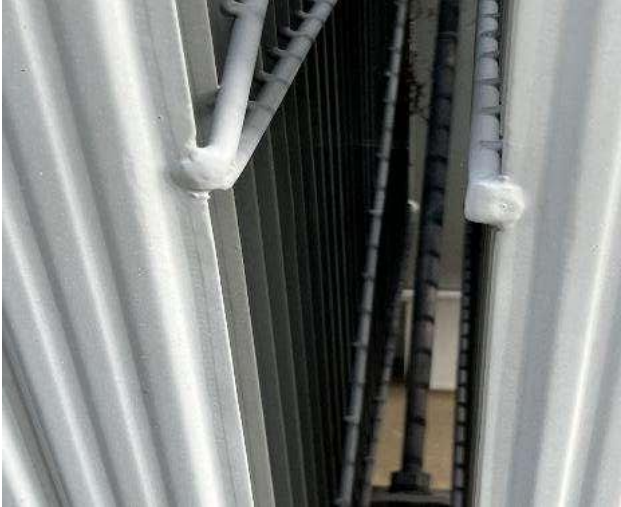
15.4 Transformer Bank 1 A Phase Birds Nest - Fixed in Field

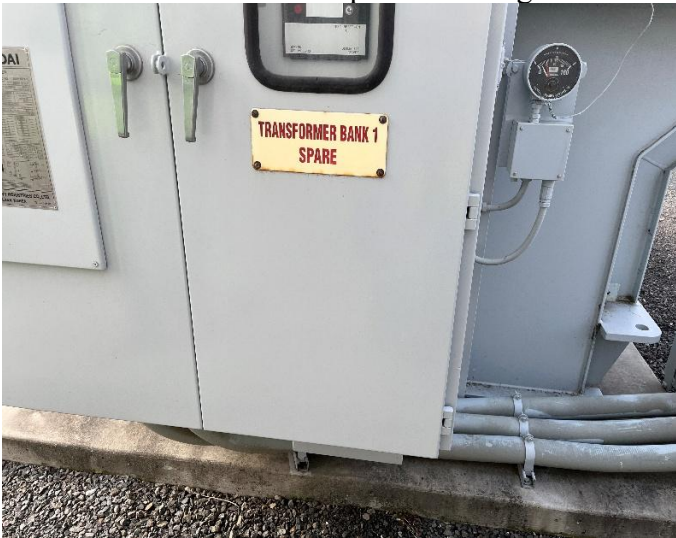
15.7 Transformer Bank 1 Spare Oil Mitigation Existing LC Tag#131990134
