**INVESTIGATION REPORT
OF THE DECEMBER 7, 2017 WILDFIRE
IN MURRIETA, CALIFORNIA INVOLVING
SOUTHERN CALIFORNIA EDISON FACILITIES THAT CAME
TO BE KNOWN AS THE LIBERTY FIRE**

**SAFETY AND ENFORCEMENT DIVISION
ELECTRIC SAFETY AND RELIABILITY BRANCH
LOS ANGELES**

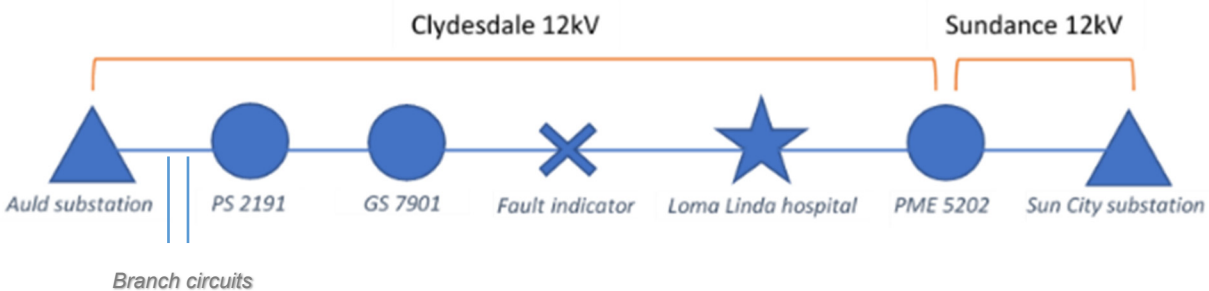
The following figure illustrates the relationship among the switches and various line elements that are part of the Clydesdale 12 kV circuit. There were no protective devices (breakers or fuses) on the circuit between the circuit breaker at Auld substation and PS 2191.

Figure 1: Line elements and locations of importance between Auld and Sun City substations

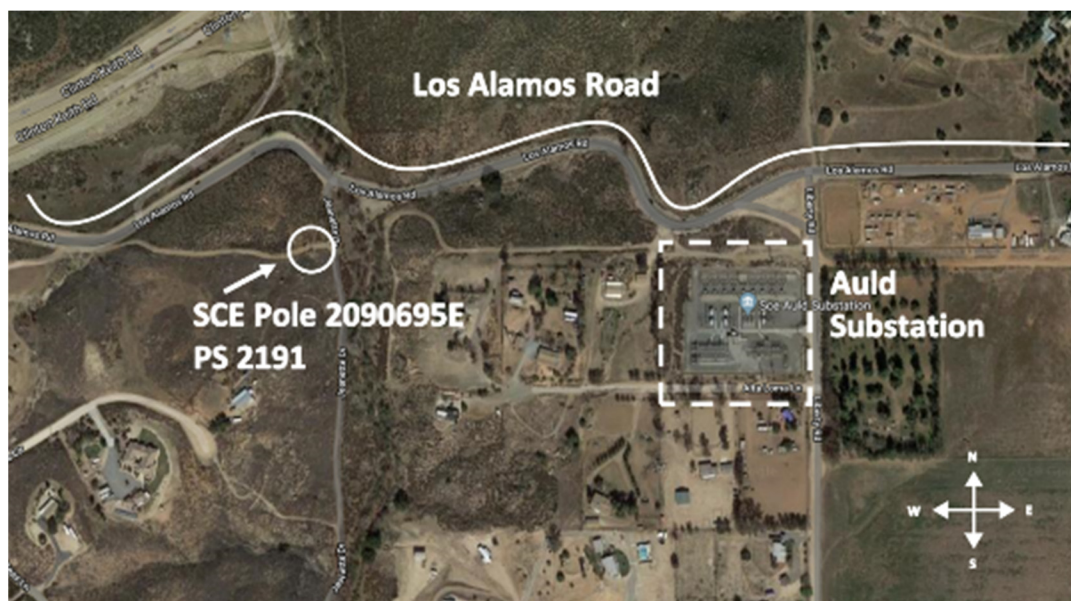
CAL FIRE investigated the cause and origin of the Liberty Fire and determined the point of origin to be at the base of Edison pole number 2090695E, located just east of the Edison Auld substation and adjacent to Los Alamos Road, which runs from east to west in the city of Murrieta, California.³⁷ Provided here are maps illustrating the point of ignition relative to the Edison Auld substation and Los Alamos Road.

Figure 6: Location of Edison pole 2090695E with attached pole switch PS 2191

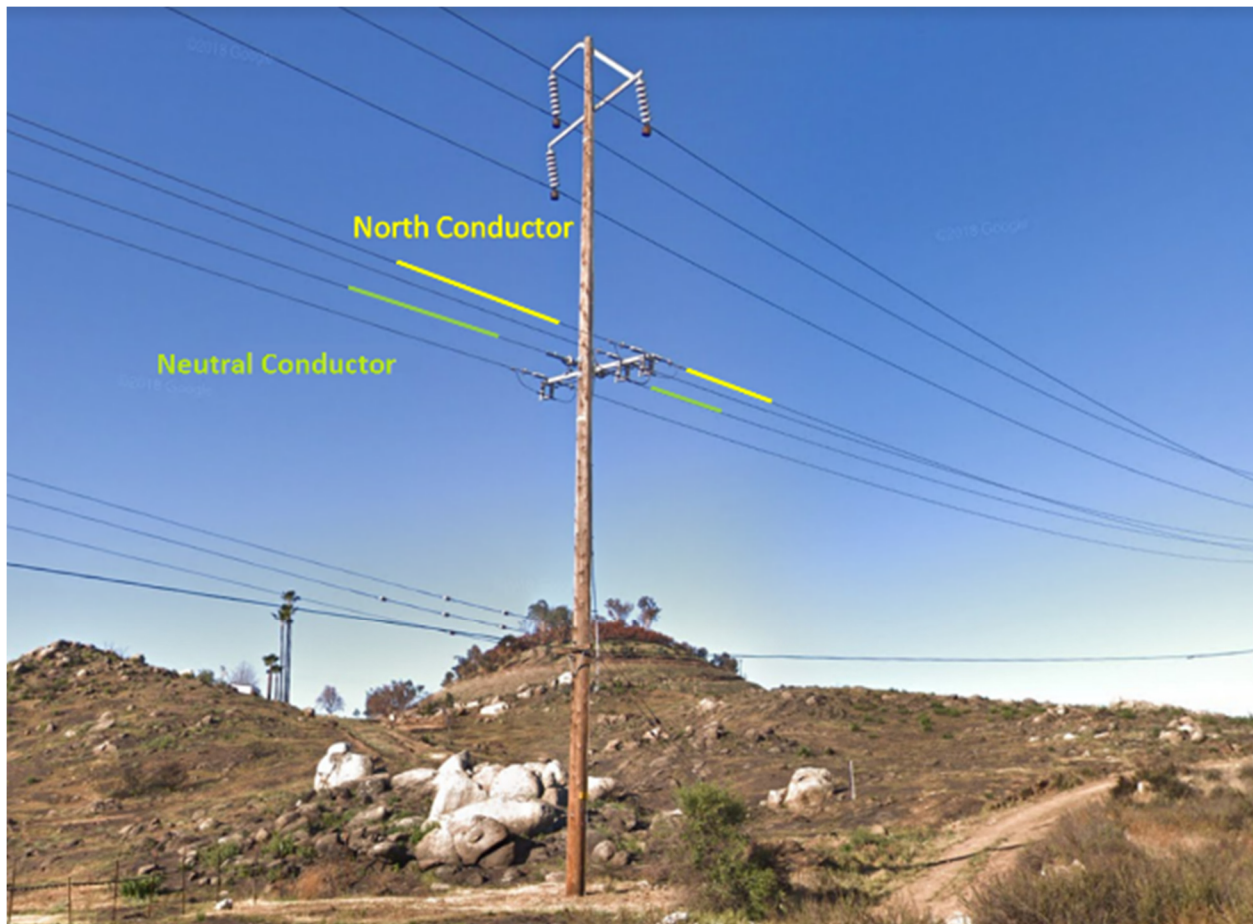
SED examined the physical evidence collected by both CAL FIRE and Edison and observed significant damage to the components of pole switch PS 2191 retained by CAL FIRE.

Figure 7: Looking south west at pole 2090695E and PS 2191 (Picture for example purpose only, image date April 2018, newly installed 12ft Omni-rupter pole switch shown)
