California Public Utilities Commission

**INVESTIGATION REPORT
OF THE DECEMBER 7, 2017 WILDFIRE
IN MURRIETA, CALIFORNIA INVOLVING
SOUTHERN CALIFORNIA EDISON FACILITIES THAT CAME
TO BE KNOWN AS THE LIBERTY FIRE**

**SAFETY AND ENFORCEMENT DIVISION
ELECTRIC SAFETY AND RELIABILITY BRANCH
LOS ANGELES**

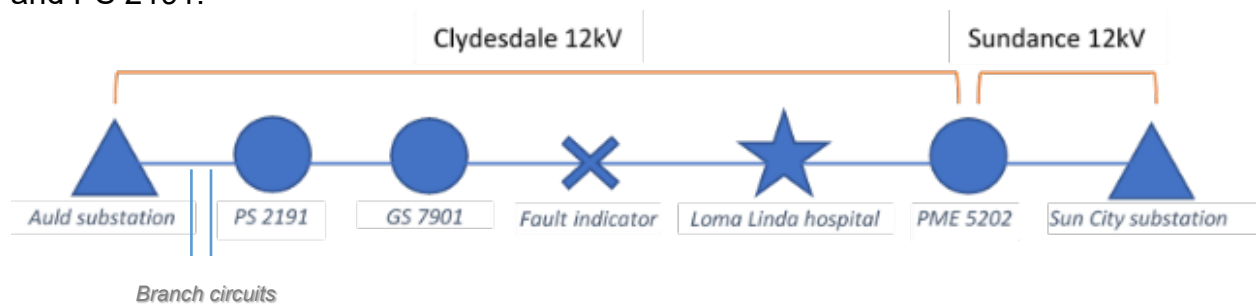
The following figure illustrates the relationship among the switches and various line elements that are part of the Clydesdale 12 kV circuit. There were no protective devices (breakers or fuses) on the circuit between the circuit breaker at Auld substation and PS 2191.

Figure 1: Line elements and locations of importance between Auld and Sun City substations

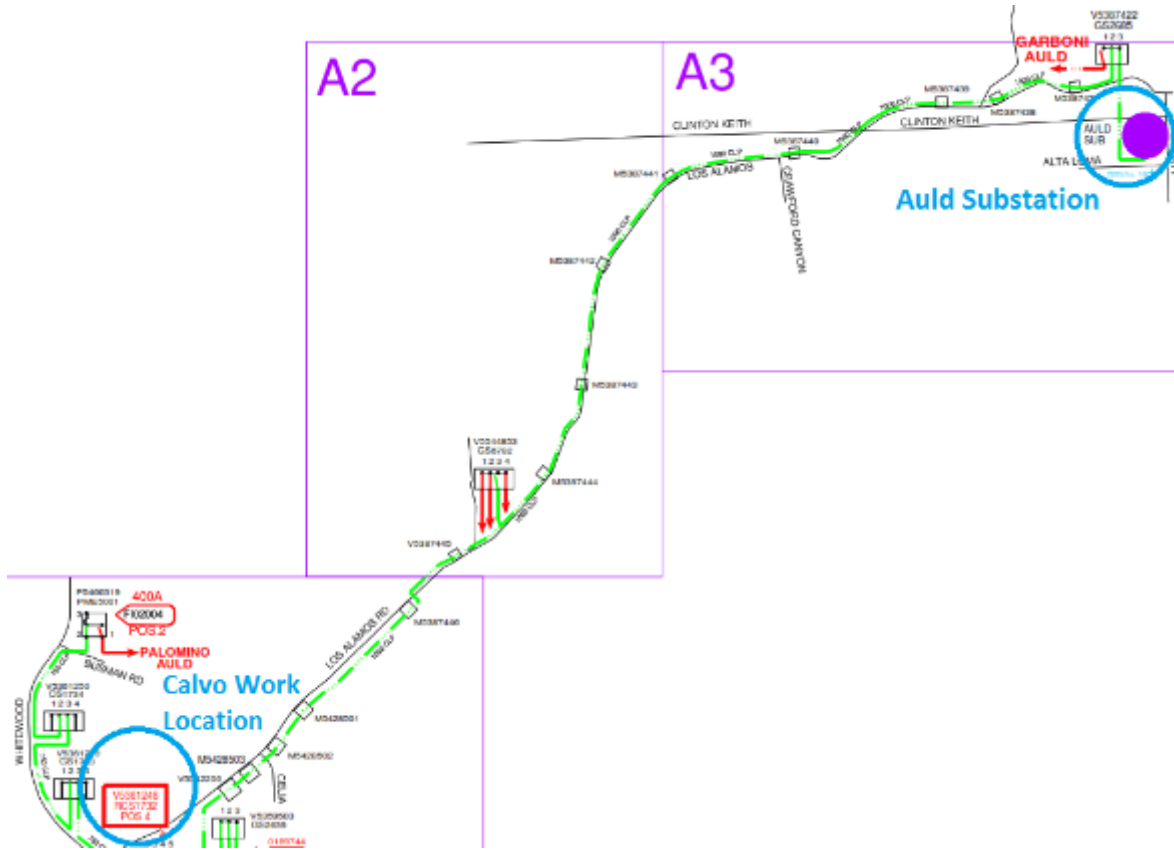
Figure 3: Calvo crew's work location relevant to Auld Substation

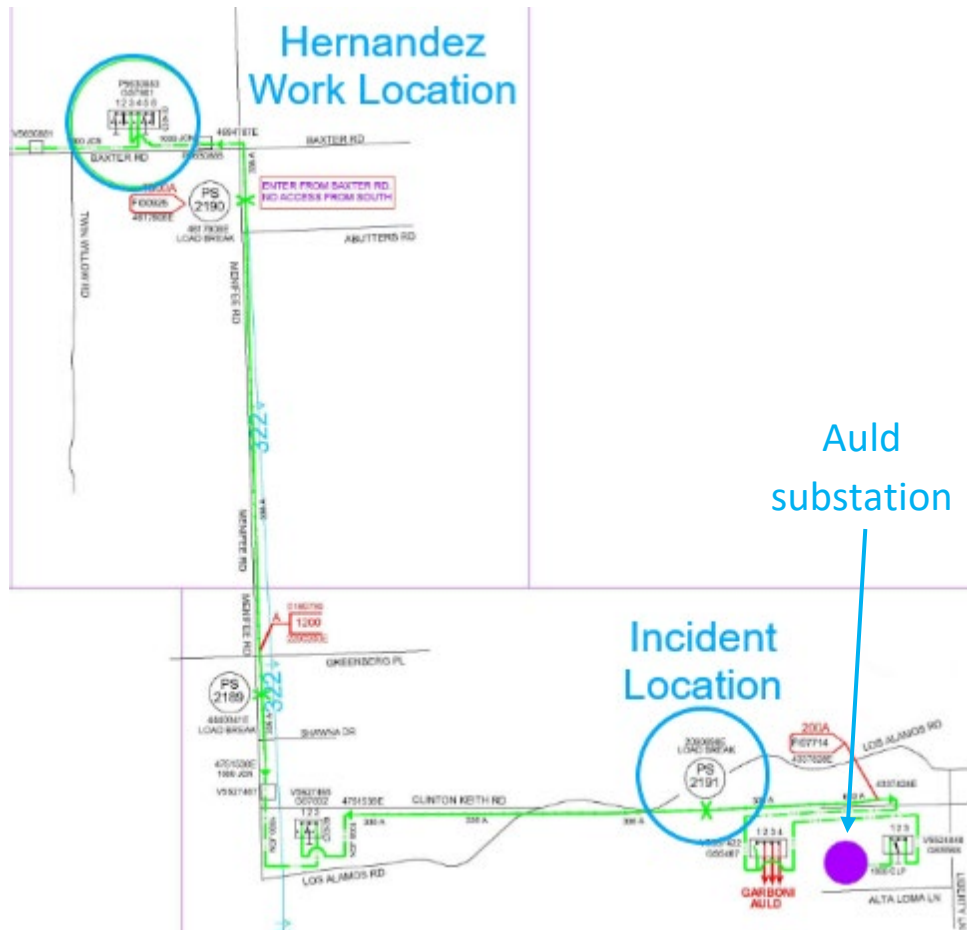
Figure 4: Hernandez crew's work location relevant to incident location

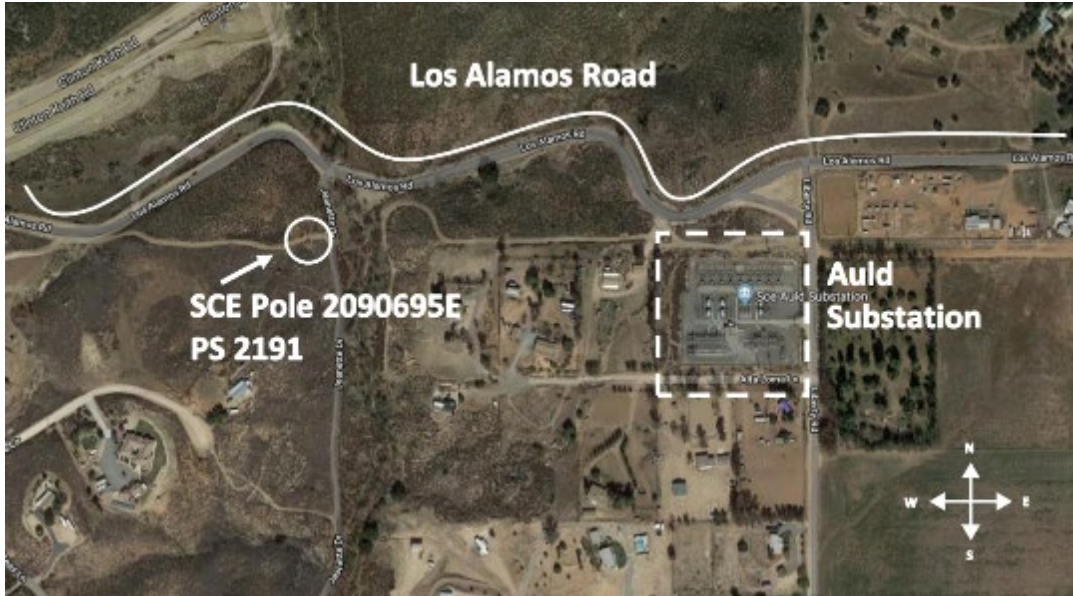
CAL FIRE investigated the cause and origin of the Liberty Fire and determined the point of origin to be at the base of Edison pole number 2090695E, located just east of the Edison Auld substation and adjacent to Los Alamos Road, which runs from east to west in the city of Murrieta, California.³⁷ Provided here are maps illustrating the point of ignition relative to the Edison Auld substation and Los Alamos Road.

Figure 6: Location of Edison pole 2090695E with attached pole switch PS 2191

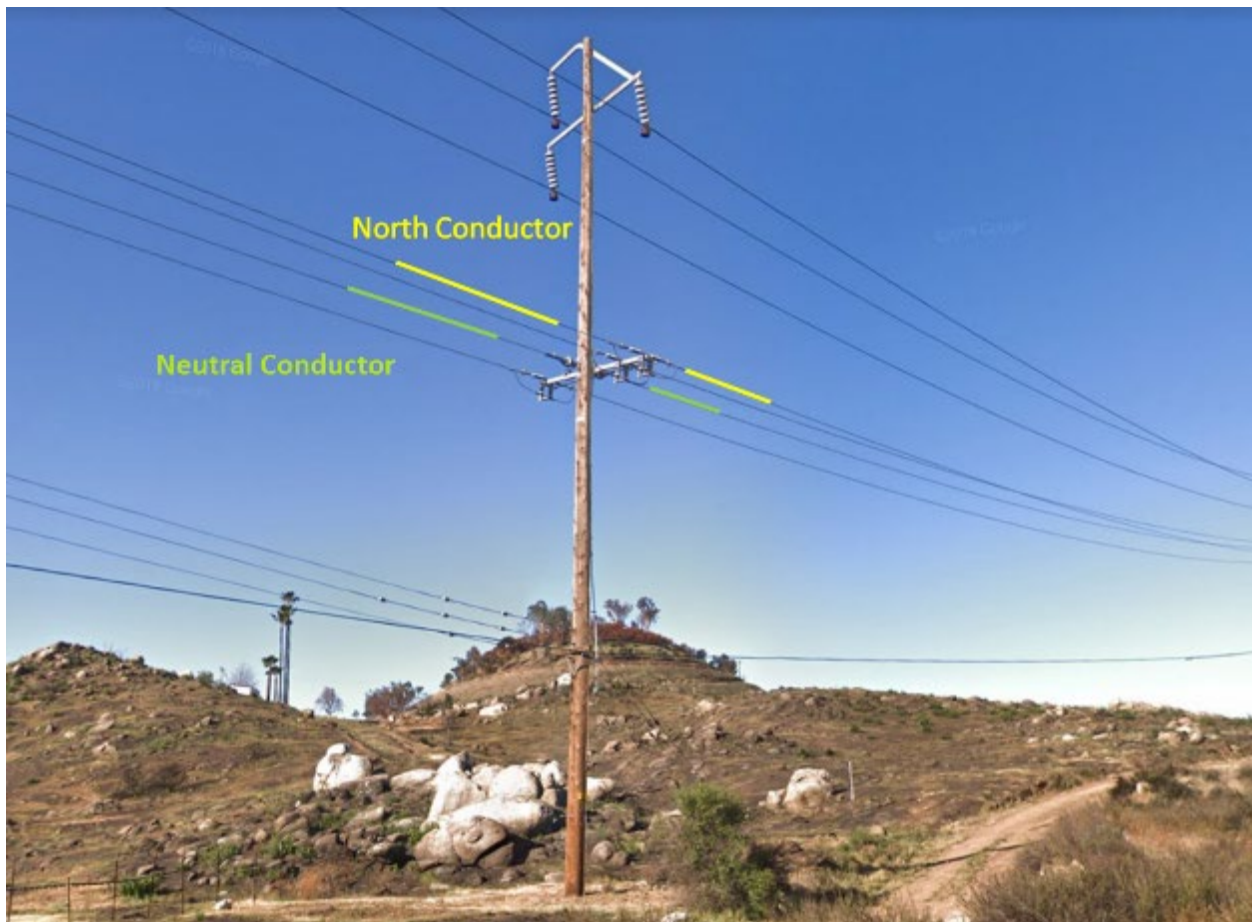
SED examined the physical evidence collected by both CAL FIRE and Edison and observed significant damage to the components of pole switch PS 2191 retained by CAL FIRE.

Figure 7: Looking south west at pole 2090695E and PS 2191 (Picture for example purpose only, image date April 2018, newly installed 12ft Omni-rupter pole switch shown)
