**INVESTIGATION REPORT  
OF THE DECEMBER 5, 2017 WILDFIRE  
IN SAN BERNARDINO, CALIFORNIA  
INVOLVING SOUTHERN CALIFORNIA EDISON FACILITIES  
THAT CAME TO BE KNOWN AS THE MEYERS FIRE**

**SAFETY AND ENFORCEMENT DIVISION  
ELECTRIC SAFETY AND RELIABILITY BRANCH**

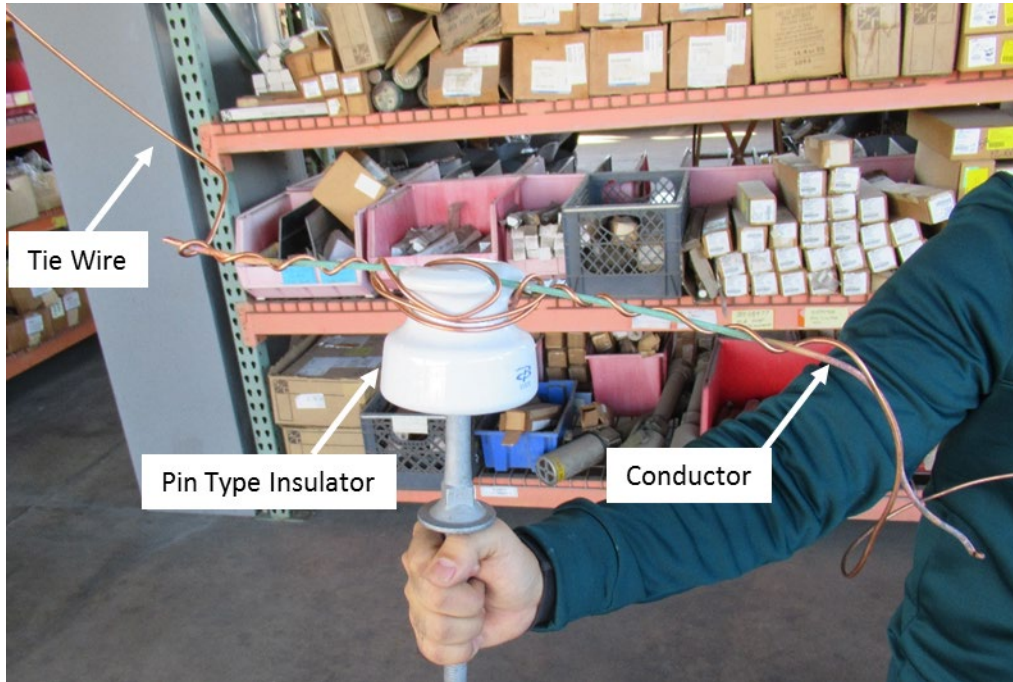
The facilities involved in this incident are located on a single-phase, two-wire section of the Northpark 12 kV circuit. The single 12 kV conductor involved in this incident was attached to Edison's poles numbered 200046S, 200045S, and 200047S. These are wooden poles installed in 1947 and located in Tier 2 of the HFTD.<sup>21</sup> The conductor was supported by a pin type insulator at the top of each pole and was held in place by a tie wire, which is meant to prevent the conductor from slipping out of the insulator. This configuration is demonstrated in Figure 4.

Figure 4: Example of how a conductor is tied down to an insulator

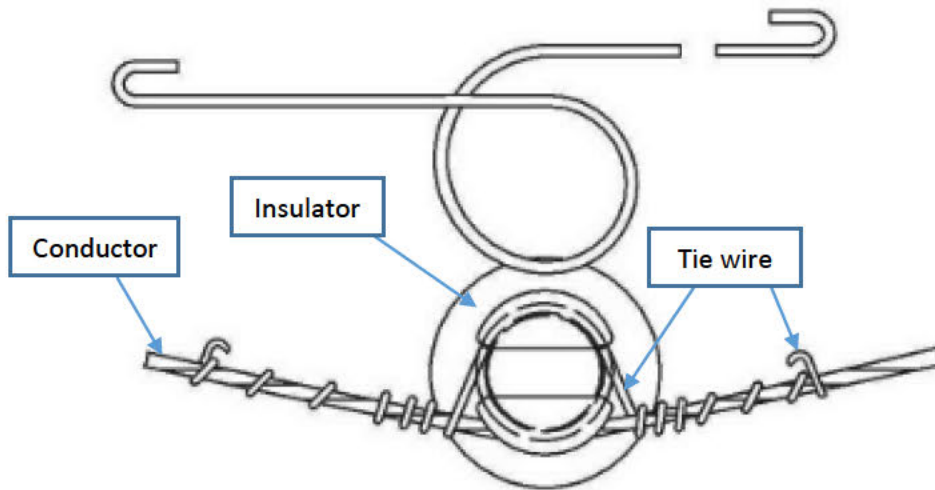
Figure 5: 2006 Construction Standards for primary tie wire used for securing conductor to insulator. Top view looking down.<sup>30</sup>
