**INVESTIGATION REPORT  
OF THE DECEMBER 4, 2017 WILDFIRE  
IN SANTA PAULA, CALIFORNIA  
INVOLVING SOUTHERN CALIFORNIA EDISON FACILITIES  
THAT CAME TO BE KNOWN AS THE THOMAS FIRE**

**SAFETY AND ENFORCEMENT DIVISION  
ELECTRIC SAFETY AND RELIABILITY BRANCH  
LOS ANGELES**

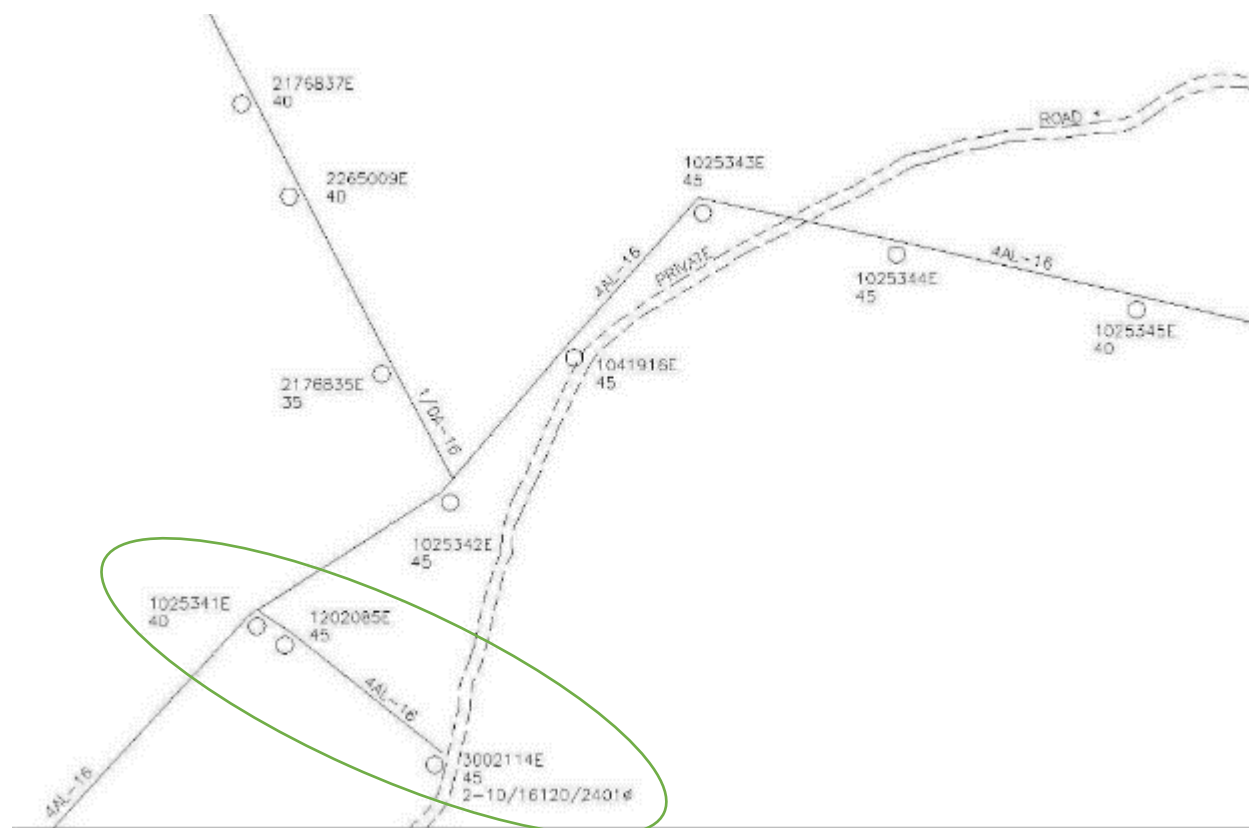
The most recent detailed inspection of the utility poles related to the Anlauf Canyon ignition site was conducted by Edison in May of 2013. No findings or notifications resulted from this inspection.<sup>59</sup> During its annual patrol inspection for the same area, Edison uncovered issues related to pole tags and ground moldings, with no issues reported related to conductor condition.<sup>60</sup>

Figure 6: FIM Anlauf Canyon area of interest<sup>61</sup>
