INVESTIGATION REPORT OF THE WOOLSEY FIRE

**SAFETY AND ENFORCEMENT DIVISION
ELECTRIC SAFETY AND RELIABILITY BRANCH
LOS ANGELES**

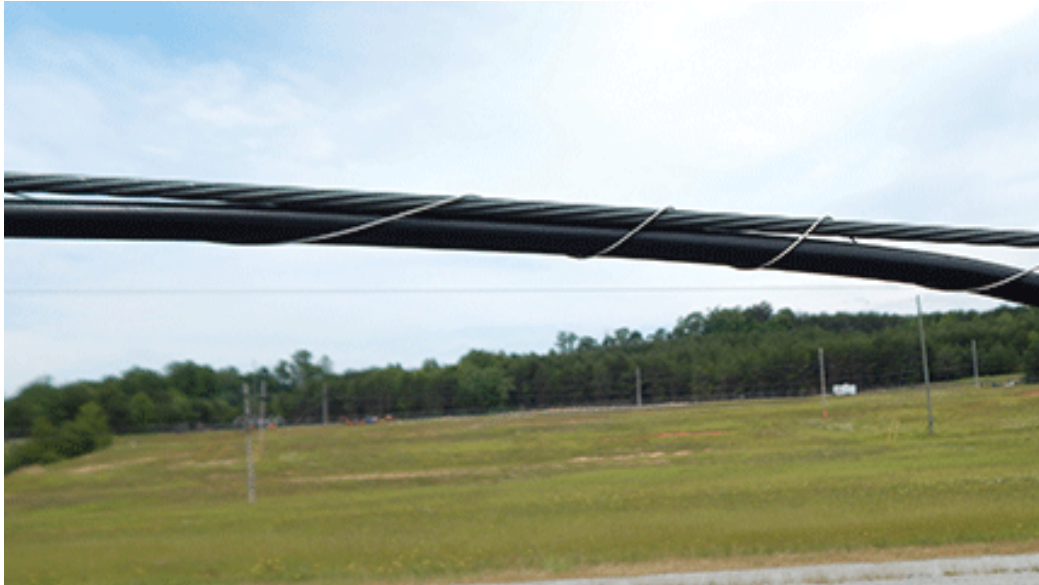
Figure 4: A messenger wire supporting a communications conductor and wrapped with lashing wire. Note that this is a stock image and that this particular communications conductor was not involved in the Woolsey Fire in any way. However, the communications infrastructure involved in the Woolsey Fire was very similar to that depicted in the image.

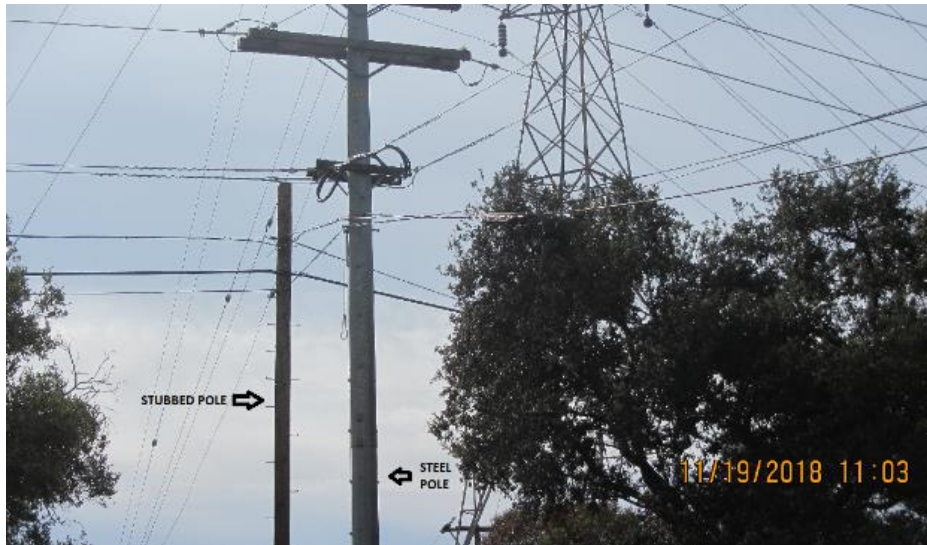
Staff observed that Down Guy 1 was loose and had sustained damage consistent with contacting the Edison 16 kV jumper wire. Staff noted that two other Edison down guy wires on the south side of the Steel Pole were also loose. The second loose down guy wire, Down Guy 2, was in contact with Messenger Wire 1 on the Stubbed Pole. The third loose down guy wire, Down Guy 3, was in contact with the top of the Stubbed Pole. Staff observed dark discoloration around the contact point between Down Guy 2 and the ECS through-bolt. See Figures 15-18.

Figure 15: The Steel Pole and Stubbed Pole as viewed from the northeast.

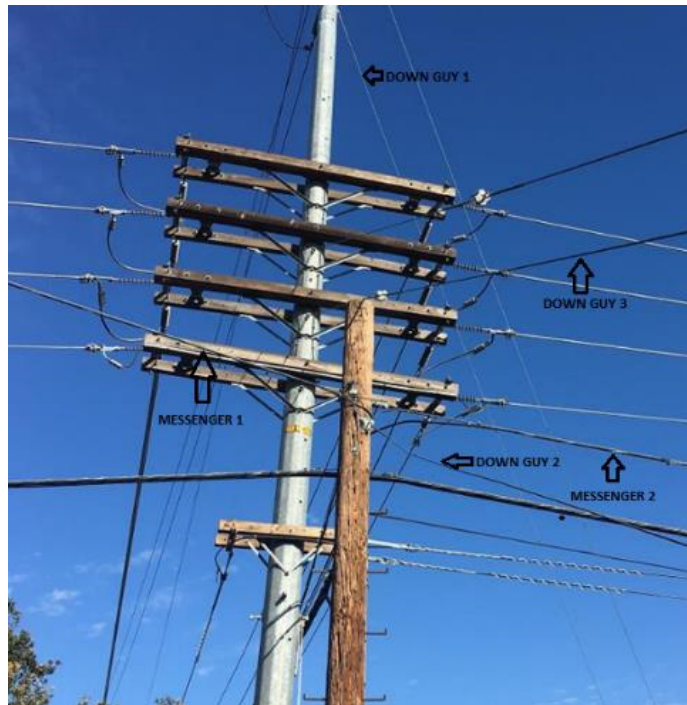
Figure 16: The Stubbed Pole and the Steel Pole as viewed from the south.²⁷
