# PG&E Gas Curb Valve Box Leak Analysis

Andres Beltran, Stephen Ramos

January 2021

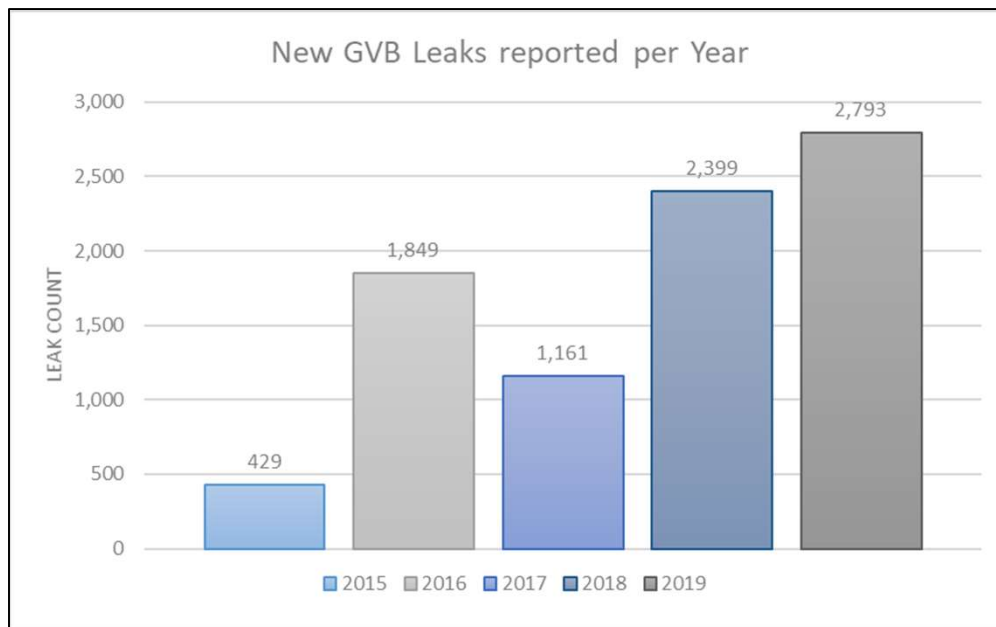
- Of the ghost leaks found between 2015-2019, there were a sizeable number of leaks reported at PG&E gas curb valve boxes (GVB)
- Leaks reported at GVBs were low in concentration (<0.1% gas) and were reported as a grade 3
- The distribution of the leaks is reported below:

Row Labels	Count of Division
San Francisco	2128
East Bay	158
Peninsula	98
Sacramento	93
Kern	52
San Jose	52
Fresno	38
Yosemite	36
Mission	32
Diablo	16
De Anza	15
Central Coast	14
North Valley	14
Sierra	14
Stockton	12
Sonoma	10
North Bay	8
Humboldt	3
<b>Grand Total</b>	<b>2793</b>

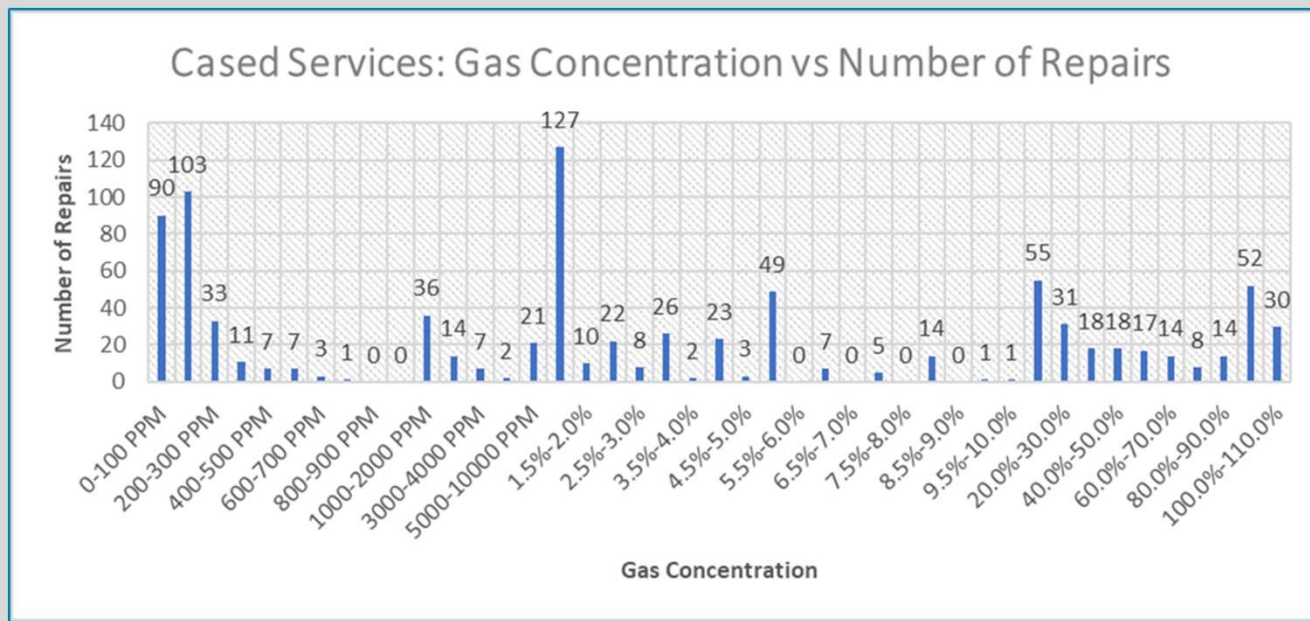
- Based on the interview with M&C, we evaluated service construction data for GVB leak repairs between **2015-2019**
- The construction data did not list service installation type, thus we needed to filter the data to determine if the repair was completed at a service with a vent casing:
  - **IF** the year of the service installation was between **1973-2017**, the service material is **plastic** AND the service is **<= 1.5” diameter**, **THEN** the service was assumed to be incased with a vent
- **1400 total repairs** were evaluated, **900** of the repairs had an **incased service line**

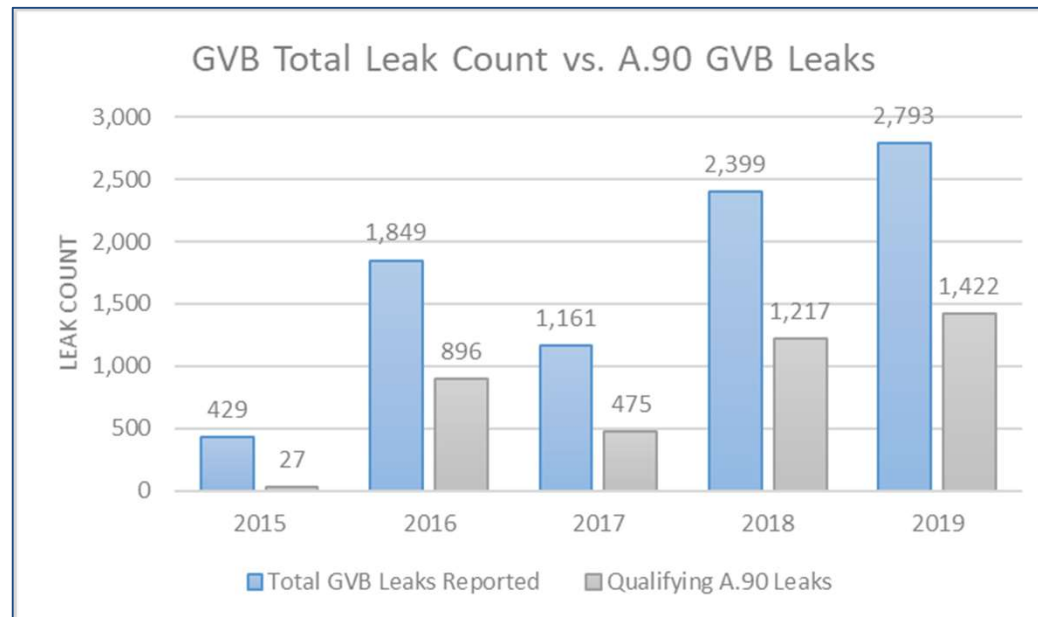
- Based on the construction data, we developed the following criteria:
- **IF** a leak is reported at a GVB:
  - **AND** has a reported gas concentration **less than 3000 PPM**
  - **AND** was installed to an **incased service line**
  - **AND** was installed between **1973-2017**, thus following the original **A.90 Standard**
  - **THEN** the curve valve box **does not have a leak** as the leak reading is **gas accumulating** from the **vent demanded by the original standard**
- Counted the number of GVB leaks that fit that criteria using the LS and GIS data
