# Root Cause Analyses

## *2017-18 Wildfires*

Root Cause Analyses of the 2017-18 Wildfires found to have been ignited by PG&E & Corrective Action Report

Prepared by: Envista Forensics, Inc. & Subcontractor Witt O'Brien's

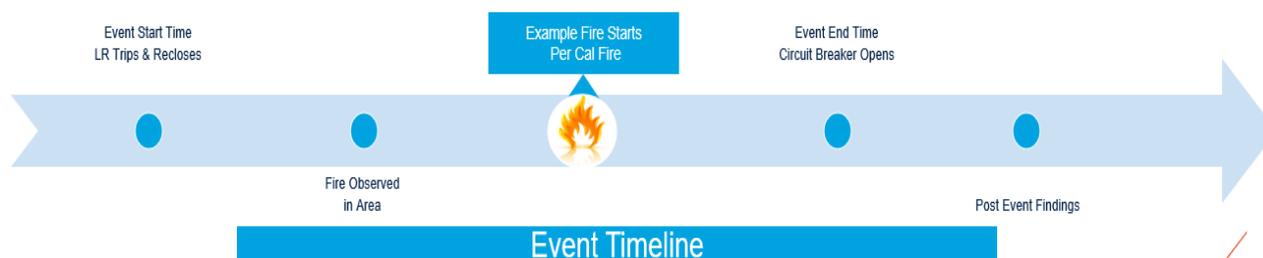
**Figure 2** – Example of Wildfire Circuit Timeline

A timeline for each wildfire circuit was created from data in the available documents and records (**Figure 2**). The analysis team used only facts from evidence to avoid misinterpretations. The timeline sequences the electrical circuitry events and formulates incident observations, such as energized downed conductors, high-impedance faults, and back-feed conditions. The fire ignition per CAL FIRE and/or CPUC-SED is also included on the timeline where available.

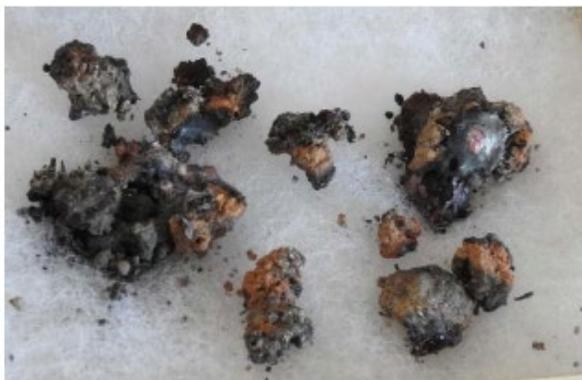
**Figure 4** – Wildfire Circuit RCA Fulgurites Created

The following circuits involved in the wildfires were found to have an energized downed conductor for over 30 minutes. Fulgurites are formed when temperatures reach approximately 1800 degrees Fahrenheit which fuses and vitrifies mineral grains found in the ground soils. (See Figures 4 & 5)

Wildfire	Circuit	Cause	Possible High-Impedance Fault Conditions	Possible-Back Feed	Possible Downed Energized Conductor Envista (Mins)
<b>Adobe</b>	Dunbar 1101	Tree	Yes	Yes	193
<b>Pocket</b>	Cloverdale 1102	Tree	No	No	186
<b>McCourtney</b>	Grass Valley 1103	Tree	Yes	Yes	109
<b>Atlas 1 &amp; 2</b>	Pueblo 1104	Tree	Yes	Yes	87
<b>Redwood</b>	Potter Valley 1105	Tree	Yes	Yes	61

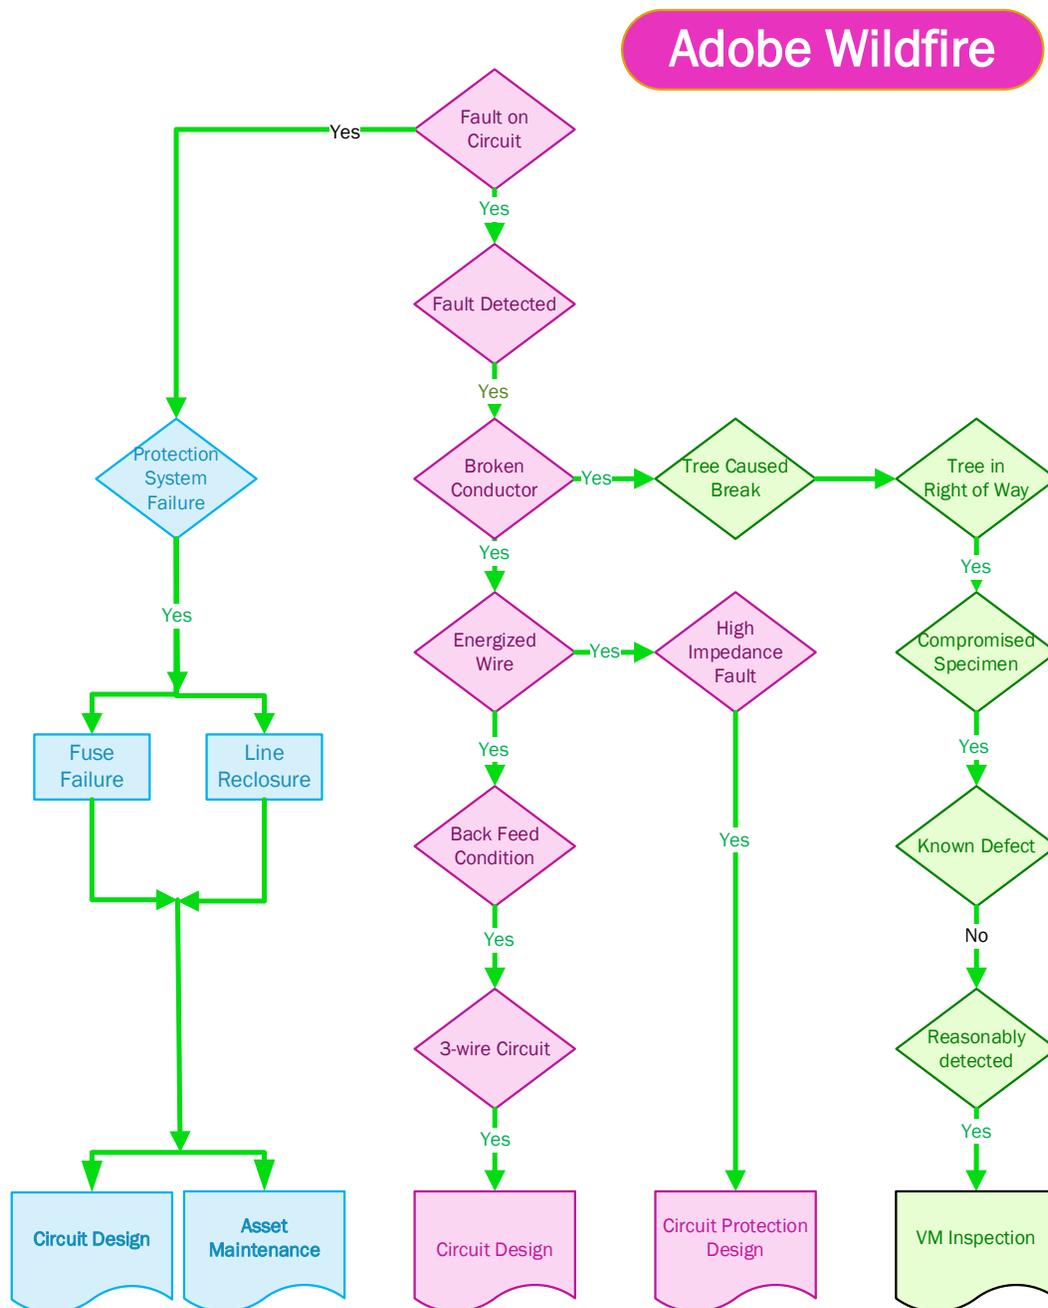
1. Adobe Failure Decision Analysis Process Results Diagram

- Asset Maintenance
- Circuit Design
- Vegetation Management Inspection

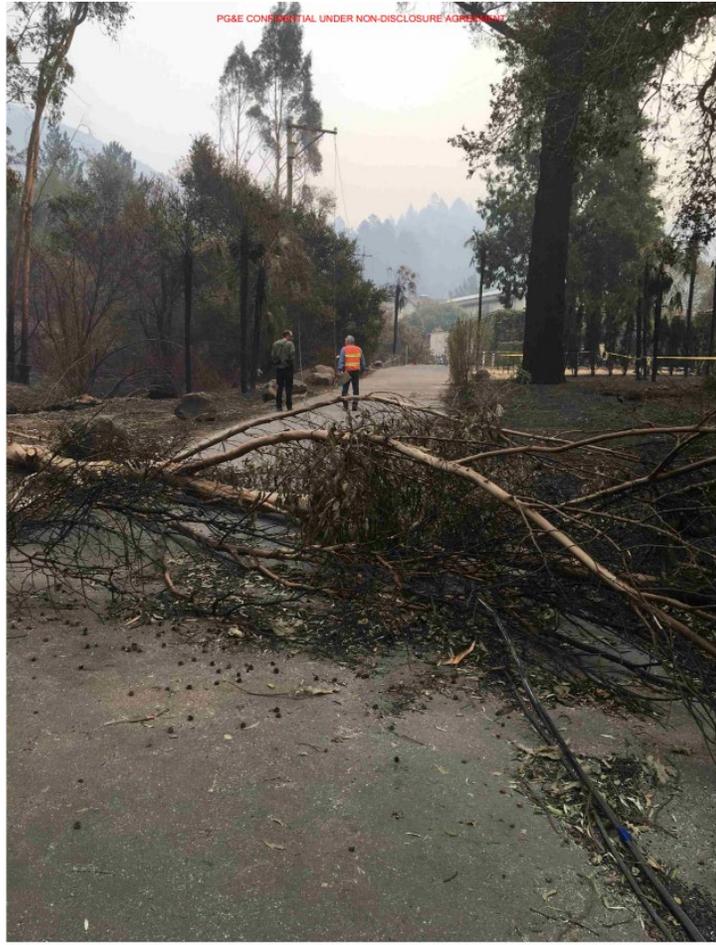
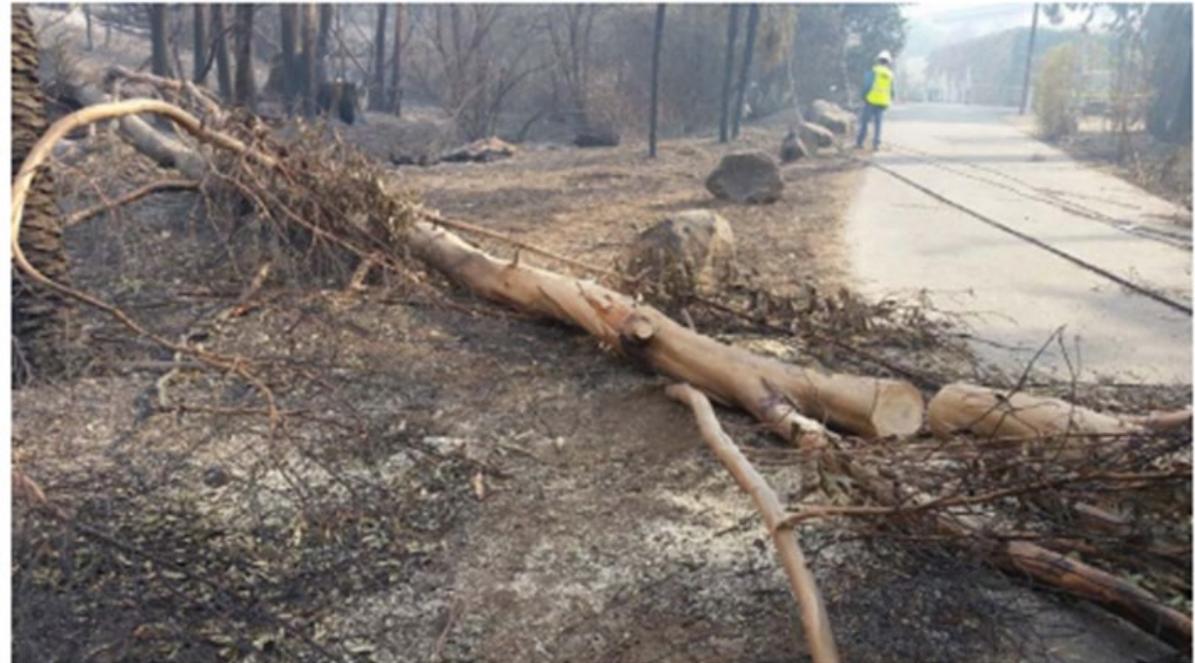
**Figure 8.** Subject Eucalyptus tree laying across the road and subject conductor spans. The tree was rooted in the top left corner of the image. (October 17, 2017)

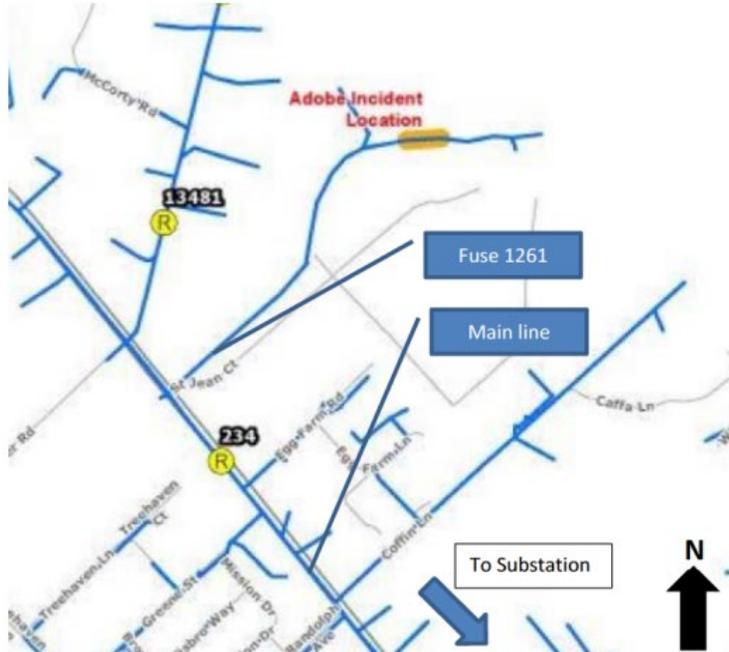
**Figure 6.** Map showing the approximate locations of protection devices upstream of incident span/Area of Interest. Not drawn to scale. (Source: PG&E)<sup>29</sup>

The incident span was protected by upstream fuse 1261, Line Recloser 234 (LR-234, manufactured by Cooper Power Systems, type F4C), and finally the Dunbar-1101 Circuit Breaker (CB-1101). Fuse 1261, located at the branch from the main line near Highway 12, consists of three 65T fuses, in line with each of the conductors.

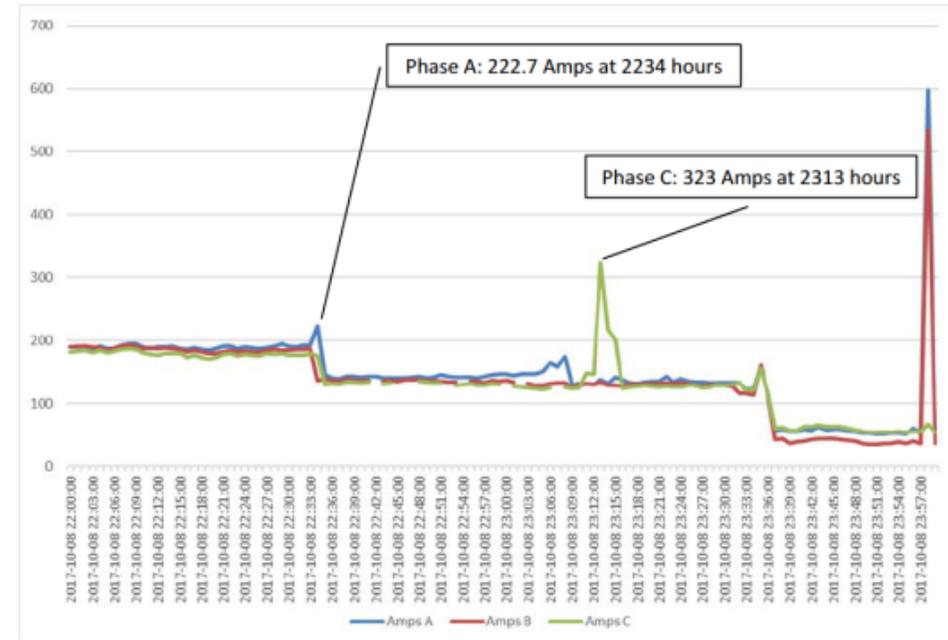
**Figure 7.** SCADA plot of load data recorded at Dunbar-1101 CB on October 8, 2017, from 2200 hours to 2359 hours. Highlight of load reduction event at 2233 to 2235 hours.

On October 8, 2017, at 2234 hours, SED staff believes the load reduction to be linked to the operation of two fuses that are part of fuse 1261. The subject Eucalyptus tree falling into the overhead lines likely caused a ground fault condition and ultimately the fire.

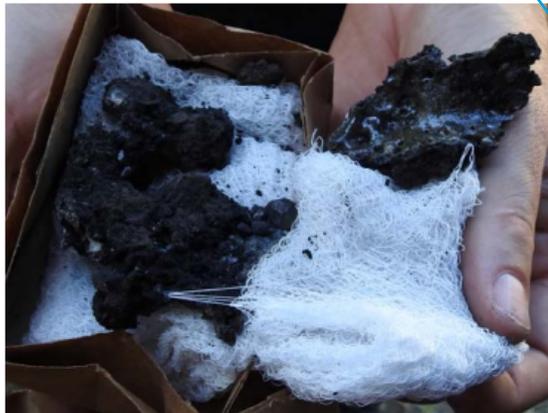
On October 12, 2018, SED staff, Wilson Tsai and Raymond Cho, met with CAL FIRE investigators in Santa Rosa to review evidence from the evidence site retained by CAL FIRE. Of the evidence reviewed and photographed, SED staff found multiple damaged electric facilities and hardware including a fulgurite-like mass, failed insulator tie wires and damaged conductors. Fulgurites<sup>33</sup> are naturally occurring masses of fused soil and/or other debris that can form when lightning discharges into the ground. In this case, a fulgurite-like mass was formed when conductors fell to the ground and discharged enough energy to fuse some of the ground material together.

Figure 10. Fulgurite-like mass found in the Adobe incident area.

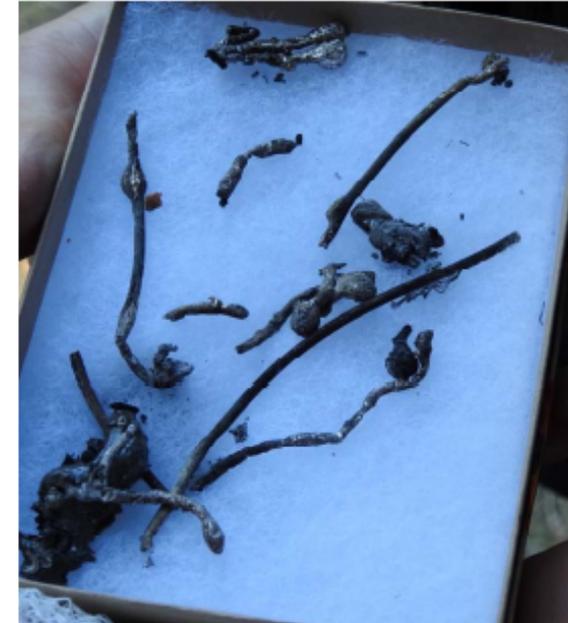
SED staff did not unwind the multiple bundles of conductor wire but reviewed the failure points. The Eucalyptus tree and fire damaged the insulating rubber material around the conductors. SED found evidence of arcing exhibited by molten metal attached to failed pieces of conductor.

Figure 11. Failed pieces of conductor strands and evidence of arcing.

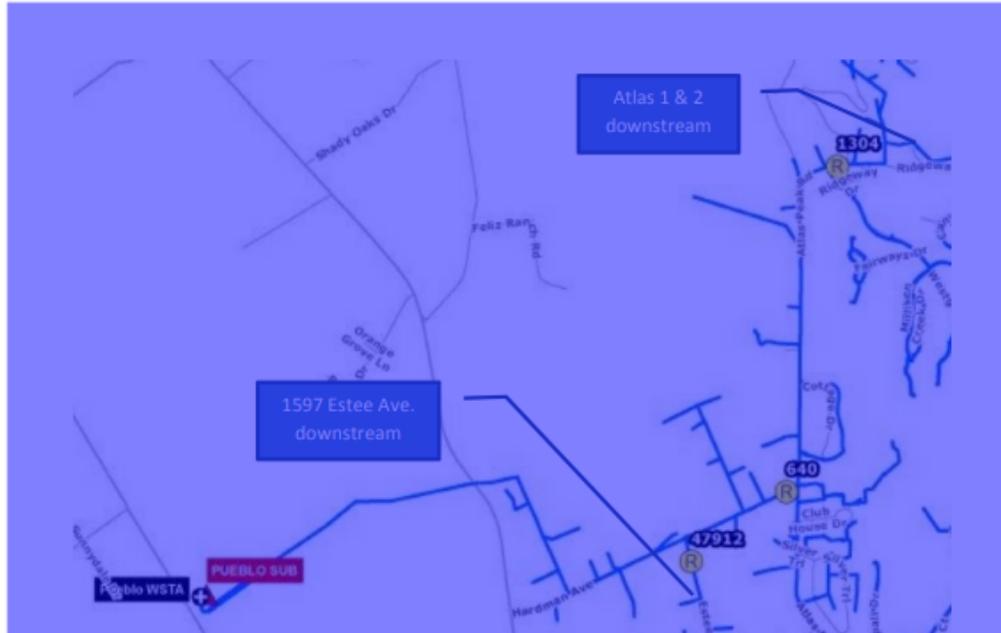
**Figure 10.** Partial view of Pueblo-1104 circuit with LR-640, LR-1304 and Sectionalizer 47912 shown. (Source: PG&E)<sup>40</sup>

Of the PG&E outage reports reviewed, SED could not determine if Fuse 709 operated after the faults occurred at both locations. Also, LR-640 and LR-1304 each seemed to have operated once within 16 minutes of each other based on the "CONTROL ALARMS" recorded locally at each device. The LRs did not lock out, but rather LR-640 was manually opened by PG&E field personnel due to the Atlas fires.

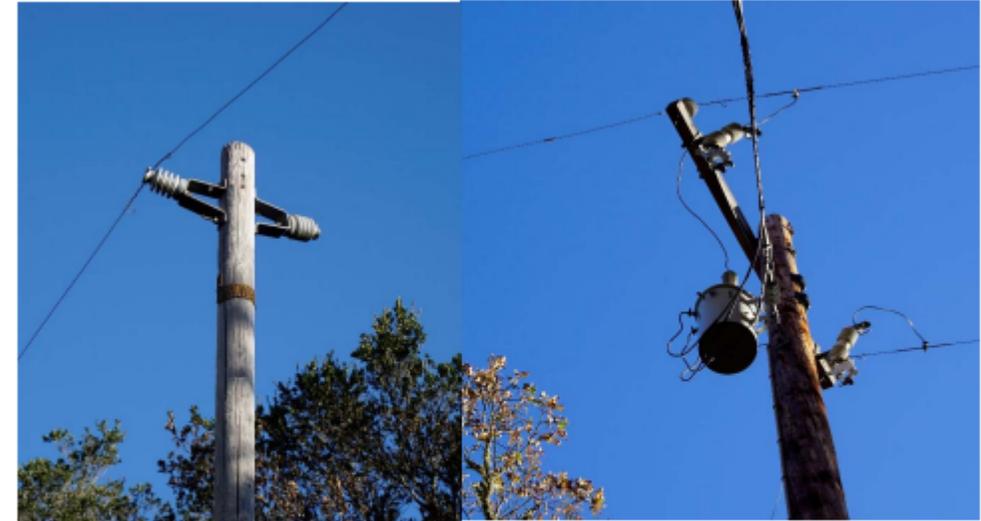
**Figure 6. Atlas 1** Left: Subject pole #1, 40-foot pole (PG&E pole #102292423, coordinates:38.409797, -122.246232). Photo taken from the southeast side of pole, looking north. Right: Subject pole #2, 45-foot pole with transformer attached (PG&E pole #102292420, coordinates: 38.409435, -122.245904). Photo taken from southwest side of pole, looking northeast.

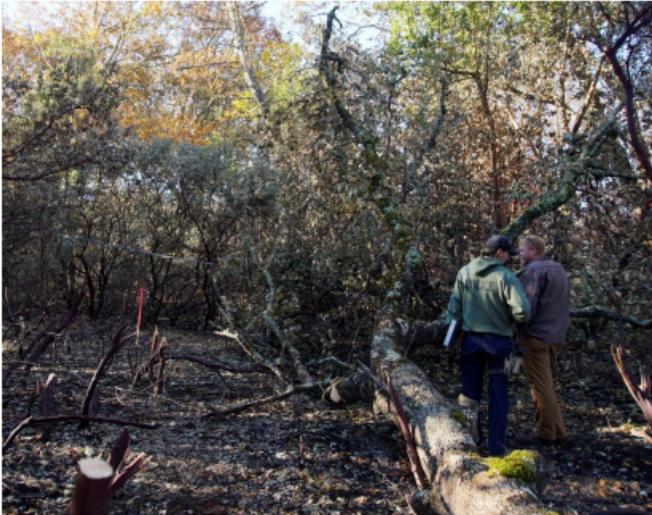
**Figure 11.** Subject Black Oak tree laying perpendicular to the road. Photo taken from road-side facing the field.

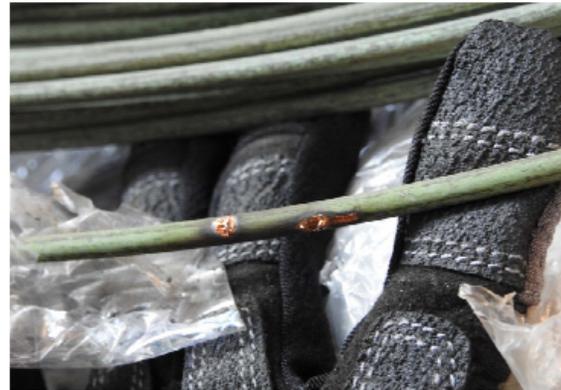
**Figure 14.** Beading on the subject copper span in the Atlas 2 incident area. CAL FIRE evidence item 3A.

For Atlas 2, SED found beading on the subject PG&E copper conductor which indicated electric arcing on another object. The evidence shows that the conductor was energized when it contacted another object.

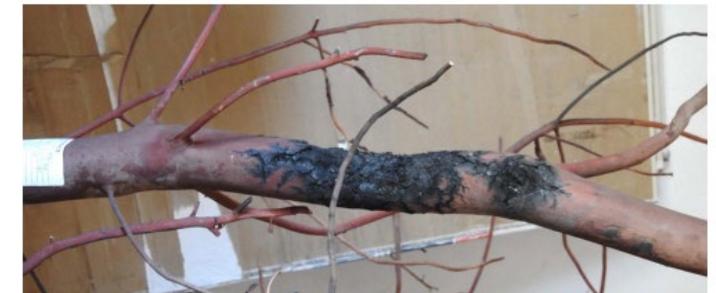
**Figure 13.** Charring on a Madrone tree branch that appears to be arcing in the Atlas 1 incident area. CAL FIRE evidence item 9B.

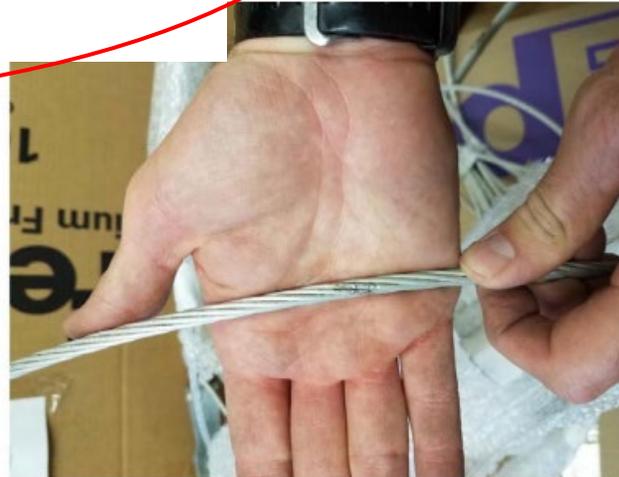
Figure 11. West conductor with burn mark.

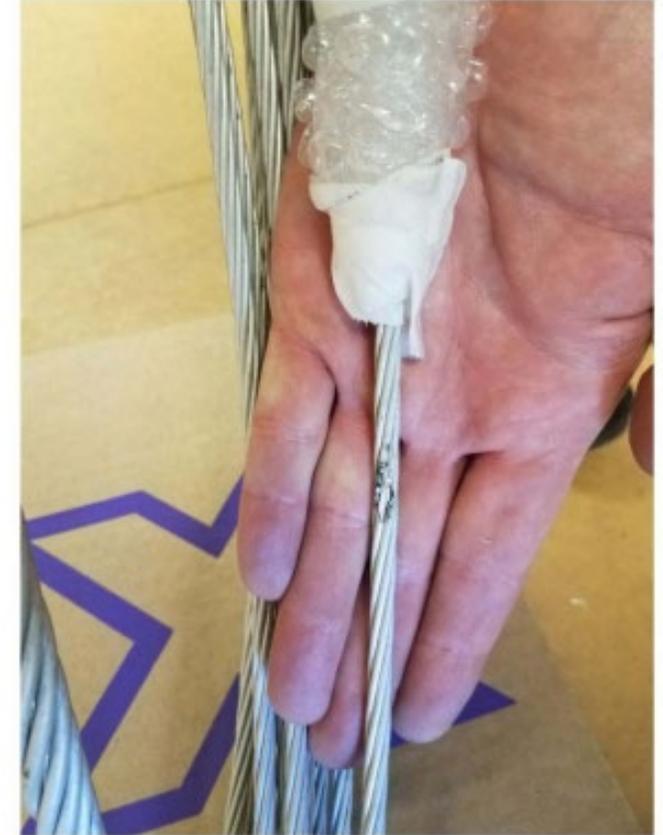
Figure 10. East conductor with burn mark.

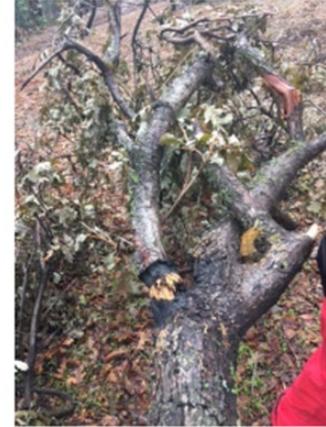
Figure 7. Burn mark from 12 kV conductor on the Valley Oak tree

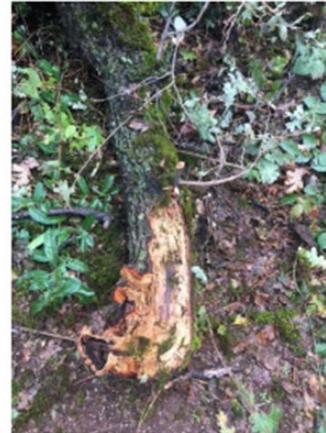
Figure 8. Another 12 kV conductor burn mark on the Valley Oak tree

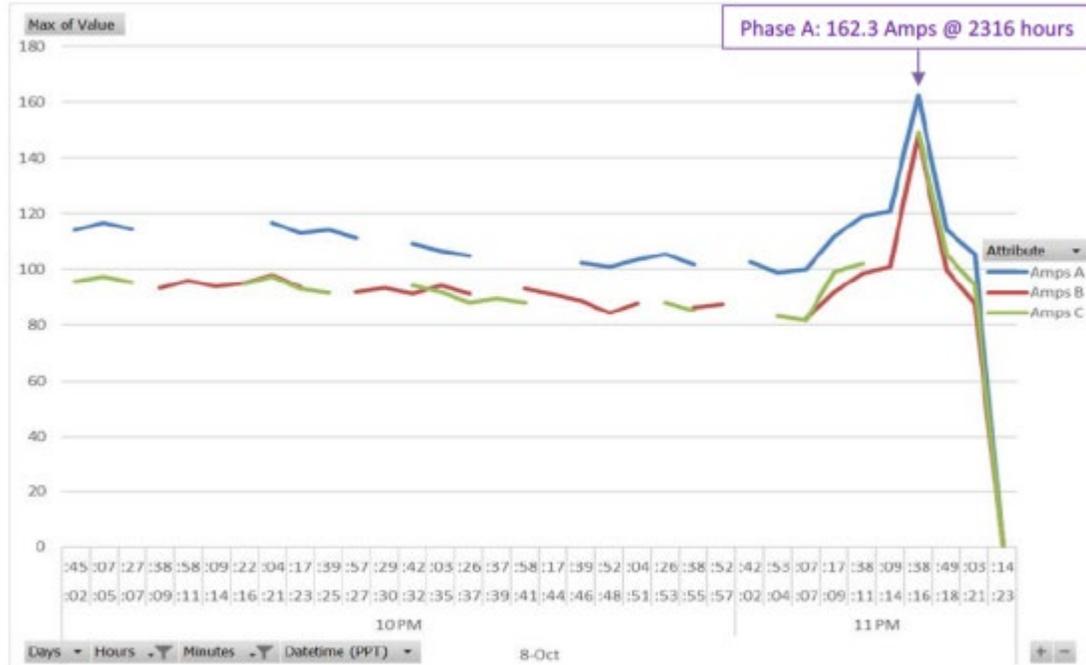
**Figure 9:** SCADA plot of load data recorded at the Bangor 1101 CB on October 8, 2017 from 2202 to 2323 hours.

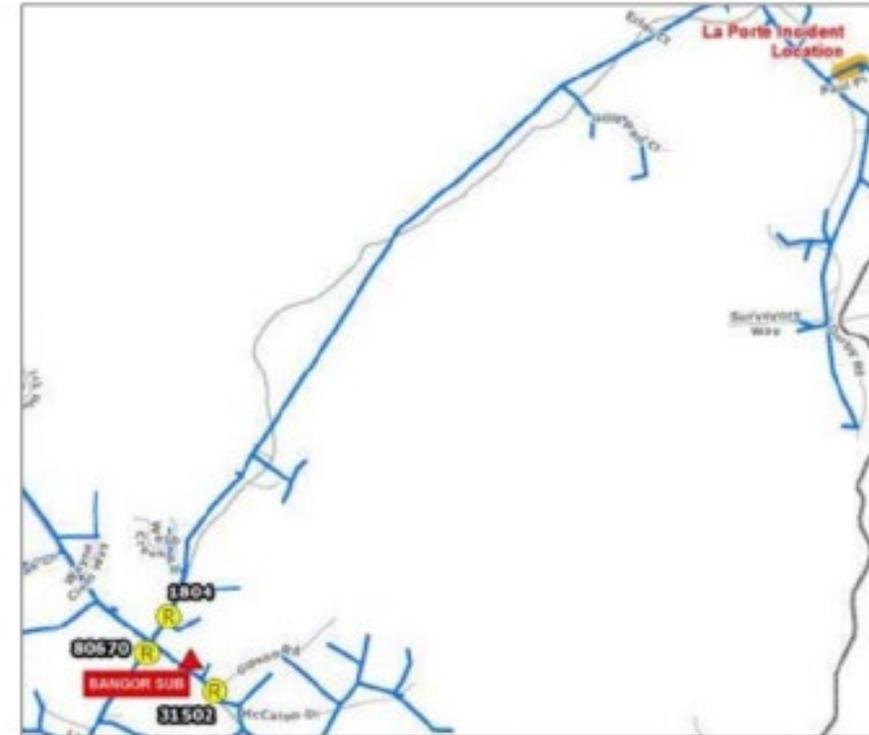
**Figure 8:** Map showing locations of Line Reclosers. (Source: PG&E)

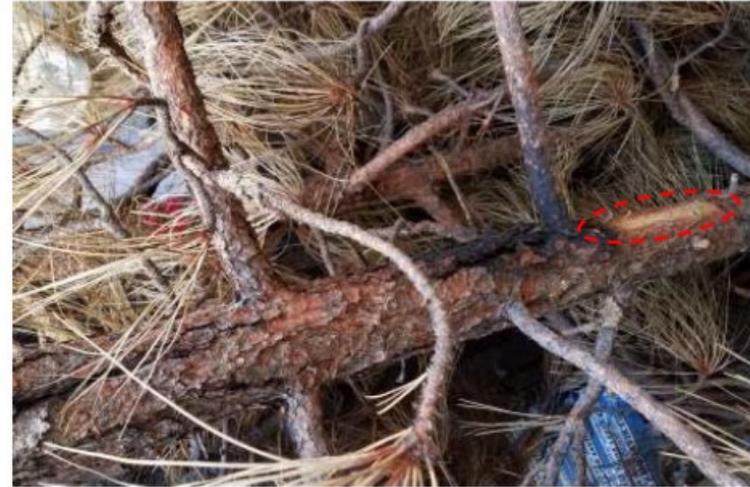
Figure 14: Subject Tree (Note: Abrasion and Burn Marks)

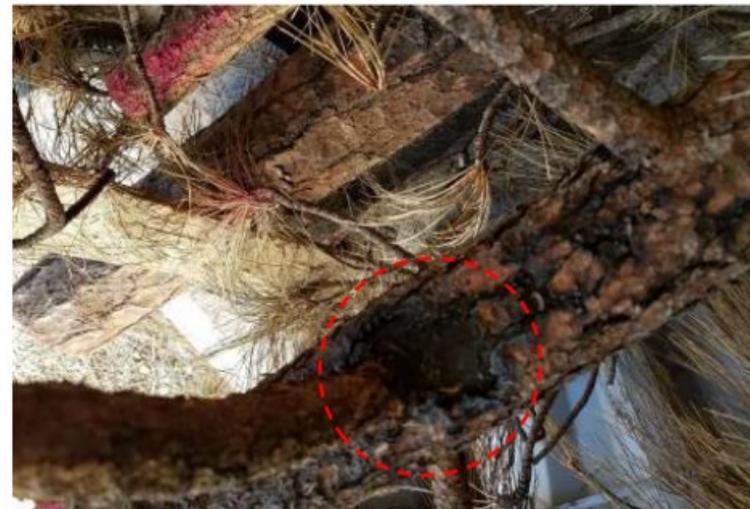
Figure 15: Subject Tree (Note: Abrasion and Burn Marks)

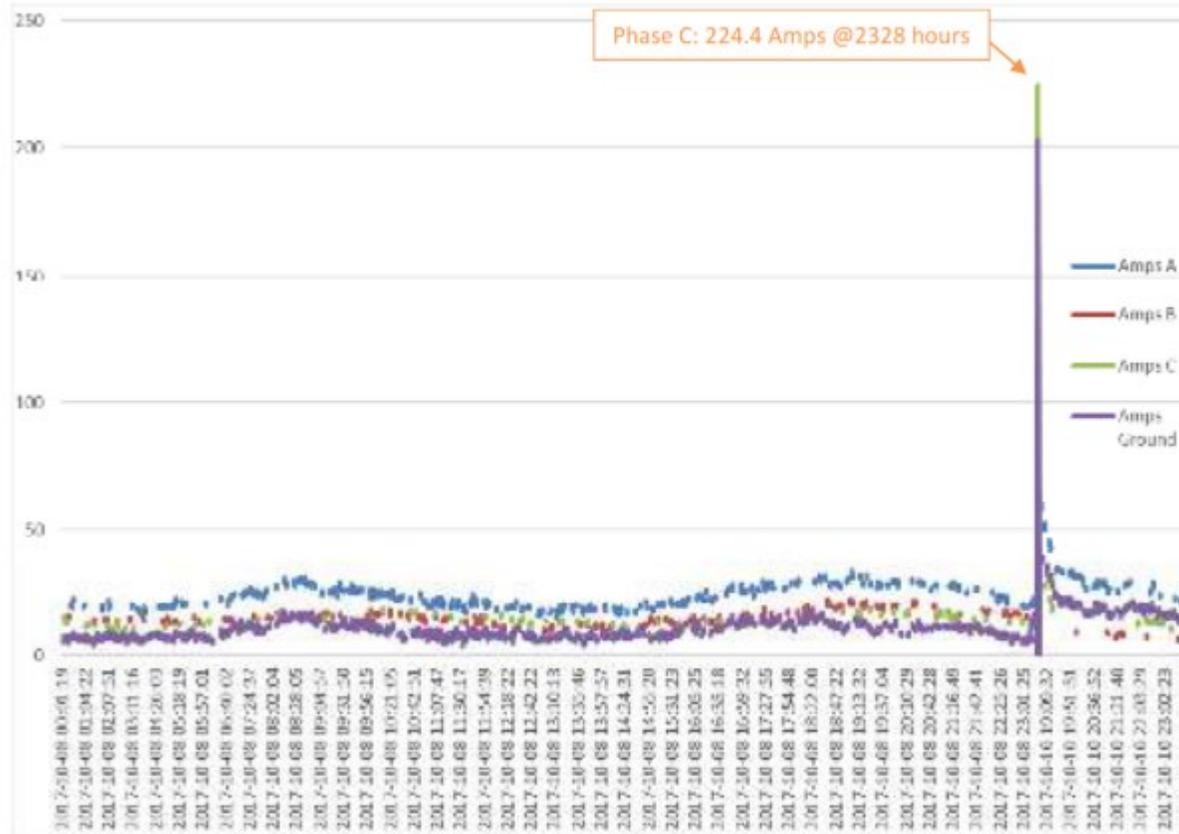
Figure 10: SCADA plot of load data recorded at LR 48484 from October 8 to 10, 2017.

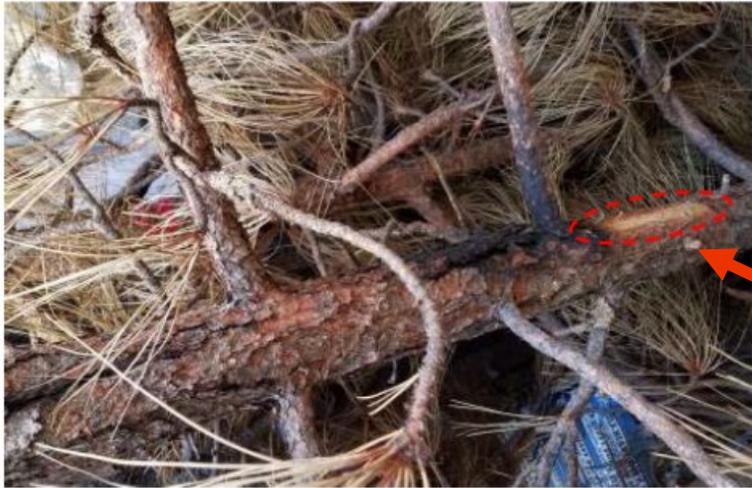
Figure 14: Subject Tree (Note: Abrasion and Burn Marks)

CAL FIRE investigator, Jeremy Monroe, found no indicators of connectivity between the burned portion of the tree trunk and the vegetation below. Therefore, Mr. Monroe concluded that: the fire originated at the point of contact between the tree and conductor span and the burning embers from the tree ignited the dry vegetation below, which started the fire. Mr. Monroe stated that high wind speeds and dead and downed trees, likely taken down by mechanical means, fueled the fire. In addition, Mr. Monroe stated

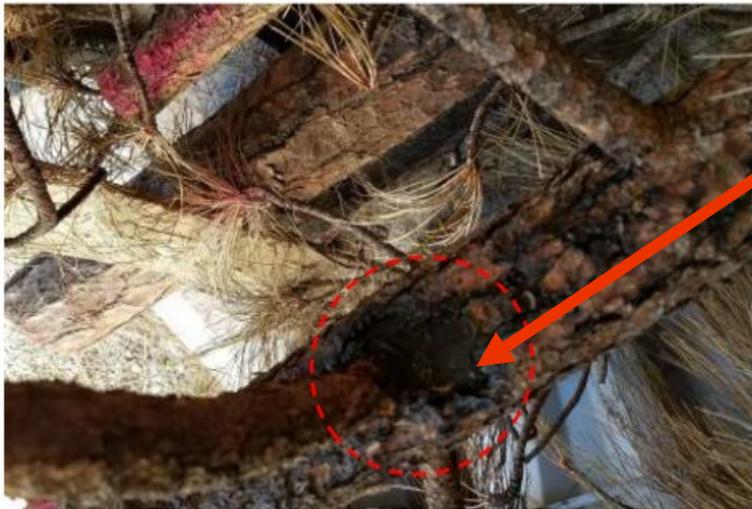
Figure 15: Subject Tree (Note: Abrasion and Burn Marks)

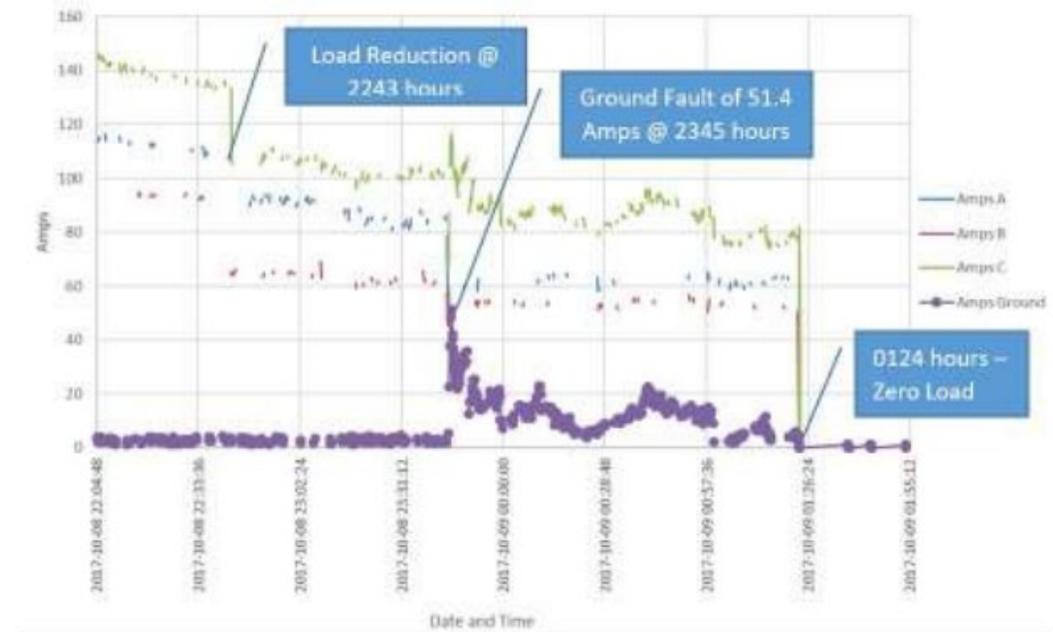
CAL FIRE stated that the McCourtney Fire began at approximately 2348 hours on October 8, 2017. This time aligns with the fact that a ground fault is seen at 2345 hours by both Line Recloser 58498 and Circuit Breaker 1103. (Figure 9)

**Figure 9:** Plot of SCADA load data recorded at the Line Recloser 58498 showing load for all phases and ground amps beginning on October 8, 2017 at 2200 hours and ending October 9, 2017 at 0155 hours.

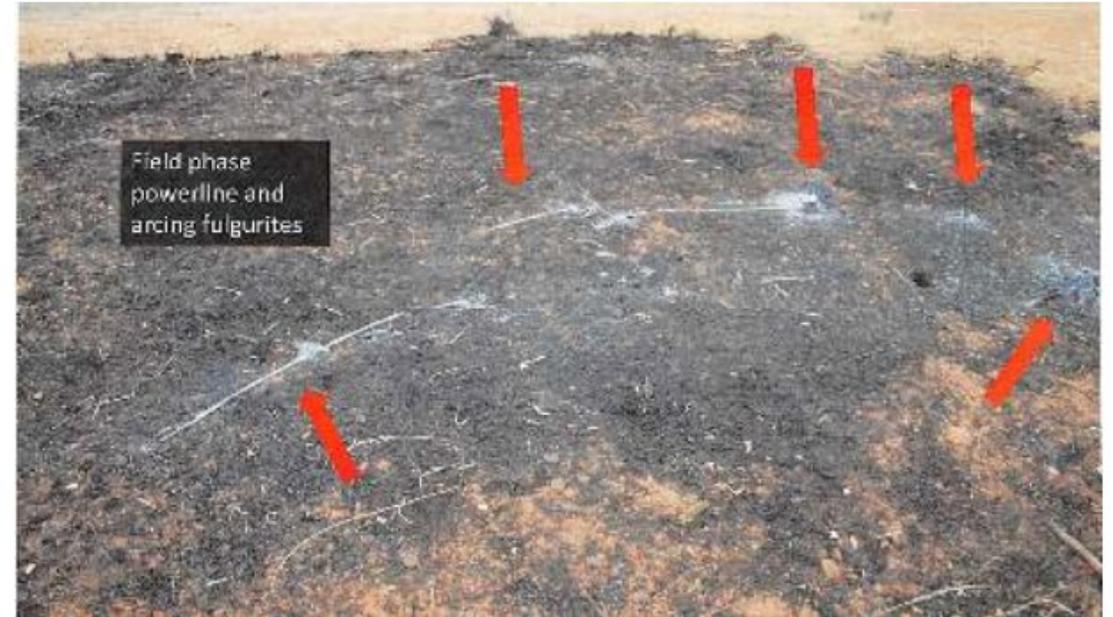
The fire at 1228 McCourtney Road was caused by the hot tap clamp failure on the source side of Line Recloser 1700. The failure led the 12-kV conductor to fall and ignite the vegetation. SED will not know why the hot tap clamp failed until a destructive test and failure analysis of the clamp is completed.

**Figure 12:** Conductor and fulgurites between Pole #10525757 and Pole #05172  
(Source: CAL FIRE)

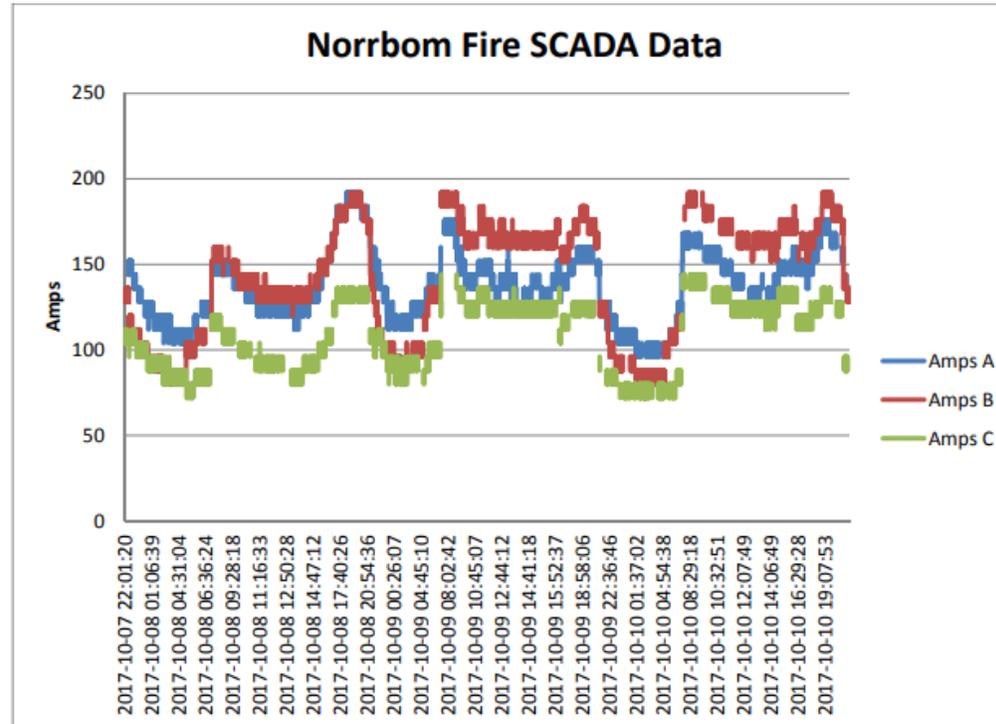
**Figure 5:** Plot of SCADA data from Sonoma 1103 CB for each phase from 24 hours prior to 48 hours after the CAL FIRE designated start time.

The start time for the Norrbom Fire according to CAL FIRE was 2200 hours on October 8, 2017. Based on Figure 5, on the day of the incident, the circuit experienced an outage between 17:40 and 20:54 hours. The decline in circuit amperage from then on indicates interruption in service either affected by the fire or by protection devices tripping.

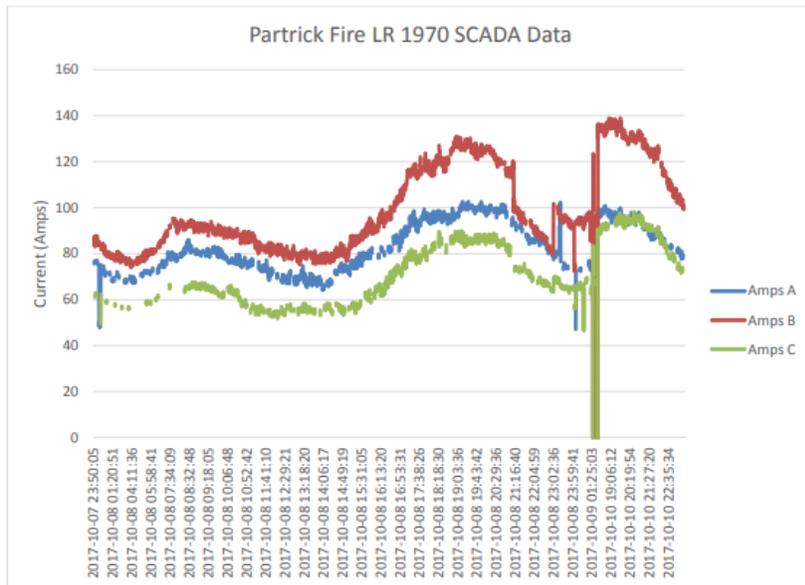
**Figure 5:** Plot of SCADA data from LR 1970 for each phase from 24 hours prior to and 48 hours after the CAL FIRE designated start time.

LR 1970 is the closest line recloser upstream from the incident location. Beginning at approximately 2100 hours on October 8, 2017, there is a noticeable drop in amperage across all phases. Around the incident start time at 2348 hours, there is a significant drop. On October 9, 2017, at approximately 0154 hours, all phases reported zero amps.

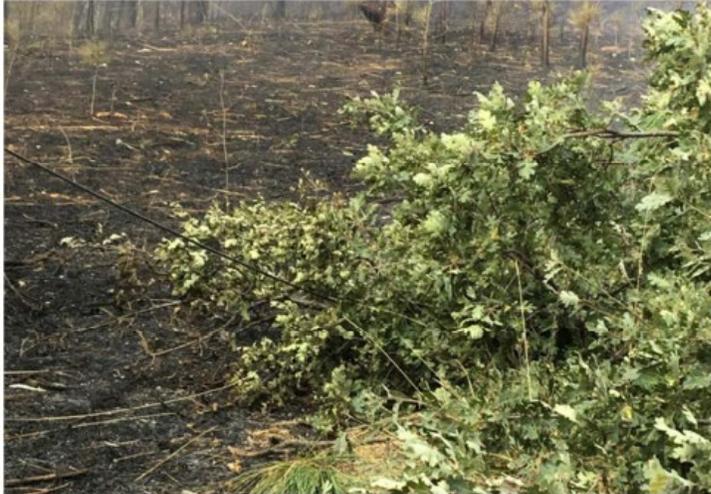
On October 9, 2017 at 0710 hours, a PG&E troubleman found one of two fuses open at Fuse L2005. The troubleman found a downed conductor and broken crossarm five poles east of Fuse L2005. The troubleman observed that several branches from the subject Valley Oak tree had broken off and that the leaves were still green. Additionally, the troubleman observed a bump sleeve on the ground with the conductor pulled out. Another PG&E troubleman found the subject Valley Oak limb lying on top of a section of conductor (See Figure 7).

Figure 7: Vegetation on the Subject Conductor (Source: PG&E)

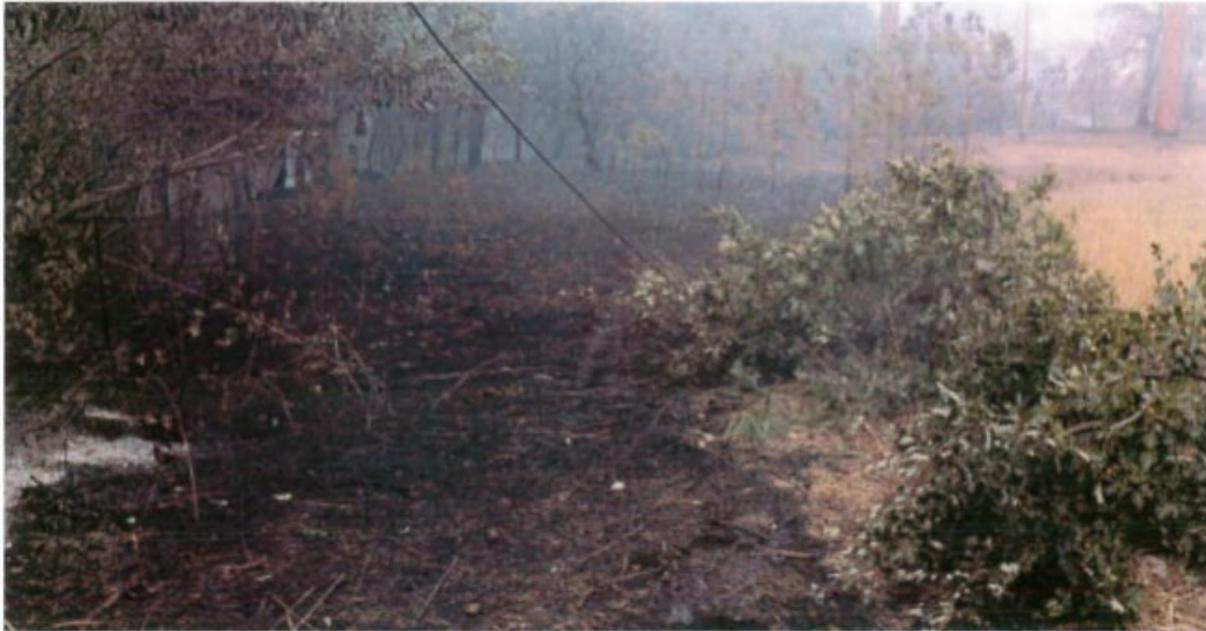
P-NW\_0025 Limbs on West end of line

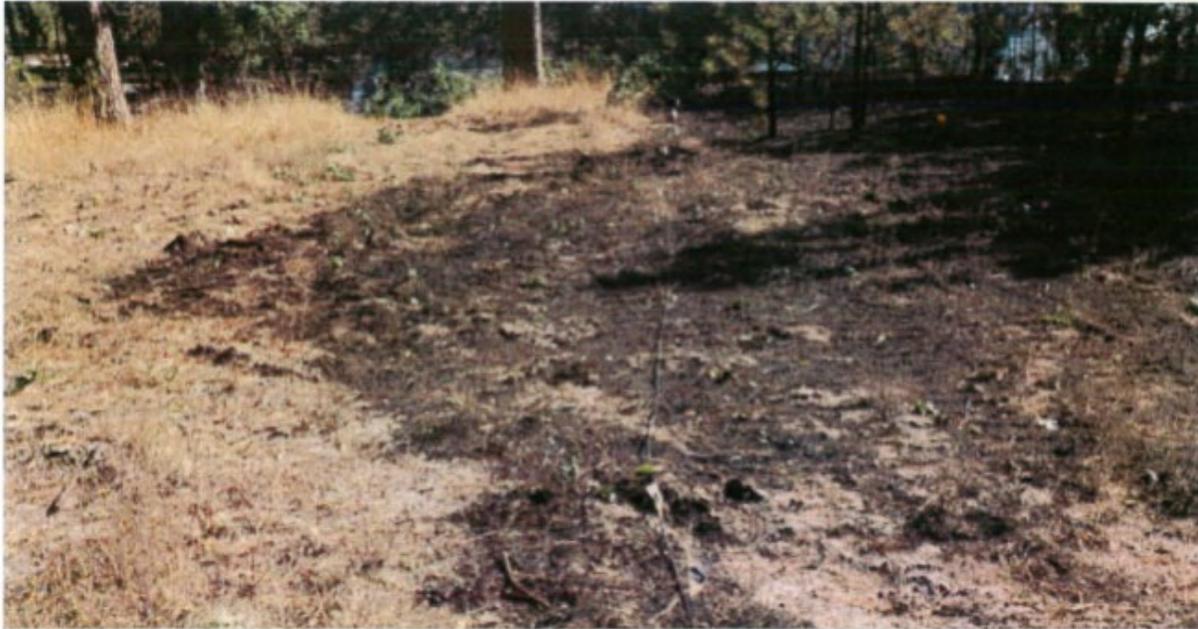
P-NW\_0085 West side of Line facing East

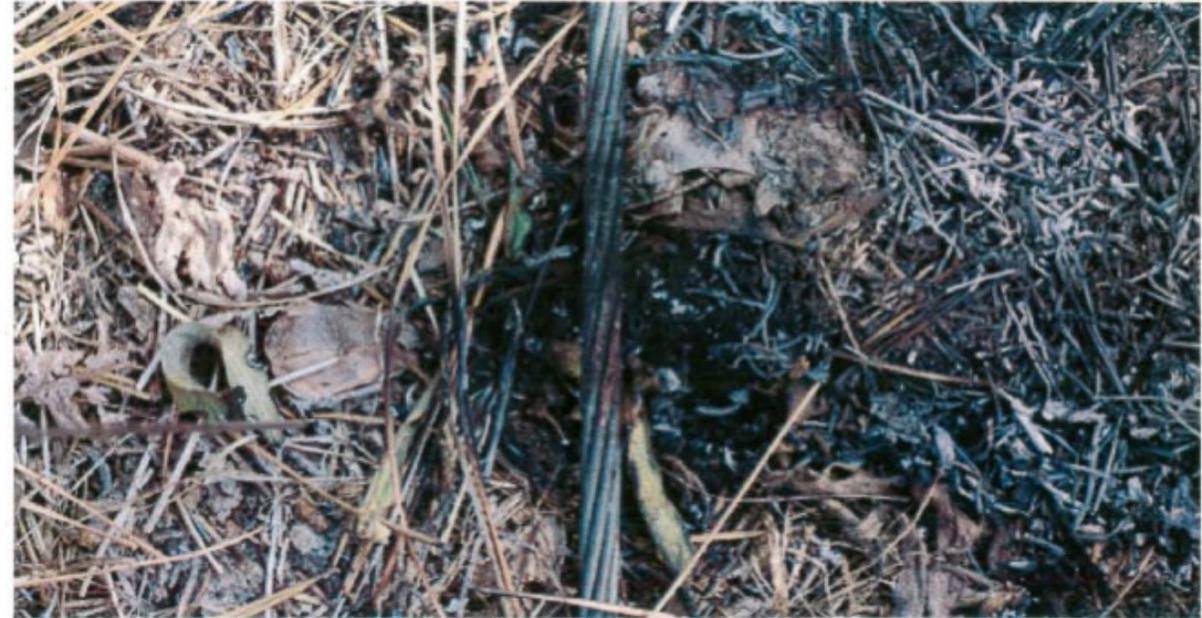
P-NW 0089 Arcina West end line

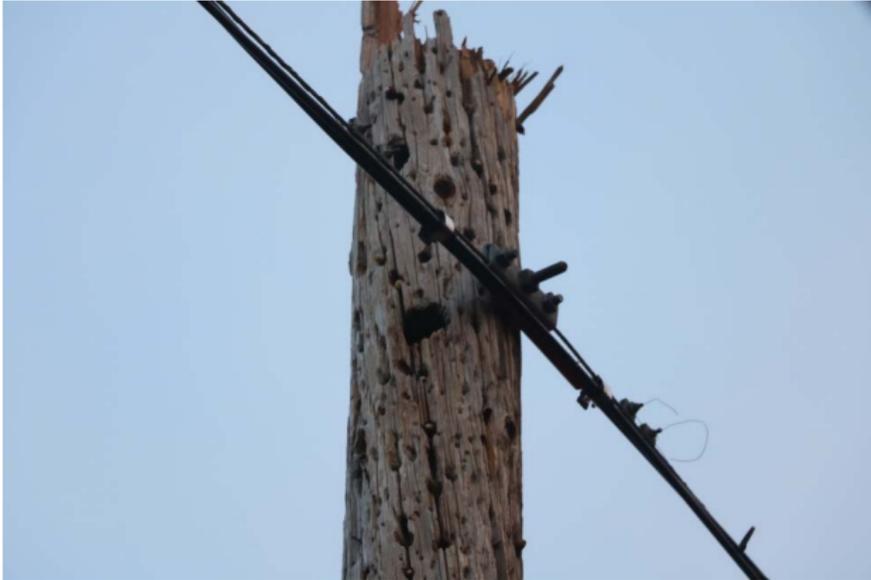
**Figure 7.** Break 18 inches above the communication conductor attachment on Fuse Cutout Pole 1447 with woodpecker holes (Source: CAL FIRE)

The bottom section of the subject failed pole was still standing and had burns at its base. CAL FIRE had cut out an approximately 4 to 6-foot pole section to retain as evidence. One cut was made on the top section, approximately 3 feet from where the break occurred. The other cut on the bottom section was approximately 1 foot from the break.

The bottom section of the pole was broken off at approximately 18 inches above the communication cable attachment. There were various woodpecker holes in this broken section of the pole. (Figure 7)

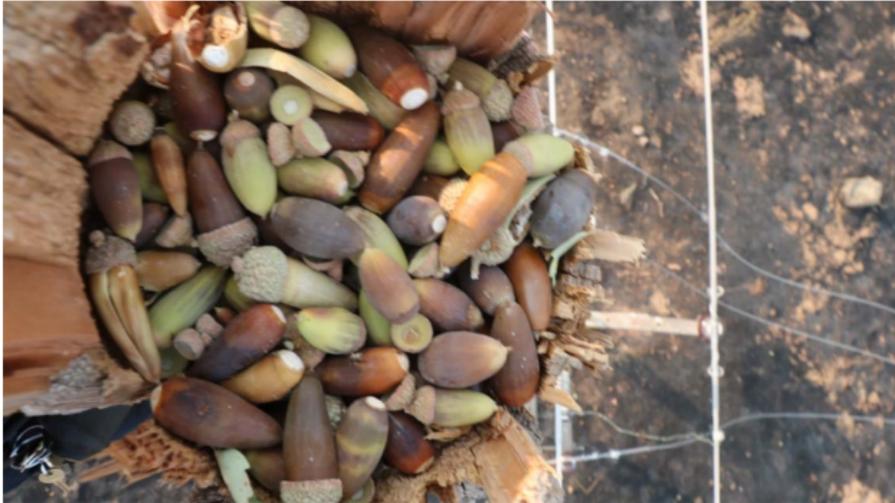
**Figure 10.** Top view of break on Fuse Cutout Pole 1447 full of acorns (Source CAL FIRE)

Chief Baldwin stated that he spoke with CAL FIRE Senior Environmental Scientist-Forest Practice Biologist Anastasi Stanish about the pole in question. Ms. Stanish mentioned that woodpeckers are usually looking for imperfections or soft spots in wood to make nests. The nests found on this pole could have been accomplished over a couple of days, but most likely occurred over the course of weeks or even months.

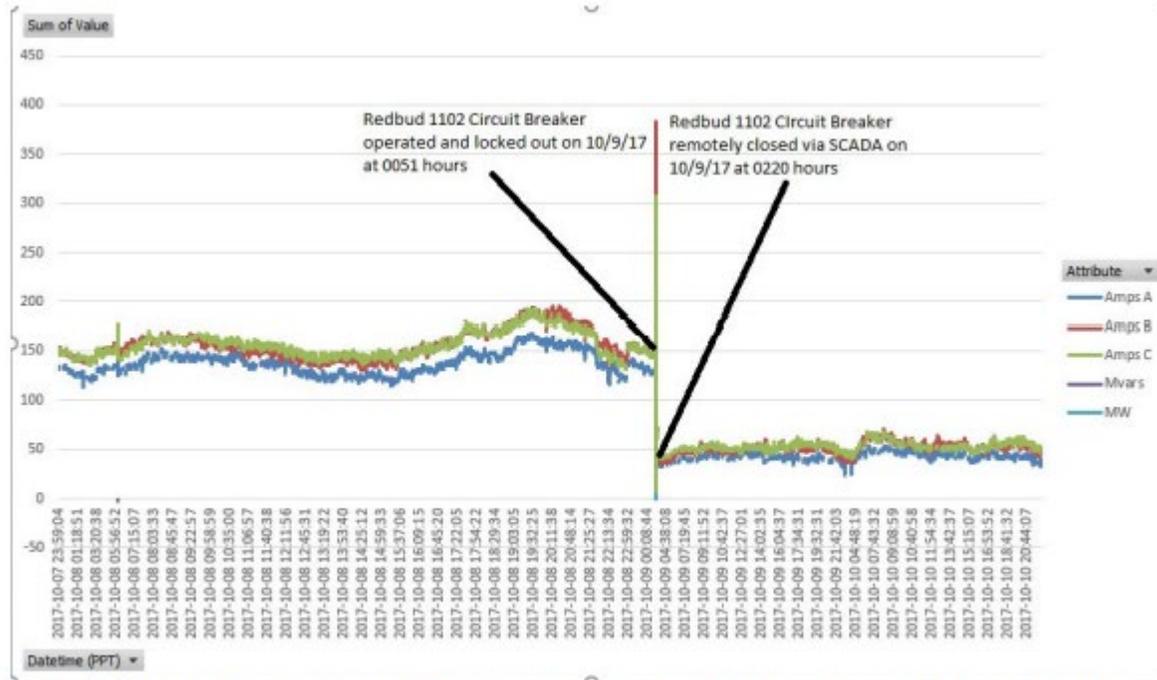
**Figure 5.** Plot of the Redbud 1102 Circuit Breaker SCADA load from October 7, 2017 to October 10, 2017.

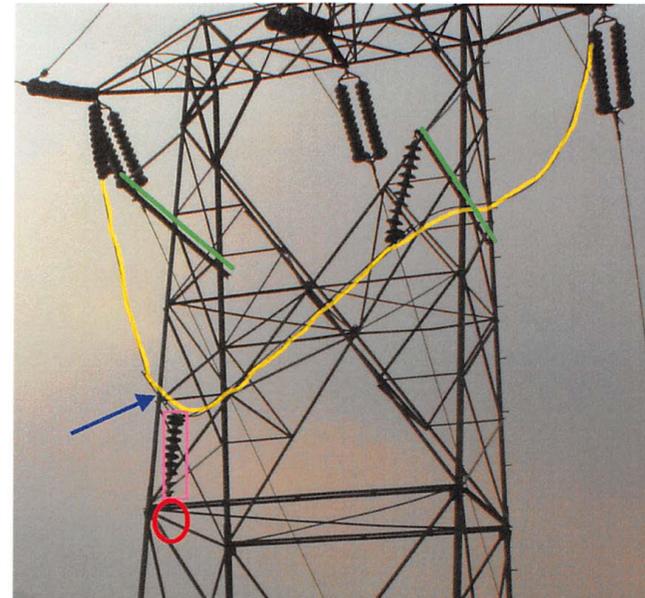
THOMPSON told me CP27/222 appeared to be damaged. I observed a section of conductor (later identified as a transposition conductor) in contact with a tower support member (highlighted in yellow in the photograph on the next page). I observed an insulator string, comprised of ten ceramic insulators, was hanging inverted from the conductor and appeared to be damaged (pink) under the left phase (LΦ) conductor. I observed four of the ten ceramic insulator sections were broken. I observed a piece of metal support hardware (later identified as a C-hook) appeared to be damaged with a portion missing (red). The C-hook was located at the end of the inverted insulator string. There was a black mark consistent with a high voltage discharge discoloration on the tower within the immediate area of the transposition conductor contact point (blue arrow). Above the damaged insulation bells was a support arm (green) with no insulator attached. Under the right phase (RΦ) of the tower was a support arm with a string of insulators attached to the transposition conductor.

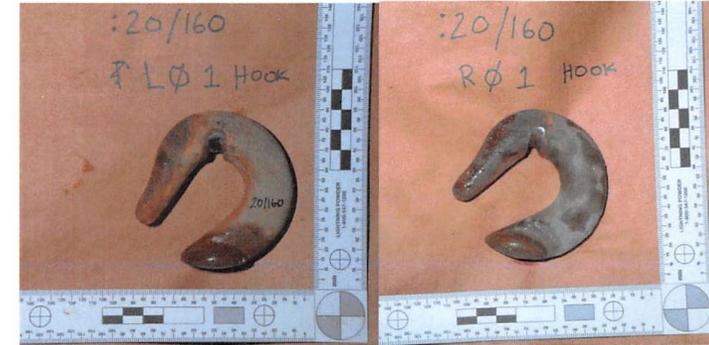
I examined all the items as they came into my custody. I observed wear patterns on every C-hook collected. The C-hooks that were attached to either a support arm or an ST20 bracket appeared to have the most wear. See the cropped photographs below:

Failed "C"  
hook

plate. Per the report the rating for a 115 KV line is 30,000 lbs. Both J-hooks tested had visible grooves and wear and failed at 11,500 lbs. The attachment plate eye with visible grooves and wear failed at 19,600 lbs. A third hook with no visible damage or scratches was also tested and failed at 6,900 lbs. Figure 4 of the report shows the worn hook
