**Outage Investigation  
Larkin Substation Outage on  
April 21, 2017**

Exponent  
149 Commonwealth Drive  
Menlo Park, CA 94025

September 15, 2017

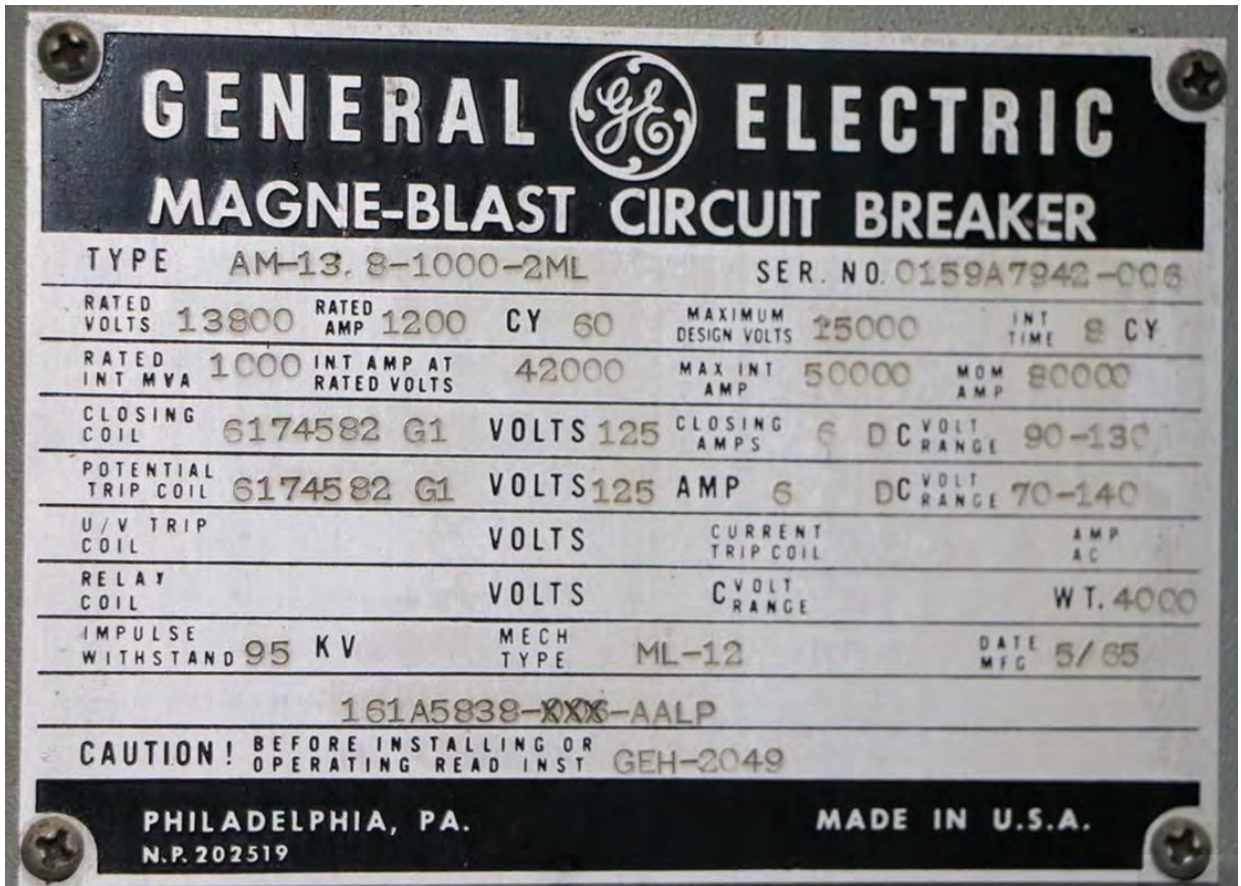
Figure 5. Nameplate of an exemplar circuit breaker.

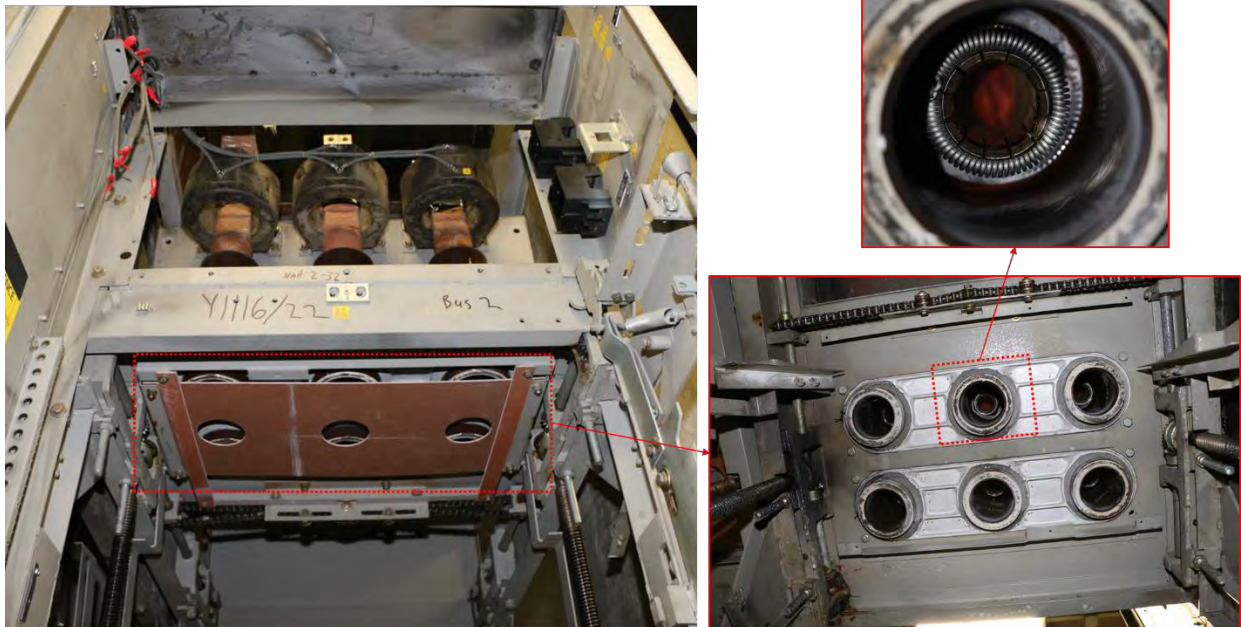
Figure 6. Connections inside an exemplar cabinet at the top of the circuit breaker cabinet.

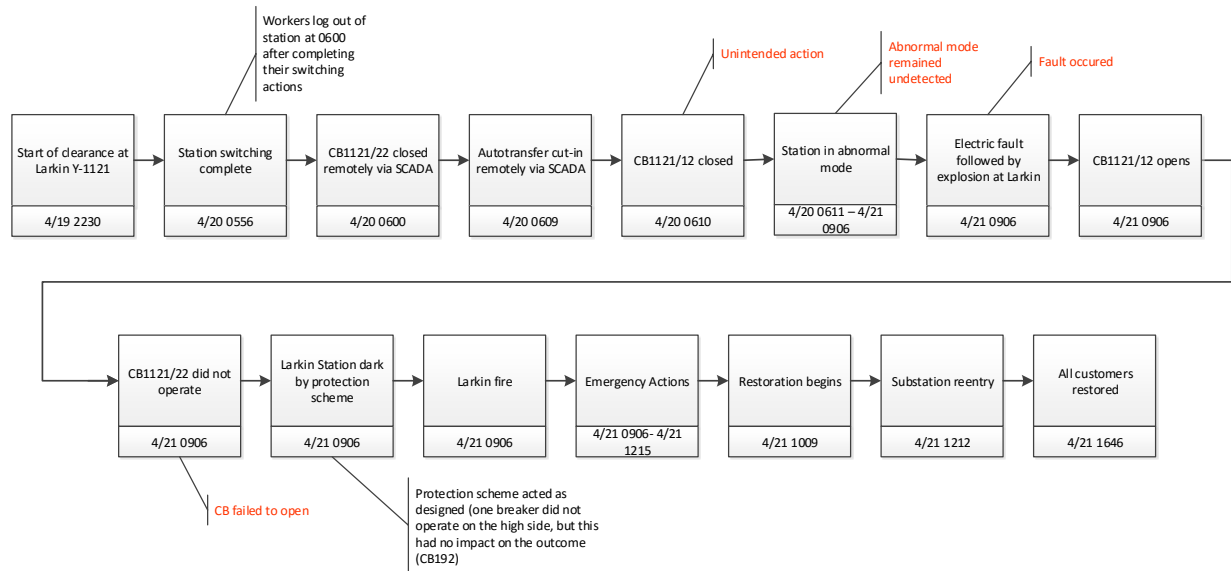
An electric fault occurred in Larkin at the time of the incident. The fault activated the feeder protection that sent a trip signal and opened the CB1121/12 breaker. The CB1121/22 did not operate and the fault continued until it was interrupted by the high-side circuit breakers in less than 1 second. This resulted in the total loss of power and the substation went dark. The fault resulted in fire and smoke in the station. Emergency actions followed and restorations started shortly after the outage began. The substation was back online and all PG&E customers restored by 4:46pm. Figure 8 shows a high-level timeline of the events.

Figure 8. A high-level timeline of the events

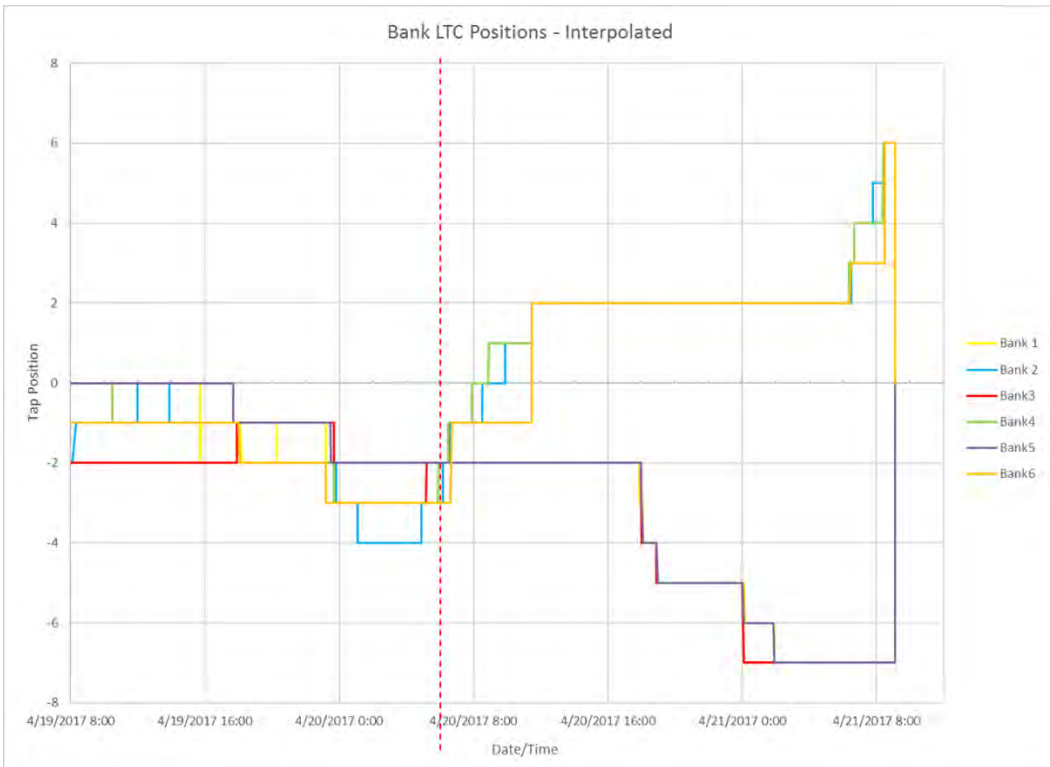
- b. Recorded data of the position of the Load Tap Changers (LTCs) at the station transformer banks show increasing voltage deviations at the two station bus bars immediately after the station’s configuration became abnormal. This translates into an increase in current through the electrical components between the bus bars at the incident feeder, including the incident circuit breaker connections. The voltage deviation increased to a maximum value just before the failure on the morning of April 21, 2017.

Figure 12. Interpolated data of the LTC positions.

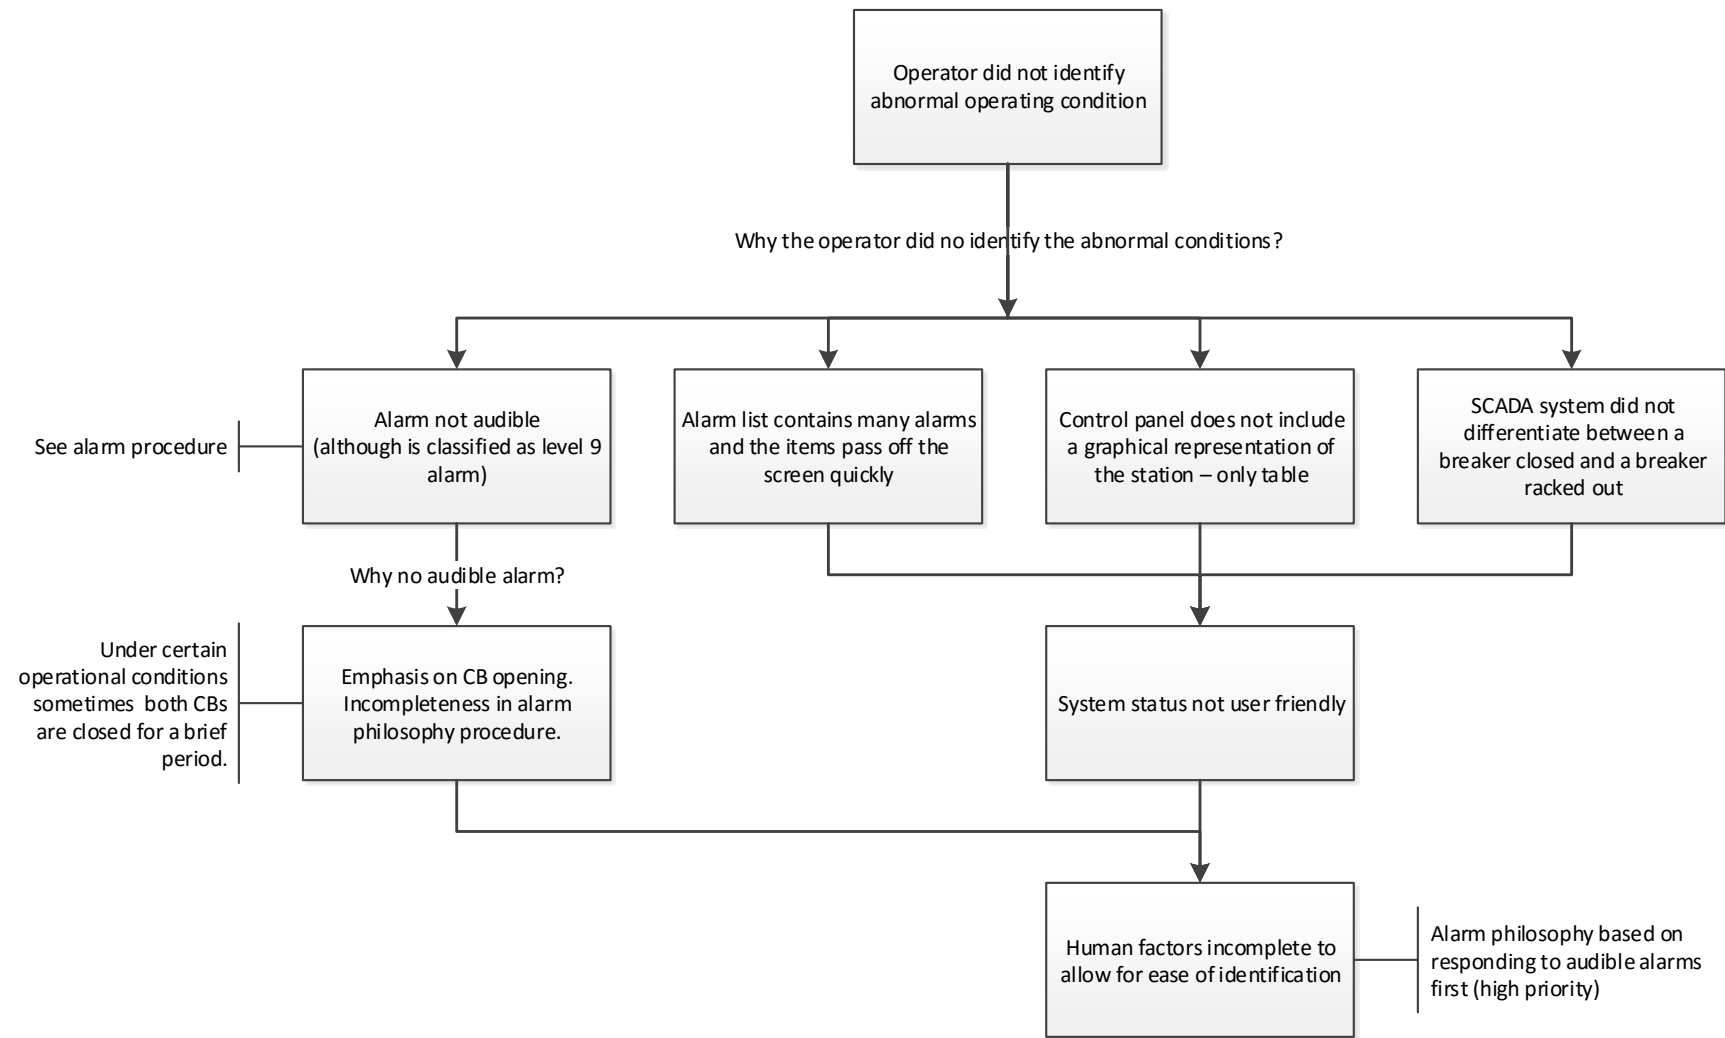
- Primary cause: Equipment malfunction due to age and wear. Based on the elimination of other possible causes of breaker closure, the malfunction of the remote operating and control system is the most likely cause of the CB 1121/12 closure and placing the circuit in a parallel bus configuration.
- Secondary cause: Human factors design of the SCADA monitoring and alarm system that did not provide for easy identification of the parallel bus configuration. For the Larkin substation, the breaker closure function is a Priority 9 alarm and it does not

Figure 15. Causal Analysis Chart (continued).

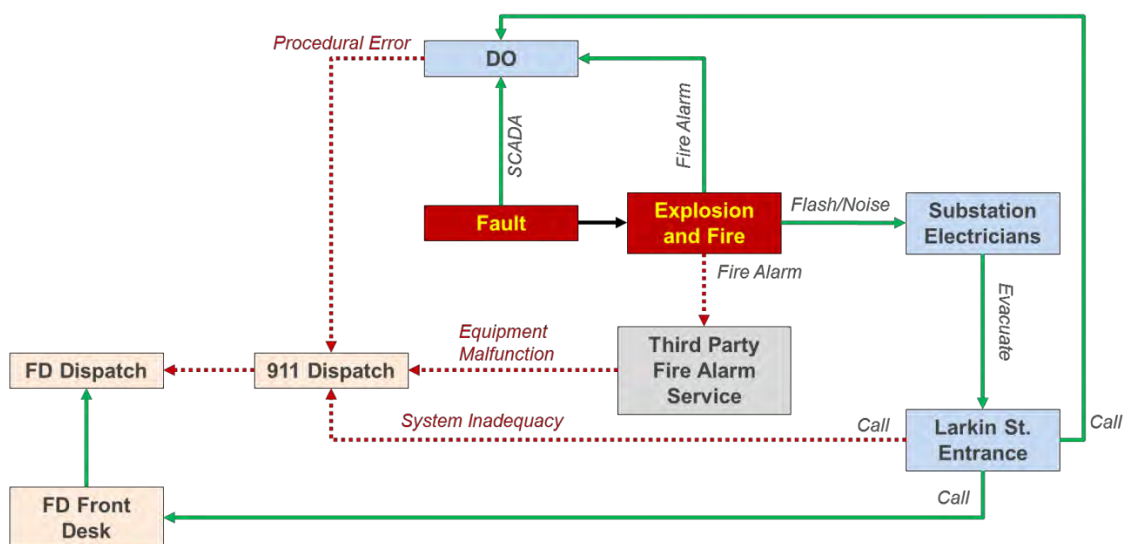
After waiting approximately 10 minutes with no sign of the fire department, Electrician 4 called 911 several times from his cell phone but was placed on hold. About 17 minutes after the incident, Electrician 4 found the number for the fire department's main office and called directly to report the fire. This message was relayed to dispatch and the fire department began its incident response at 9:28:19 am. The fire department arrived less than 4 minutes later, reporting Engine 03 on scene at 9:31:59 am, about 26 minutes after the incident.

Figure 17. Flow Chart of Emergency Notification Process by PG&E following fault and explosion at Larkin substation. 911 is not reached due to three separate issues. Station electricians eventually called the fire department's main office directly to report the fire.

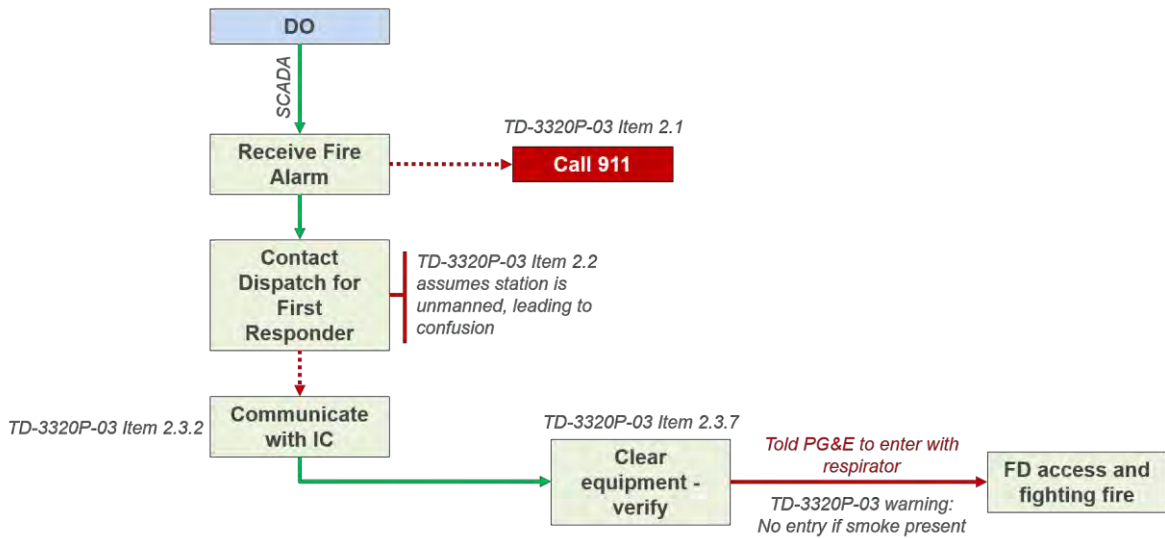
The actions taken by DO following the incident and up to the fire department entering the building at Larkin are illustrated in Figure 18. DO received the fire alarm via SCADA and contacted dispatch to send a first responder to Larkin, but did not call 911. The first responder was Electrician 6 at Daly City substation, although three electricians were present at Larkin at the time of the incident. DO did not establish a clear communication link with the Incident Commander. Electrician 7 was told that the equipment was clear and the fire department could enter to fight the fire at 9:43:29 am, approximately 37 minutes after the incident. Electrician 7 was not the acting Incident Commander at any time during the response, rather, Electrician 6 arrived around this time and assumed Incident Command. DO told Electrician 7 that a PG&E employee would need to enter the building with the fire department with a respirator to help the fire department navigate the substation. The procedure TD-3320P-03 warns that no non-emergency personnel should enter the substation if smoke is present.

Figure 18. Response and actions taken by DO in response to the incident at Larkin Substation.

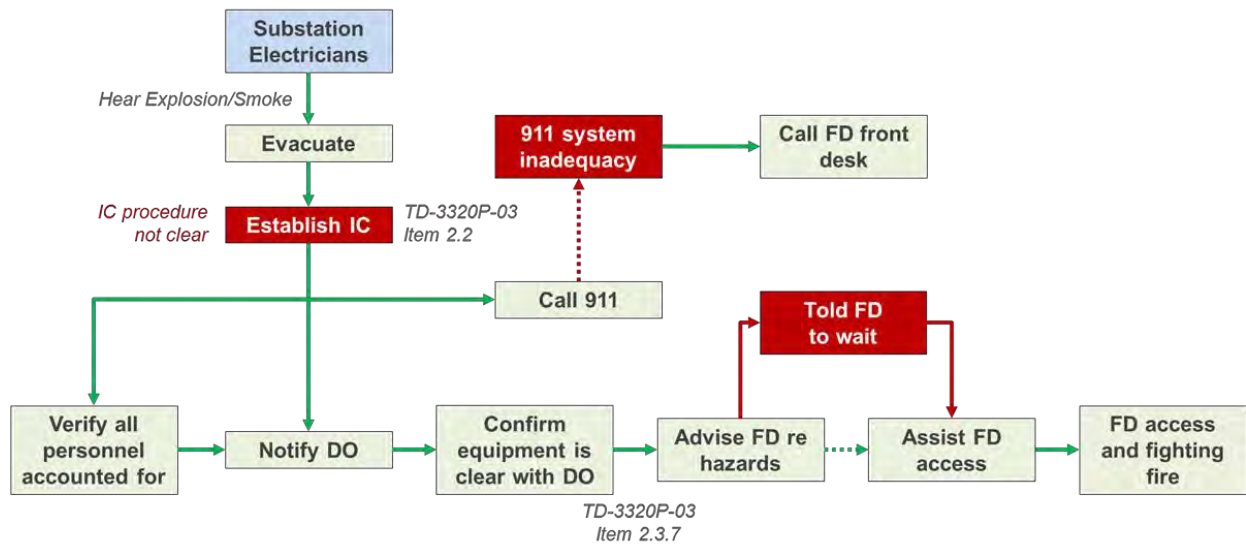
The actions taken by employees and contractors present at the site are illustrated in Figure 19. Electricians 3, 4, and 5 were in the break room, the cable splicer was outside, and Contract Inspector 1 was in the switching area, approximately 30 feet from the incident breaker when the incident occurred. Responding to the noise and signs of a fire, all personnel evacuated to the front entrance on Larkin Street. At this point, no employee clearly took the role of Incident Commander. Electrician 3 was in contact with Supervisor 2 and was considered to be in command by several personnel present, based on interview responses. DO received a call from Electrician 3 describing the loss of power and fire. DO verified with the cable splicer that all personnel were safely outside the substation. After approximately a 10-minute wait without seeing the fire department, Apprentice Electrician 4 called 911 unsuccessfully, and eventually reached the fire department’s main office on his cell phone at approximately 9:23 am.

Figure 19. Response and actions taken by restorations personnel on site at Larkin substation.

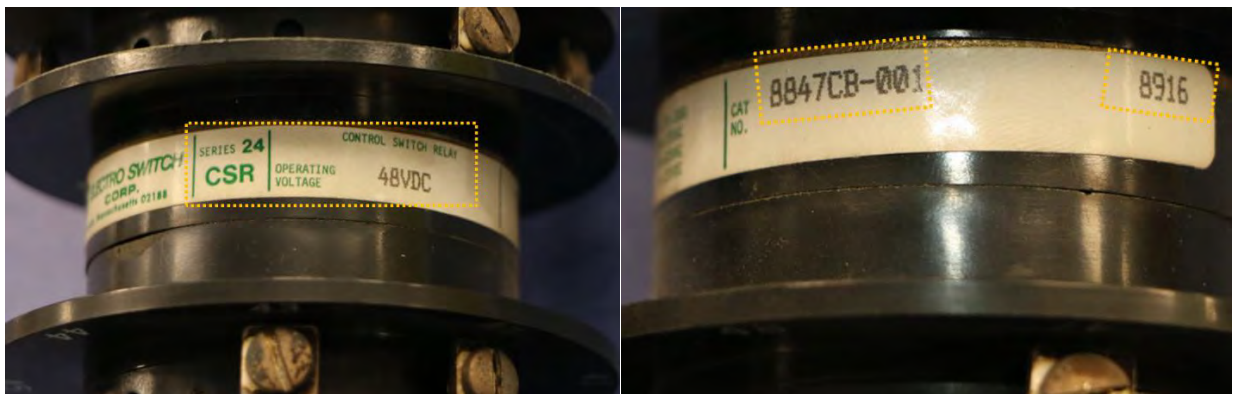
Figure 2. Incident switch markings: CSR 24, 48 VDC, catalogue No. 8847CB-001, serial No. 8916.

1. Replace the remotely operable switch for the second circuit breaker (CB 1121/12) at the incident feeder inside the station (completed).
2. Develop an improved approach to identify and alarm the parallel bus configuration via feeder breakers, including:
  - a. Reevaluate the SCADA alarm categories, priorities of the alarms, and which alarms should be audible.
  - b. Replace the existing tabular reports of the breakers status in the Larkin station with a graphical (single-line diagram) report for ease of identification (completed).
  - c. Provide a separate detection and alarm system using SCADA for the closed feeder breakers causing a parallel bus bar in the Larkin station (in progress).

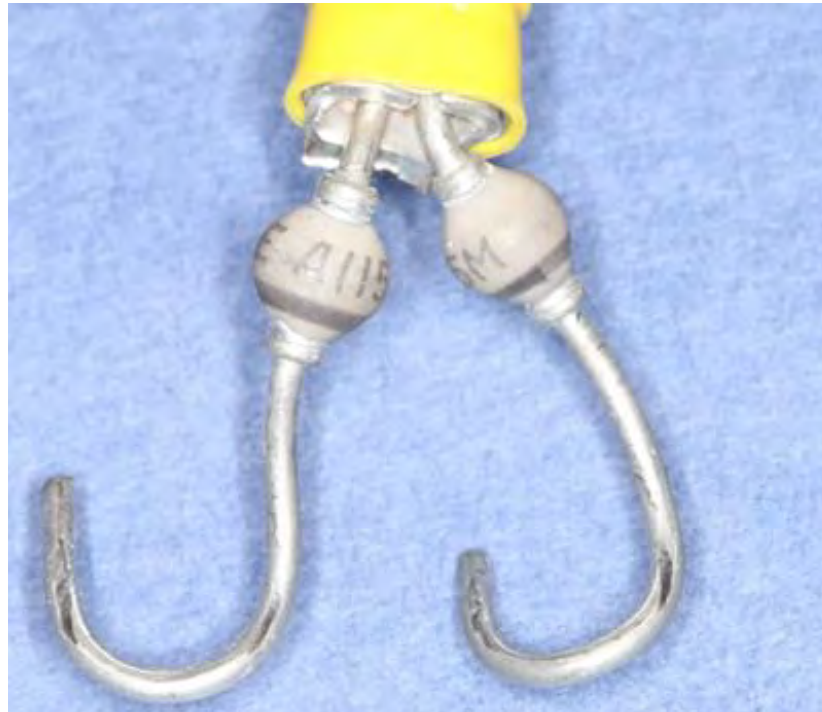
The 600V fast recovery diodes attached to the incident switch were identified using the markings on the diodes, which read “GE A115M”. The diodes were manufactured by General Electric (GE) and identified as 3-Ampere rectifier diodes and appear to have been used as surge protective devices at the switch terminals. Figure 4 shows the diodes after disconnecting from the switch terminals. An excerpt of the data sheet of the diodes is shown in Figure 5.

Figure 4. The 600V fast recovery diodes after disconnecting from the incident switch terminals.

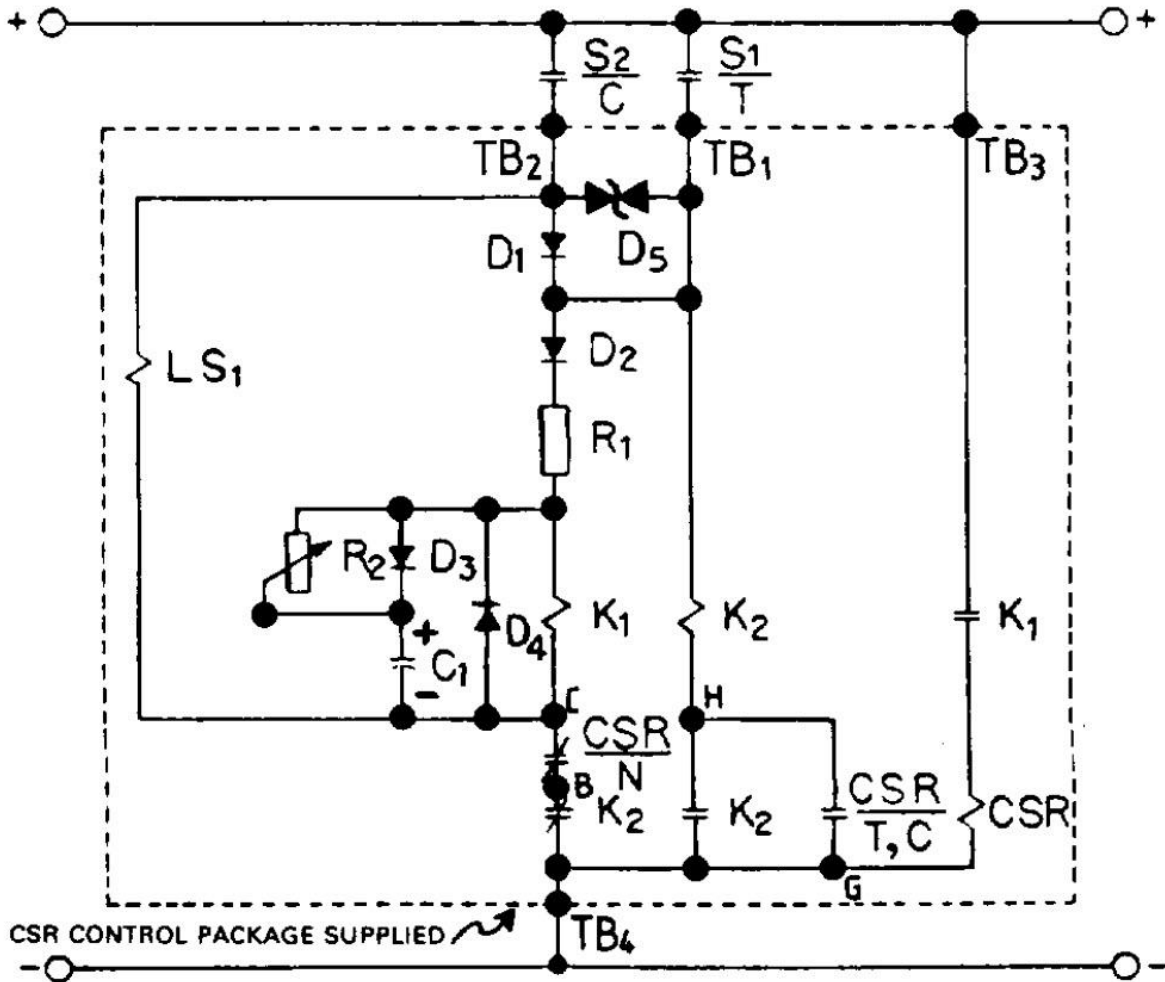
With reference to the circuit diagram in Figure 7, when the CLOSE position is commanded by S2/C, the linear solenoid, LS1, operates, setting the direction of the relay rotation to clockwise for CLOSE. This is achieved by the linear solenoid pushing a roller at the end of the solenoid’s drive arm so that the actuation of the rotary solenoid, CSR, causes the roller to strike and roll down to the left face of a cam inside the switch. This causes the rotation to occur in the clockwise direction to CLOSE position as illustrated in Figure 9.

A second relay, K2, provides the Anti-pumping function. When the CSR rotary relay is actuated for either CLOSE or TRIP, the CSR/T,C contact closes, energizing the K2 relay coil. This actuates K2 and opens its normally-closed contacts which in turn opens the current path to the K1 relay coil. This action causes the CSR to energize (after 1 second time delay) and the relay returns to its normal position. At the same time, the normally-open contacts of K2 are closed that keeps the K2 coil energized as long as a TRIP or CLOSE command persists at the switch terminals. This prevents the CSR from operating again or “pump” until the TRIP or CLOSE commands are removed from the switch terminals.

Figure 7. The switch internal control circuit-diagram.

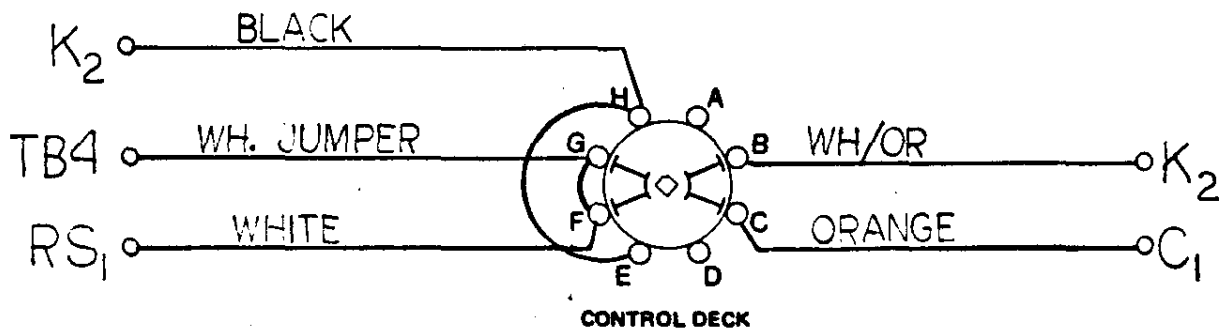
The internal circuit diagram of the switch shown in Figure 7 shows internal connections to the outside terminal points (TB1 to TB4). A schematic diagram of the switch control deck is shown in Figure 8. This type of circuit is known as the “Circuit B”. It is designed for 1-second time delay and is equipped with “Anti-pumping” circuitry. TB1 and TB2 terminals are to be connected to 41 to 56 VDC line via outside relay contacts of S1/T and S2/C for the TRIP and CLOSE commands, respectively, as shown in Figure 7. The TB3 terminal provides power to the main actuating relay once the controls are activated. The switch control provides 1-second time delay using capacitor C1 and the adjustable resistor R2. This capacitor provides enough energy to K1 relay coil to keep the relay closed for 1 second after actuation. The Normally Closed

Figure 8. Schematic diagram of the switch control deck (deck 1).

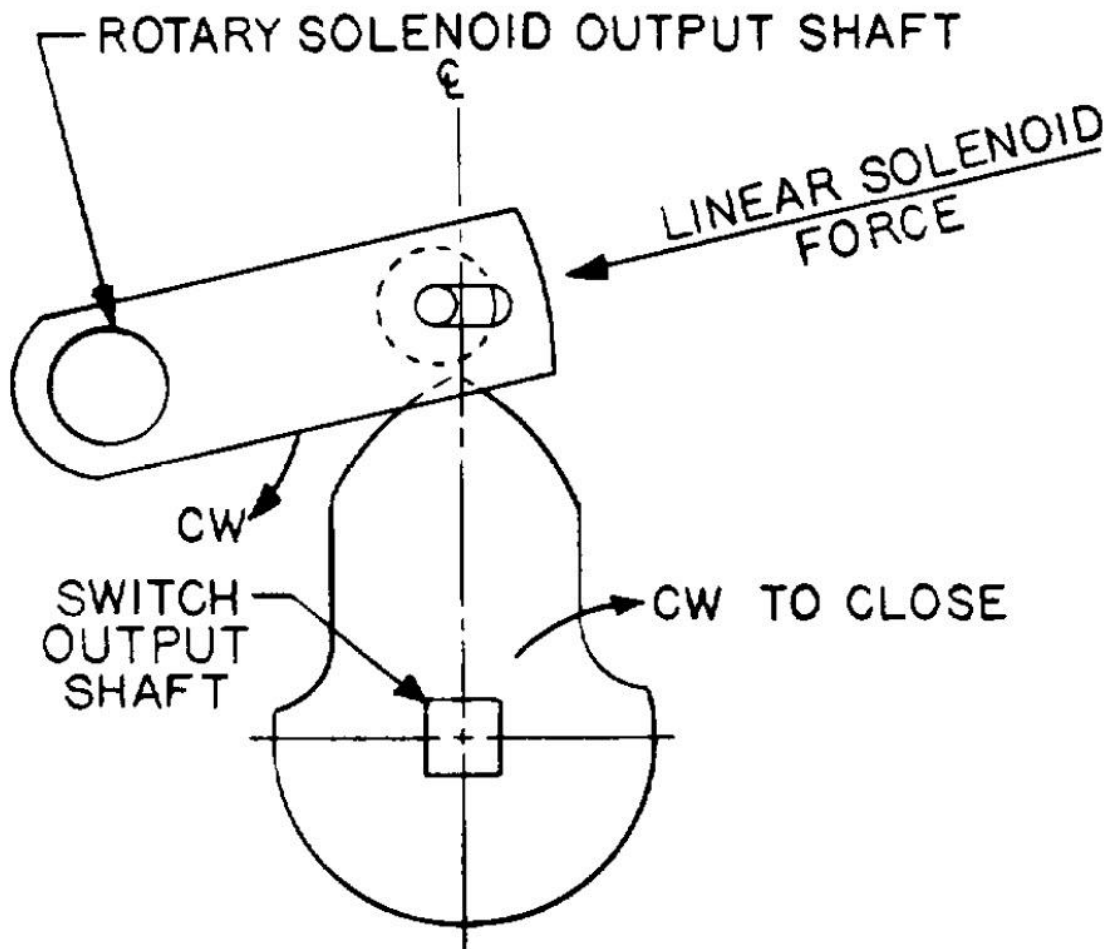
Figure 9. The cam mechanism for clockwise direction to CLOSE position: The linear solenoid is actuated when the CLOSE position is commanded at the switch terminal TB2.

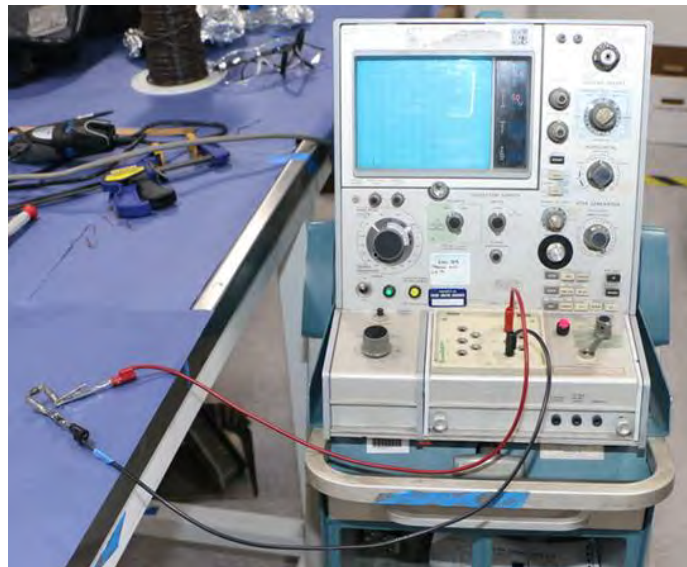
Figure 10. Curve tracer used to characterize the diodes of the incident switch

It was discovered that the reverse voltages of all the diodes had changed but were greater than their specified values. The 200V Transil diode attached to the incident switch had peak reverse voltage of 240V rather than 200V (Figure 11). Also, the reverse breakdown voltage of the 600V fast recovery diodes had increased to approximately 1000V (Figure 12).

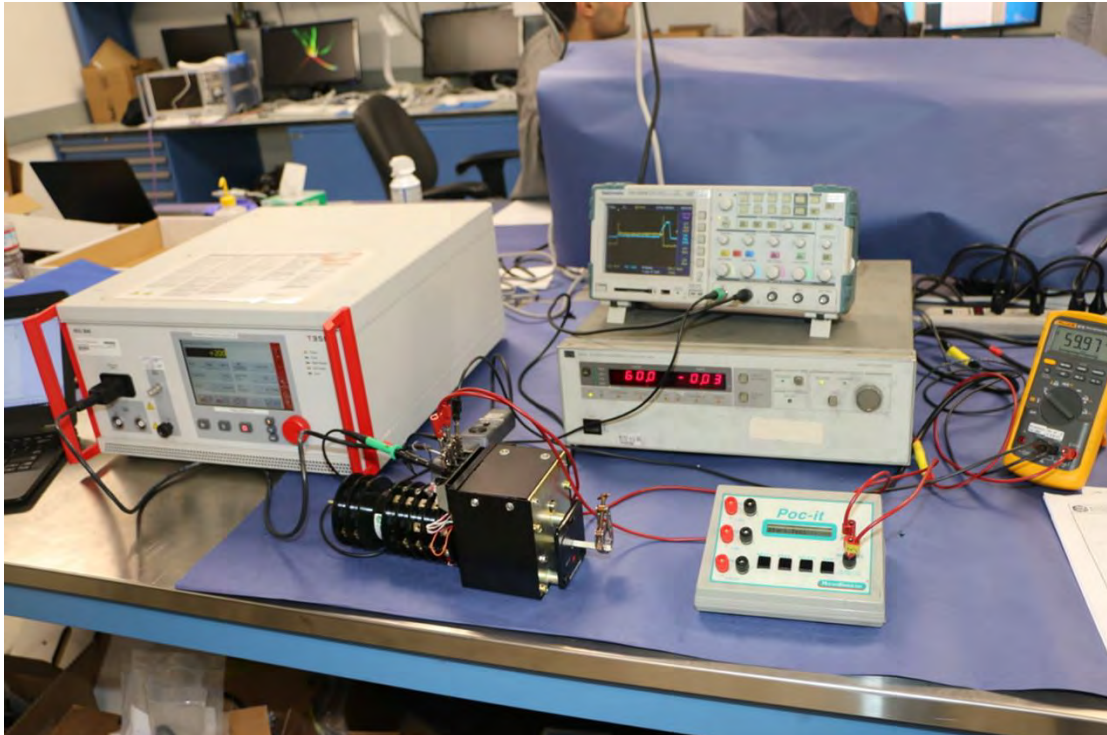
Figure 13 shows the laboratory test setup that was used for the transient testing. A transient surge generator (TESEQ NSG 3040) was used for standard fast transient surge testing. An exemplar switch was energized by a DC power supply and IEC standard fast transient surge voltage applied to the CLOSE terminal of the switch. The transient voltage peak was increased up to 2 kV, at which point the exemplar switch failed without causing a CLOSE function.

Figure 13. Laboratory test setup used for the transient testing.
