CALIFORNIA PUBLIC UTILITIES COMMISSION
Safety and Enforcement Division
Electric Safety and Reliability Branch

Supplemental Incident Investigation Report

Incident Number: E20150801-01

Utility: SCE

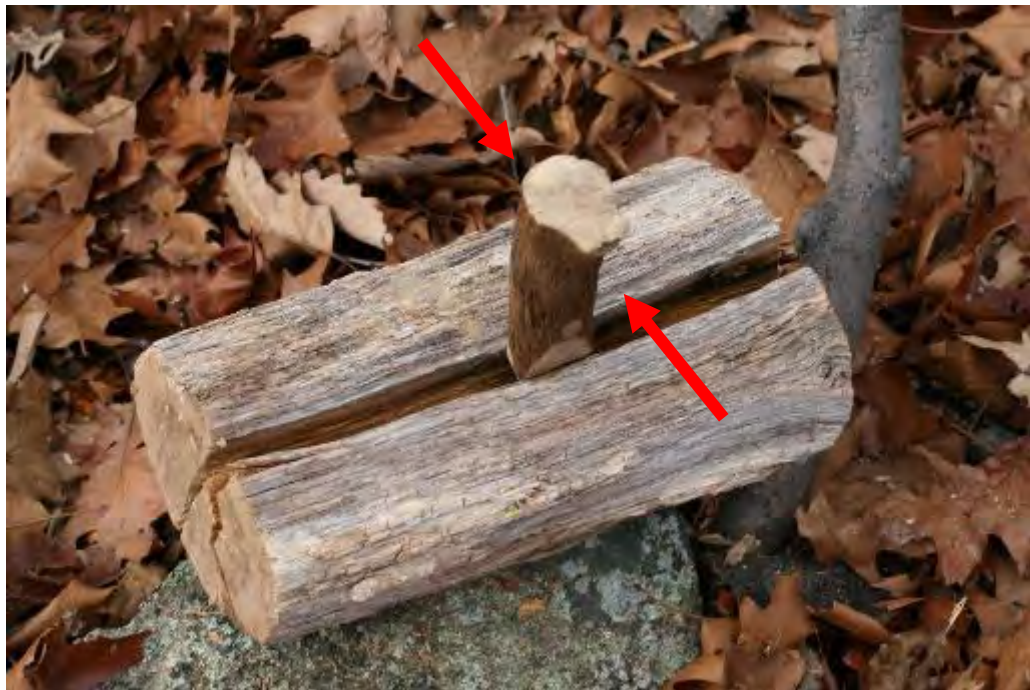
Based on the facts and evidence available, SED concludes that the shearing damage in the crossarm was caused, in part, by cyclic loading (see Figures A-13 and A-14) of both the North End insulator pin, which did not fall off the crossarm in the incident, and the South End insulator pin, which *did* fall off the crossarm in the incident. The cyclic loading resulted in tensile stress and shearing of the crossarm along both the Vertical Shearing Plane and the Horizontal Shearing Plane. Additionally, SED concludes that the bending damage at the South End of the crossarm (resulting in South End – Broken Piece 1 and South End – Broken Piece 2 breaking off and falling to the ground) was due to the crossarm becoming weakened as a result of shearing along the Vertical Shearing Plane, making the crossarm susceptible to bending failure due to wind loading. It is likely that visible shearing of the South End along the Vertical Shearing Plane prompted utility personnel at some time prior to the incident to install the “Anti-split” throughbolt (see Figures A-3 through A-6). This conclusion is based on the fact that the South End of the crossarm exhibited a partial Vertical Shearing Plane despite having the “Anti-split” throughbolt, indicating that it was already sheared prior to the “Anti-split” throughbolt’s installation. Additionally, the Vertical Shearing Plane passes along the bottom of the “Anti-split” throughbolt, meaning that the shearing would have been visible to utility personnel standing on the ground. Finally, the installation of “Anti-split” throughbolts at the time of construction is not a known utility practice.

Figure A-14: A log splitting technique that utilizes the tensile stresses produced from moving a wedge back and forth (i.e. cyclic loading) to split a log along a shear plane without needing other tools or equipment.
