# Confidential Incident Investigation Report

## Incident Investigation Report

**Incident Number:** E20151018-01

**Location of the Incident:** Moss Landing Substation, Moss Landing  
County: Monterey

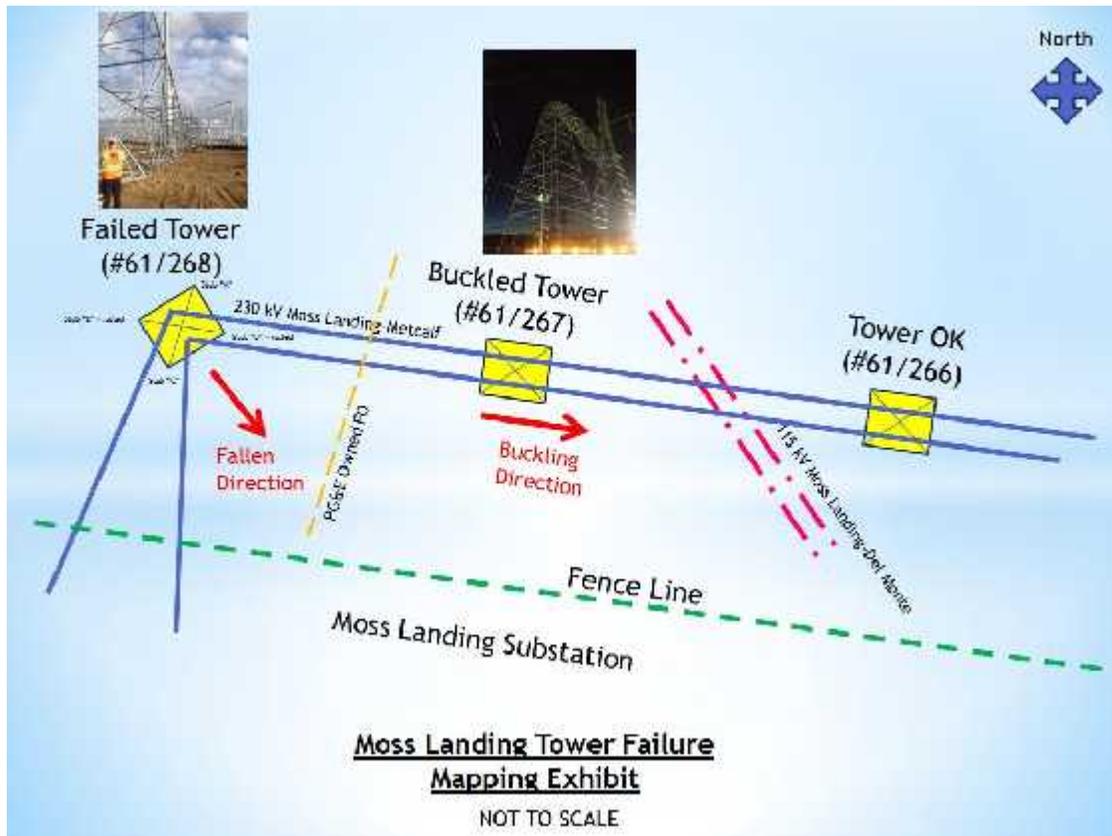
Figure 1

Tower 61/268 was located north of PG&E's Moss Landing Substation, just outside of the substation fence. The tower was designed to support two 230 kV Moss Landing-Metcalf transmission circuits, Number 1 and Number 2 (see Figure 1).

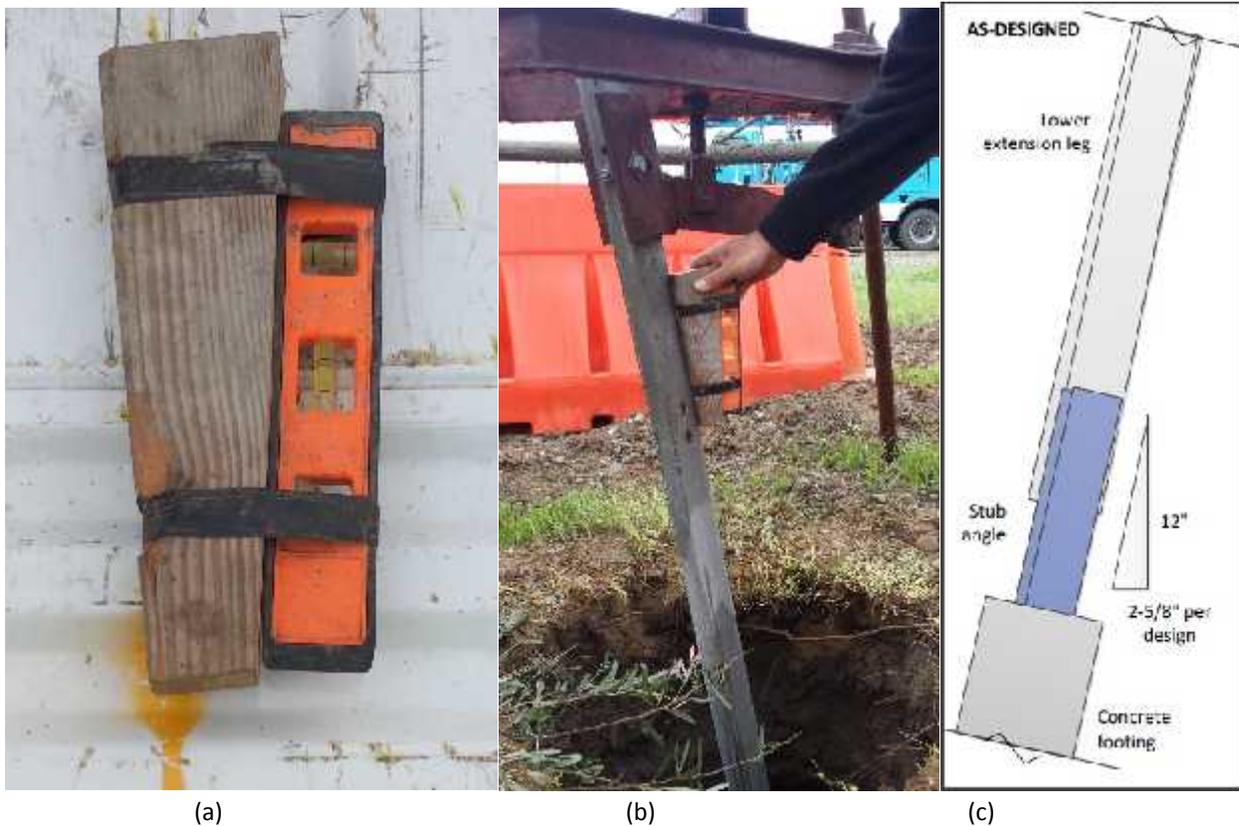
Figure 3: (a) Example of a batter board, (b) its use, (c) close-up of the bottom of a tower, detailing the concrete footing, stub angle, and tower leg.

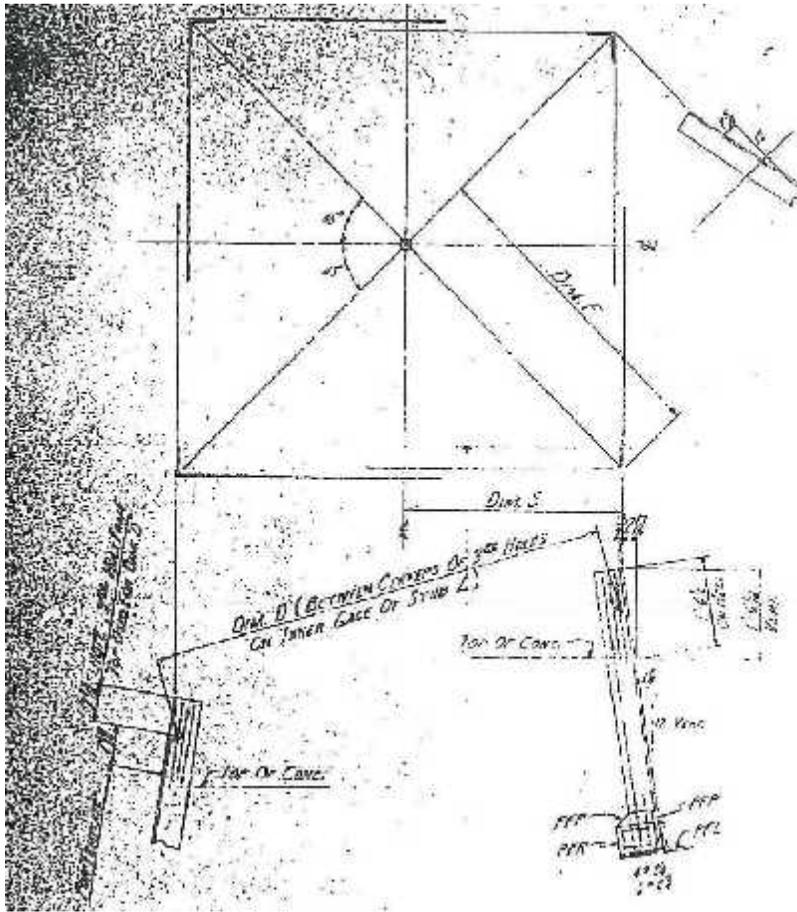
Figure 4 – Stub Angles from PG&E Record 621915

Record 621915 had two batter dimensions for the concrete footing and stub angles (collectively referred to as “foundation stubs”): the “heel batter” and the “face batter.” The heel batter had a lower slope – 2-5/8 inch by 12-inch – while the face batter had a higher slope – 1-7/8 inch by 12-inch (see Figure 5). The batter board is supposed to be crafted based on the heel batter and not the face batter.

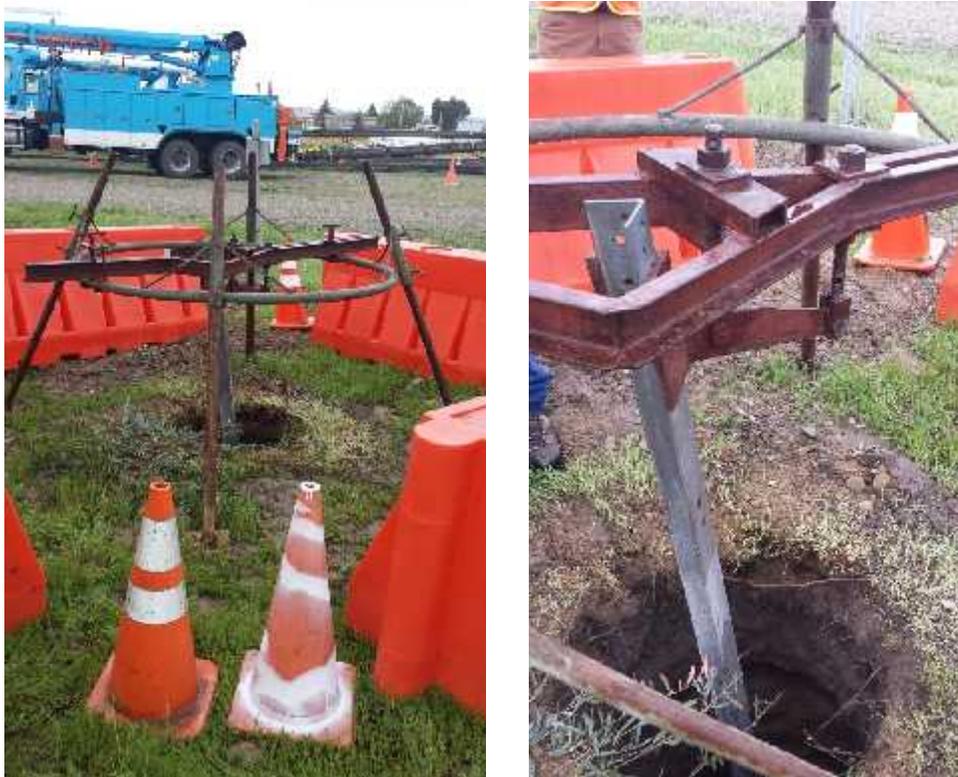
Figure 6 – Sample of a template ring holding a foundation stub

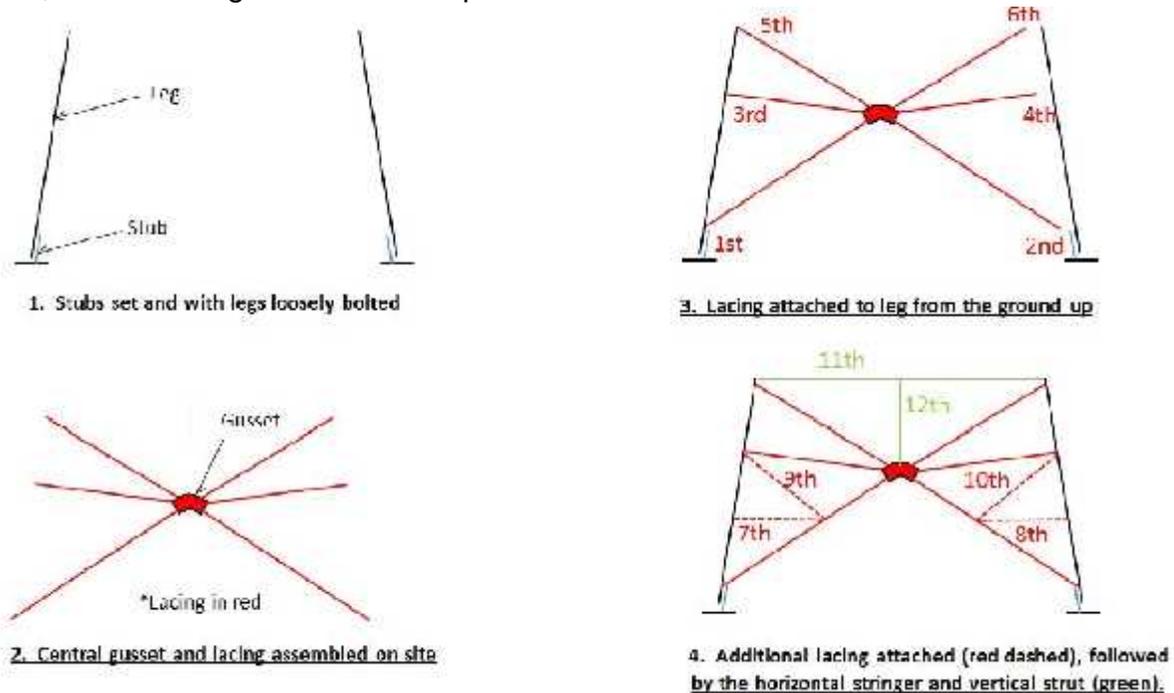
Figure 7 – Tower Body Installation Process

During the tower body installation, [REDACTED] found the pre-assembled lacing members were about one inch off when connecting to the tower legs. The crew was able to bend the tower legs with their arms to fit (or force fit) the pre-assembled lacing members.
