**Enclosure 3 – PG&E Moss Landing Tower Collapse Root
Cause Analysis**

**Moss Landing Tower Collapse
Root Cause Analysis**

Prepared for

April 4, 2016

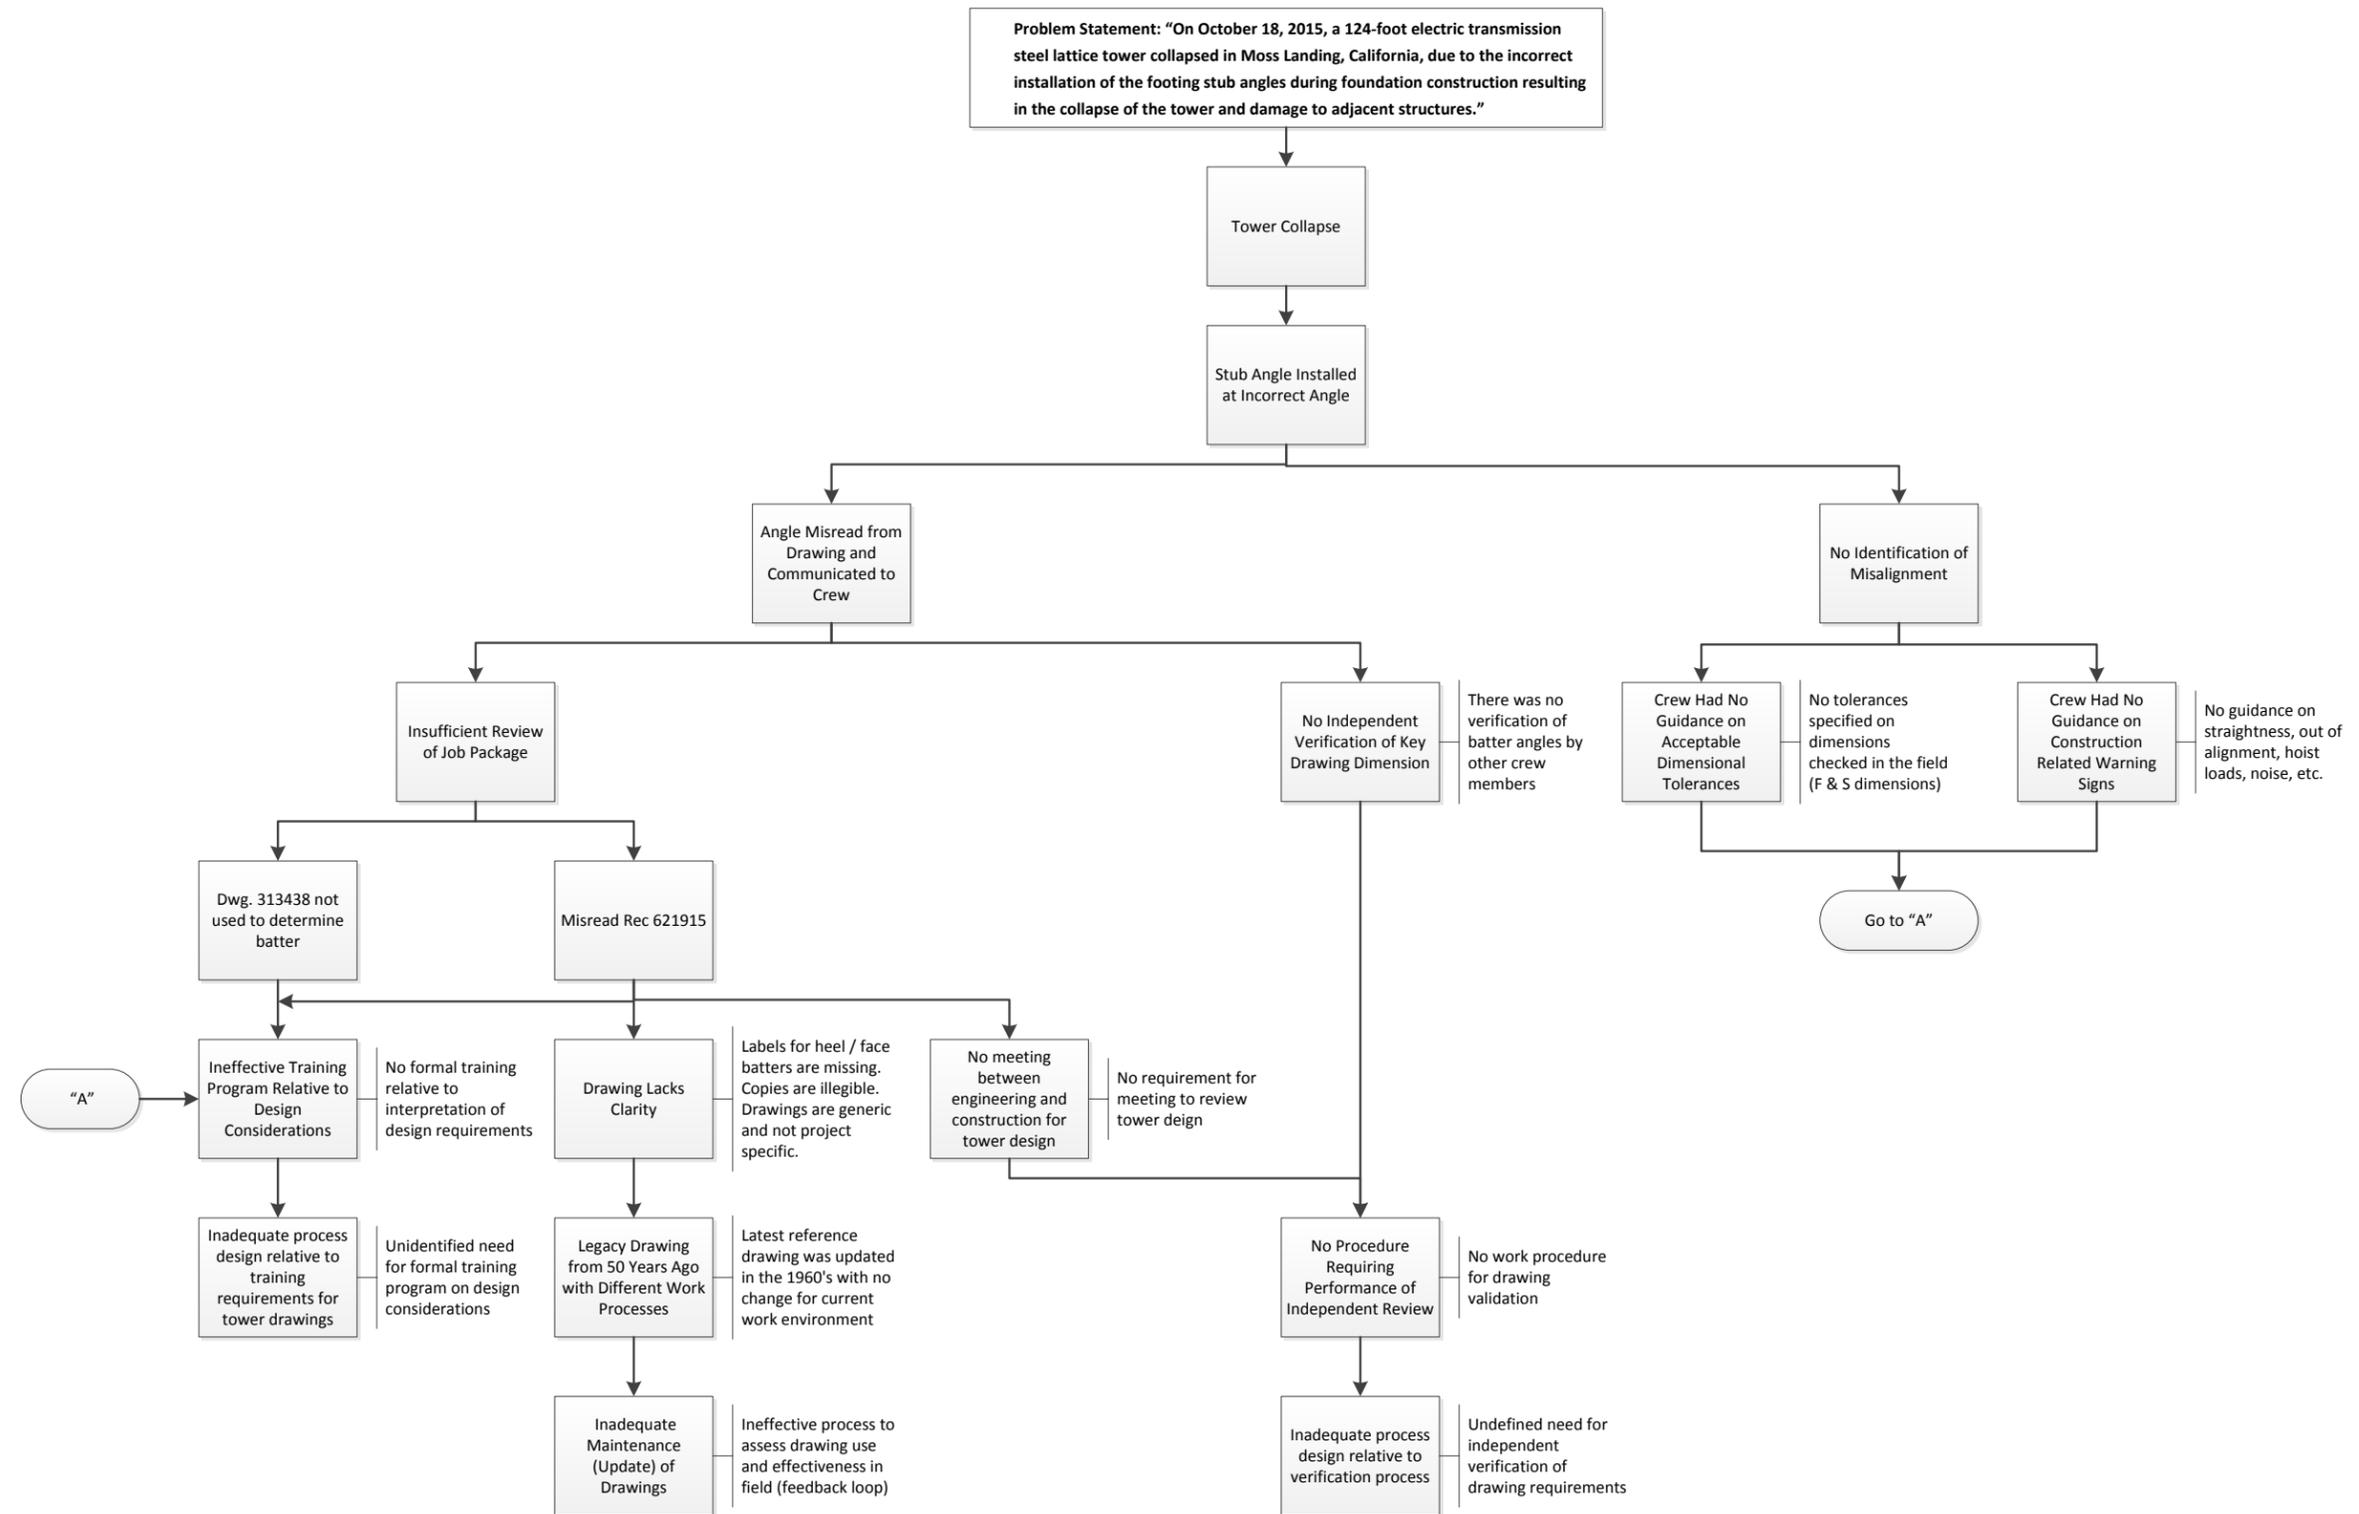
Event and Causal Factors Chart

The Event and Causal Factor Analysis (ECFA) is used to evaluate the cause for each of the findings previously determined. The analysis is performed by looking at the causal chain for each finding, based on the evidence and facts gathered during the data collection activities. The ECFA is presented in the causal diagram shown in Appendix D. This section describes the results of the ECFA.

From the findings identified and described in Section 5, the tower collapse event was initiated by the incorrect settings of the stub angle due to a human error in reading the drawing heel batter; and the subsequent communication of this incorrect heel batter to the crew, for use in setting the stub angles. Based on Figure 7, this human error represents an unintentional action (error or slip). Human errors may occur for a variety of reasons, but work processes and programs are put in place to prevent human errors from having significant consequences. Typical human error barriers include; training, procedures, clear documents and communication, and independent verification. Since the human error relative to the stub angle alignment with the tower legs resulted in a significant occurrence, the causal analysis will include a review of these barriers and their failure to prevent the event.
