CALIFORNIA PUBLIC UTILITIES COMMISSION

Incident Investigation Report

Incident Number: G20170112-2136

Utility: Pacific Gas & Electric Co. (PG&E)

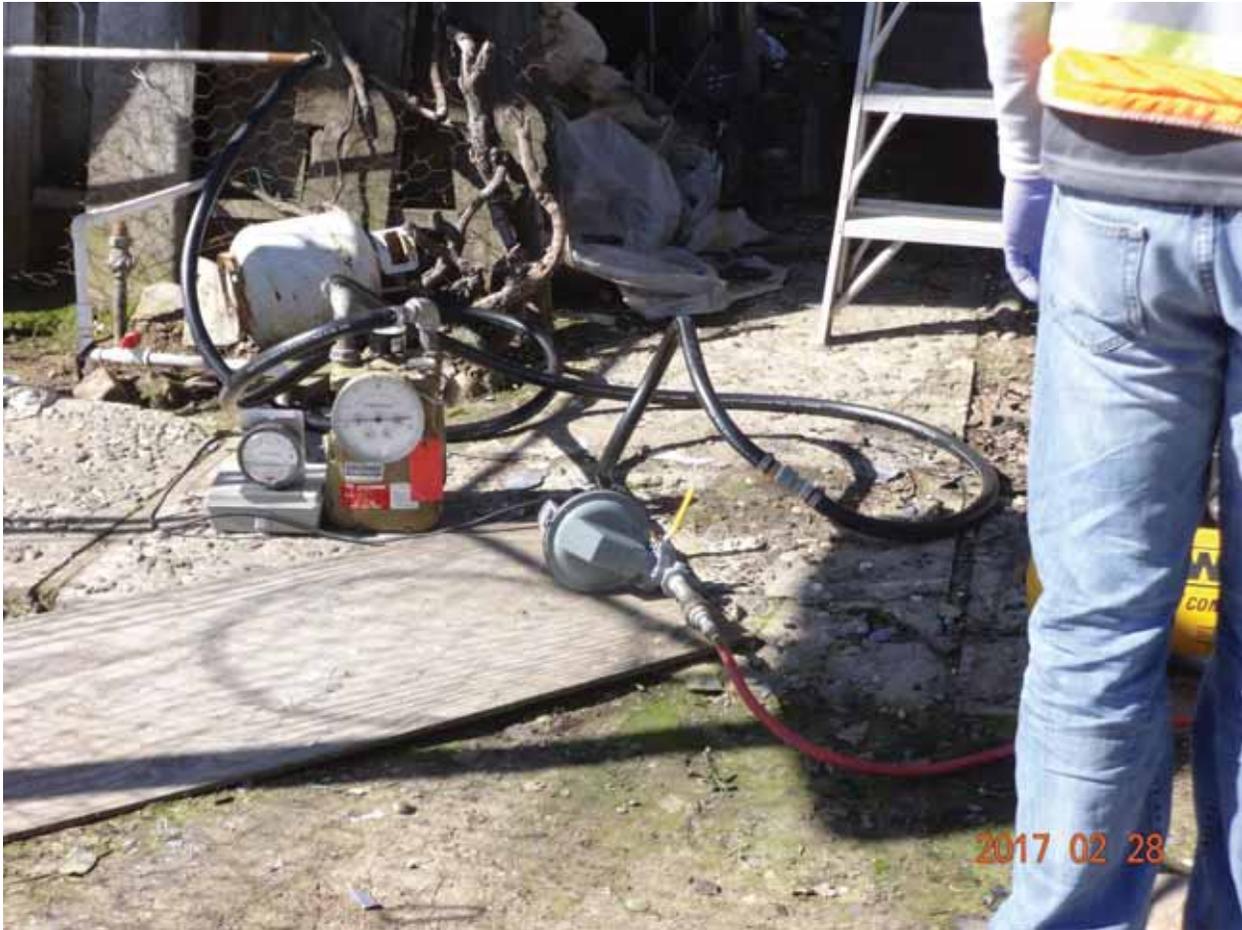
Figure 12: Exponent's test head setup

A picture of the test head set-up is included in Figure 12. An air compressor (yellow tank, visible through legs on far right) is connected to a ball valve and pressure regulator to control the flow. The regulator is connected to a flow meter (brown meter with large clock dial) and pressure gauge (smaller grey instrument, far left) to record any flow through the line or pressure drops. The valve near the pressure regulator is in the closed position because this photo was taken before any test was being performed.
