CALIFORNIA PUBLIC UTILITIES COMMISSION

Incident Investigation Report

Incident Number: G20160810-2059

Summary of Incident: On August 10, 2016 two PG&E employees were dispatched to [REDACTED] Deer Park to perform maintenance on a Nordstrom-type customer service valve that was stuck in the open position. During an attempt to free the stuck valve, the valve came apart forcefully and gas began flowing through openings in the valve body. The gas flow ignited on the pilot light of a nearby water heater, and the resulting fire burned two utility workers, and caused severe damage to the house. SED found that PG&E personnel did not follow utility procedures, and this directly contributed to the incident. SED also determined that deficiencies within PG&E's maintenance procedures and Operator Qualification program contributed to the incident.

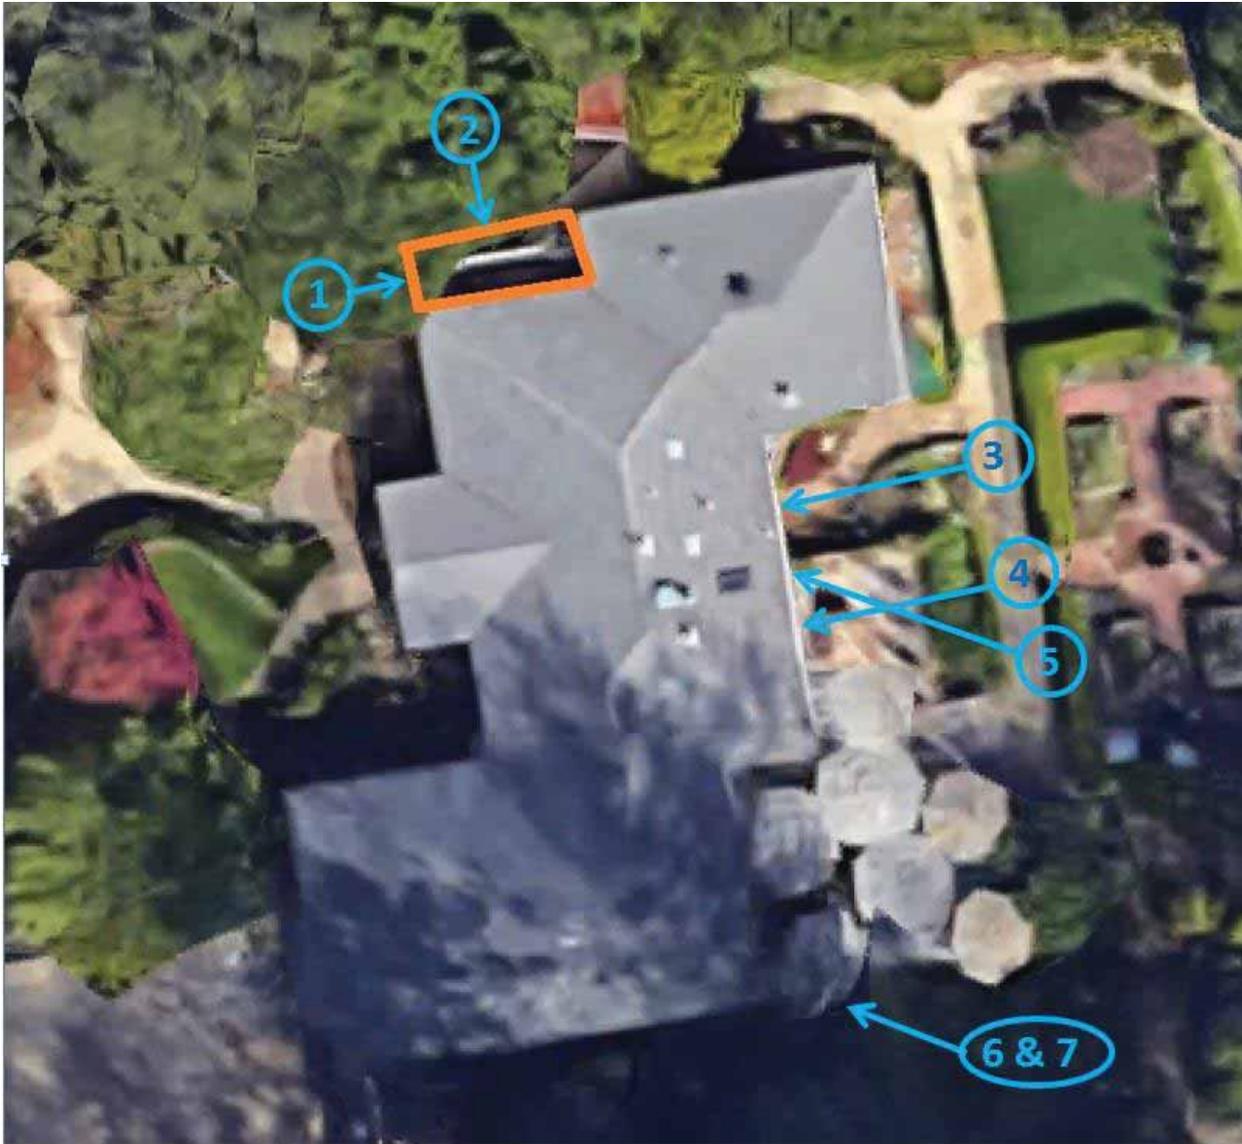
Figure 8: A bird's eye view of the house at [REDACTED] with photo index. The circles correspond to the placement of the photographer in the corresponding preceding figures, and the arrows show the angle of the viewer. The orange boxed area on the northeast corner is the walled enclosure that contained the gas service.
