**CALIFORNIA PUBLIC UTILITIES COMMISSION**  
**Safety and Enforcement Division**  
**Incident Investigation Report**

**Incident Number:** G20150417-01

**Utility:** Pacific Gas and Electric (PG&E)

**Location of the Incident:** 7633 N. Weber Ave  
Fresno, CA  
Fresno County

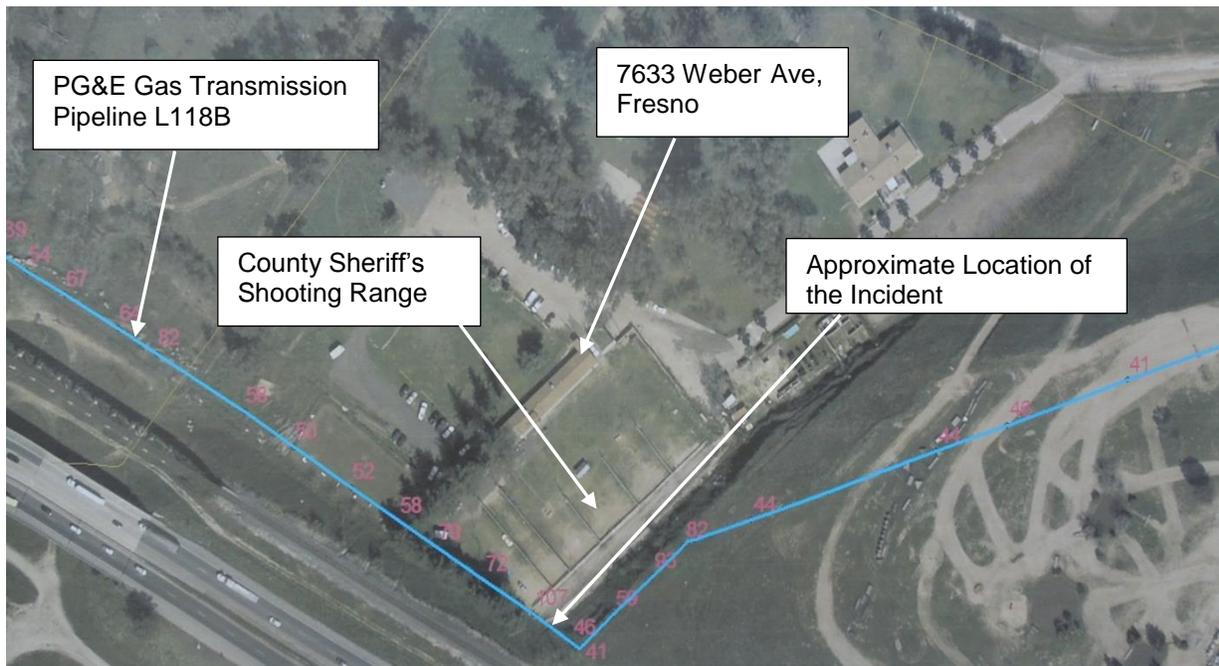
**Figure 1:** Aerial View of the Incident Location

Figure 1 shows the location of the incident at the County Sheriff's Shooting Range.
