April 8, 2020

Re: Monthly Report Summary #28 for the South Orange County Reliability Enhancement (SOCRE) Project

SITE INSPECTION CHECKLIST (Based on monitor's observations during site visit; responses do not imply that monitor observed all staff, crews, and parts of the project during this inspection)

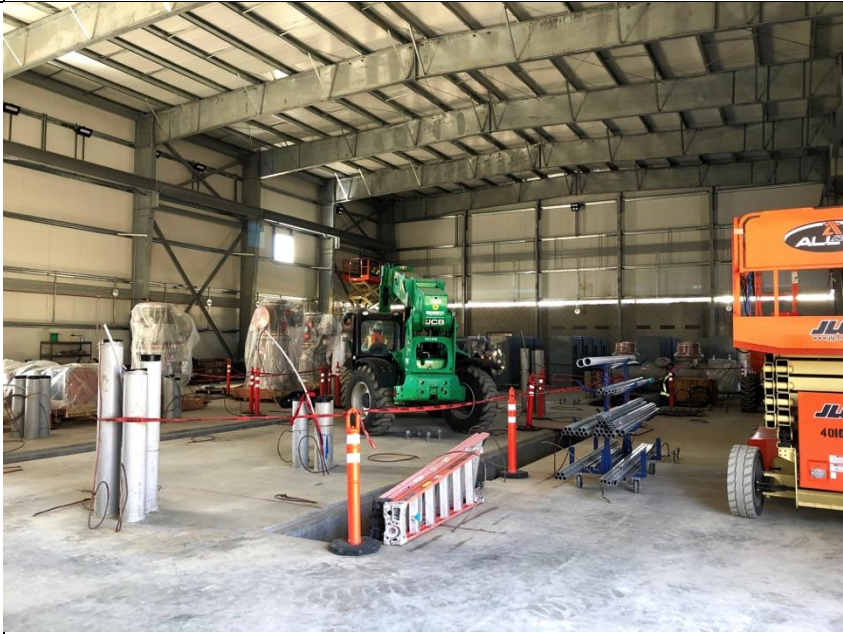
A wide-angle photograph of the interior of a large, high-ceilinged industrial building. The floor is concrete and appears to be under construction or maintenance. In the center, a green tractor is parked. To the right, an orange lift truck is visible. Various pieces of equipment, including pipes and structural beams, are scattered throughout the space. The lighting is bright, likely from overhead industrial lights.	Photo 10 – Inside the 138-kV GIS building.
02/05/20	San Juan Capistrano Substation

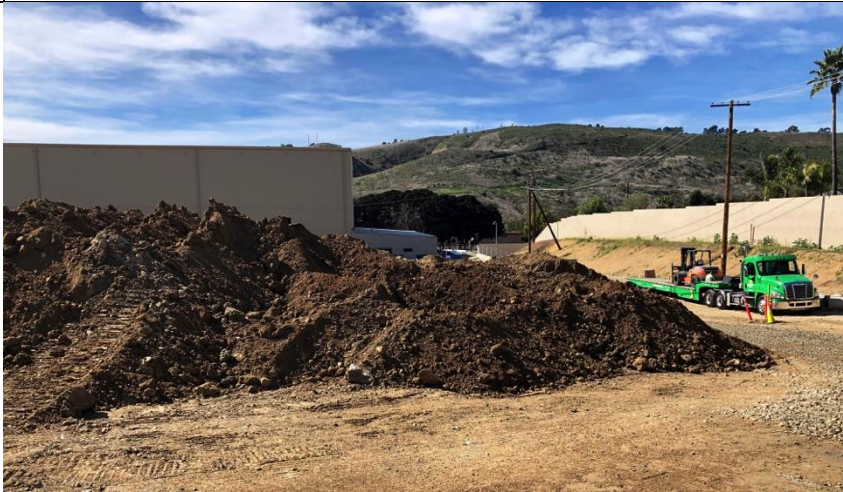
Excess soil continues to be stockpiled at the same location on the substation site (Photo 11).

An outdoor photograph showing a large, dark brown pile of soil or earth in the foreground. In the background, there is a white wall, a green truck, and a utility pole. The sky is blue with some clouds. The ground is dirt and gravel.	Photo 11 – Soil stockpile area at the substation. Photo facing west.

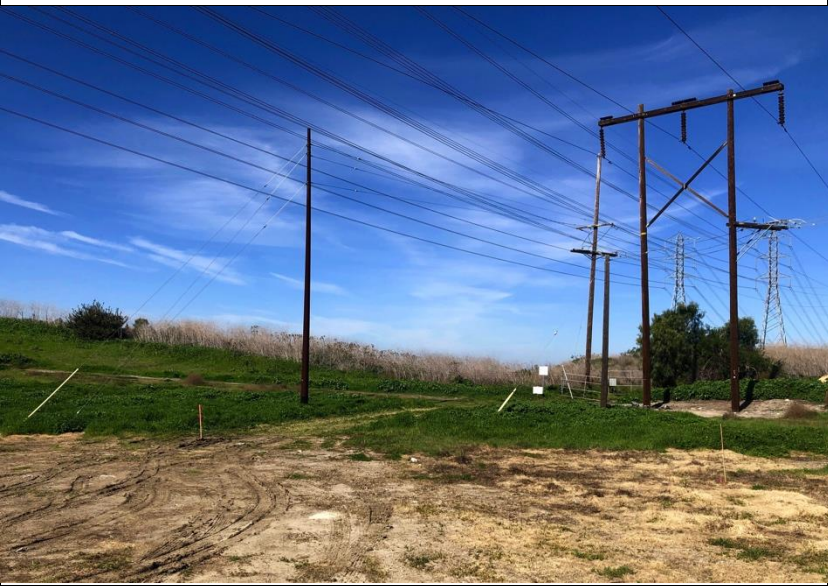
We stopped at tower location #22 on our way into tower location #21. At tower location #22, no nesting issues and the site was observed to be flat with no need for vegetation clearing or BMPs (Photo 16). A pair of RTH has since been observed nesting in the SCE towers near tower location #21 and a reduced nest buffer has been approved. The LEI has had signage installed to indicate the area's sensitivities (Photo 17). Vegetation removal is underway outside of the nest buffer (Photo 18).

A photograph showing a transmission line tower and power lines in a field. The ground is a mix of dirt and sparse vegetation. The sky is blue with some light clouds.	Photo 16 – Tower location #22. Photo facing northwest.
02/13/20	Transmission line route, near tower location #21	  A photograph showing a dirt road leading to a transmission line tower. In the foreground, there is a sign on a wooden post that reads "ESA (Environmentally Sensitive Area) NO ACCESS PERMITTED". The area is overgrown with tall grass and brush. The sky is blue.	Photo 17 – Access road into tower location #21. Photo facing north.

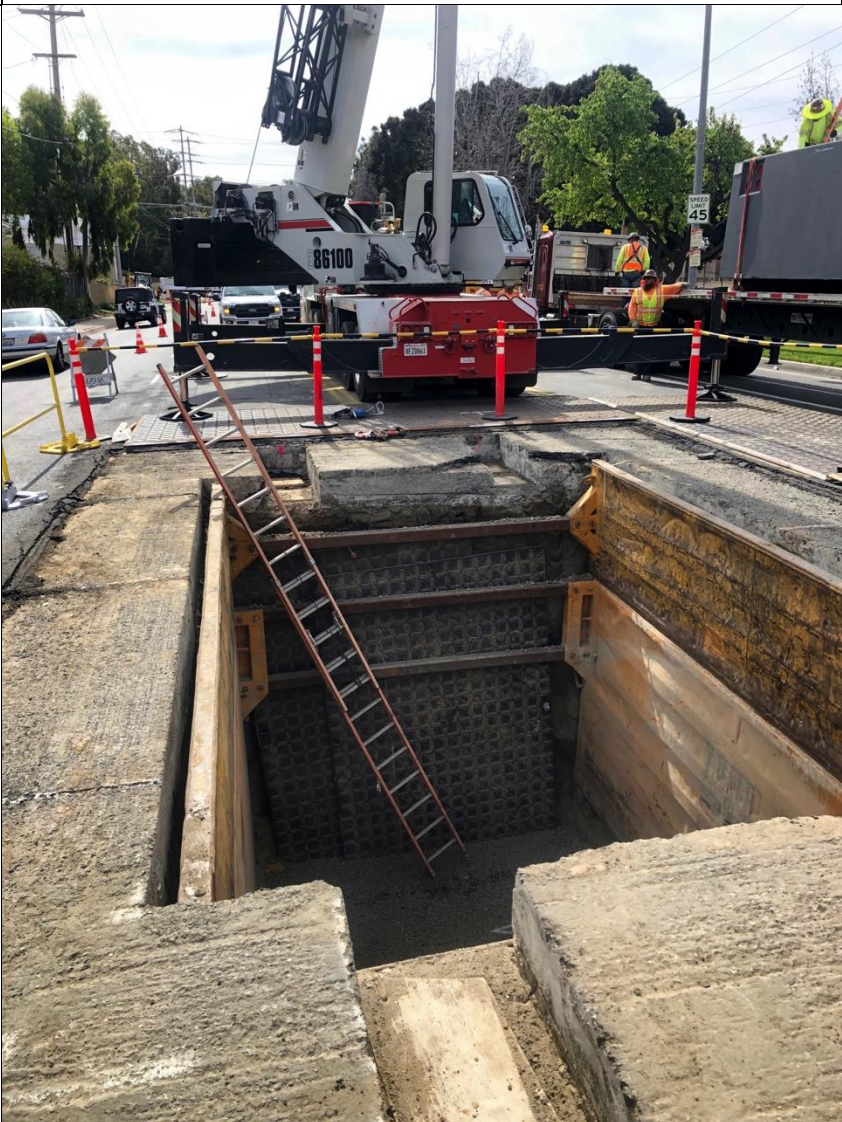
A large concrete vault is under construction. A white crane with the number 86100 is positioned on a red truck. The vault is a deep, rectangular structure with concrete walls and a stepped interior. A wooden ladder is leaning against the side. The site is cordoned off with orange and white safety barriers. In the background, there are trees, utility poles, and a speed limit sign for 45.	Photo 8 - Conduit vault installation within Camino Capistrano. Photo facing south.
02/27/20	San Juan Capistrano Substation

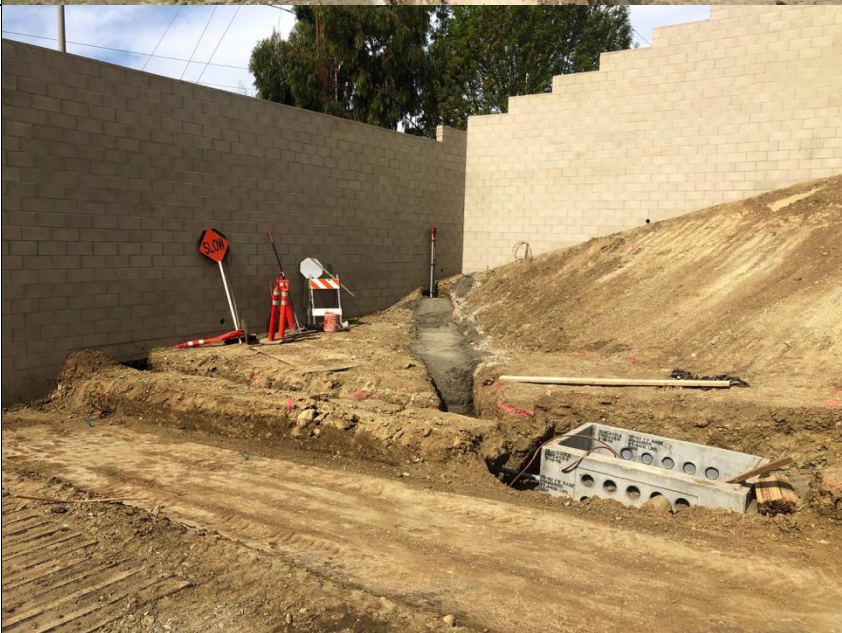
Electrical conduit continues to be installed at various points along the boundary walls (Photo 9). Road base is being delivered and compacted along the project access road (Photo 10).

A lighting conduit is installed in a trench. The trench is filled with dirt and has a concrete curb on one side. A white conduit with multiple circular openings is visible. Safety cones and a sign are placed near the trench. The background shows a concrete wall and trees.	Photo 9 - Lighting conduit installed in the northwest corner of the substation. Photo facing northwest.
