CALIFORNIA PUBLIC UTILITIES COMMISSION
Safety and Enforcement Division
Electric Safety and Reliability Branch

Summary of Incident

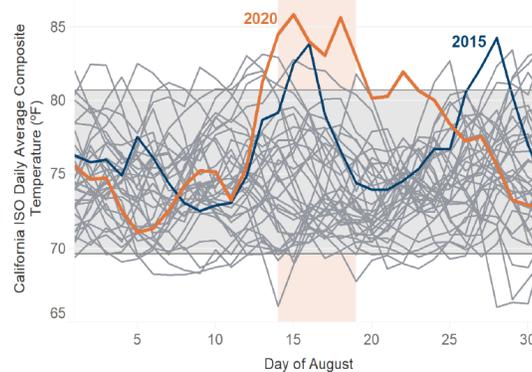
**Graph 1:
August 2020 1-in-35-year Temperatures¹¹**

In mid-August 2020, the State of California experienced an unprecedented and widespread heat storm forcing electrical demand to exceed available resources. The resulting stage 3 power alerts culminated into rolling outages throughout the CAISO control area on August 14th and August 15th and resulted in more than 2,700 MW of derates at electric generating facilities.⁵ In response to the situation, the CAISO Board of Governors held a meeting on August 17th anticipating further shortfalls of 111 to 4,400 MW.⁶ During the meeting, the CAISO commented that, “Existing resource planning processes are not designed to fully address (such) extreme (conditions as a) heat storm” (see Graph 1), projecting that climate change would make such events worse.⁷ The CAISO reported that on August 14th, forced outages totaled 4.8% of available capacity,⁸ and on August 14th and 15th natural gas plant outages equated to a loss of 1,400 to 2,000 MW.⁹ During this period, California experienced four out of the five hottest August days since 1985. August 14th was the third-hottest August day; August 15th was the hottest.¹⁰ Graph 1 below shows the 1-in-35 year temperatures California experienced during the August 2020 heat wave.
