PROJECT MEMORANDUM PG&E ATLANTIC-DEL MAR REINFORCEMENT PROJECT

To: Jensen Uchida, CPUC
From: Vida Strong, Aspen Project Manager
Date: December 1, 2005
Subject: Weekly Report #32: November 20, 2005 – November 26, 2005
CPUC Environmental Monitor (EM): Anne Sweet

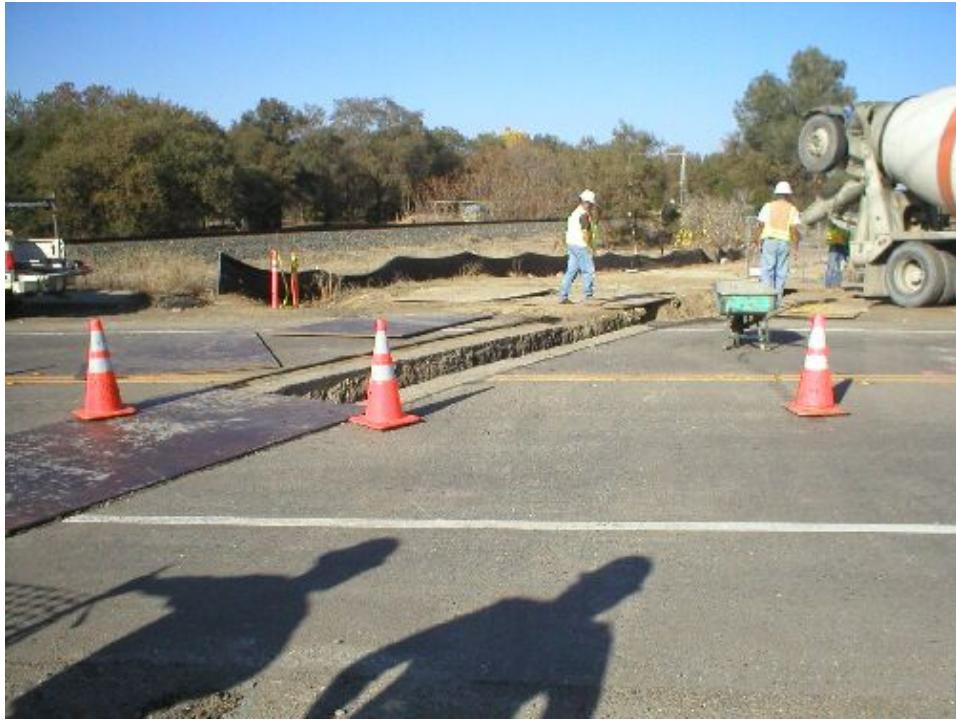
During the subject week, crews laid conduit from the south side of the Drainage #30 area through Railroad Avenue and poured thermal concrete over the conduit installation. Backfill was conducted through the Amtrak parking lot at the corner of Rocklin Road and Railroad Avenue. Crews completed trenching and conduit installation through Midas Boulevard (see Figure 1).

Figure 1 - Trench line across Midas Boulevard, November 21, 2005.

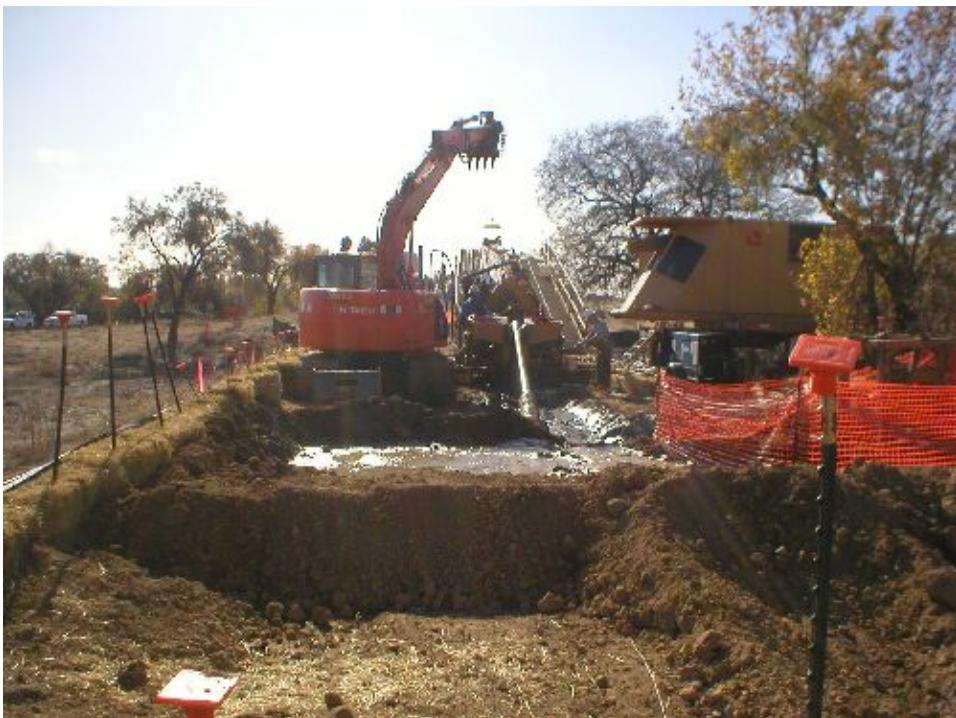
Boring operations commenced on Friday, November 18 (see Figure 2). Topsoil from Wetland #2 was salvaged prior to the commencement of the bore. The bore crew installed visquene/plastic sheeting under all of the bore equipment to catch any potential leaks. A frac-out occurred in Wetland #2 soon after boring operations began. Per the Army Corps permit and mitigation agreements, PG&E is allowed to take Wetland #2. The frac-out area was isolated with hay bales; a vac-truck arrived at the location and the bentonite was removed from the wetland area (see Figure 3). Crews inserted a casing around the drilling rod to better enable the bentonite slurry returns (see Figure 4).

Figure 2 - Bore rig setup, November 21, 2005.

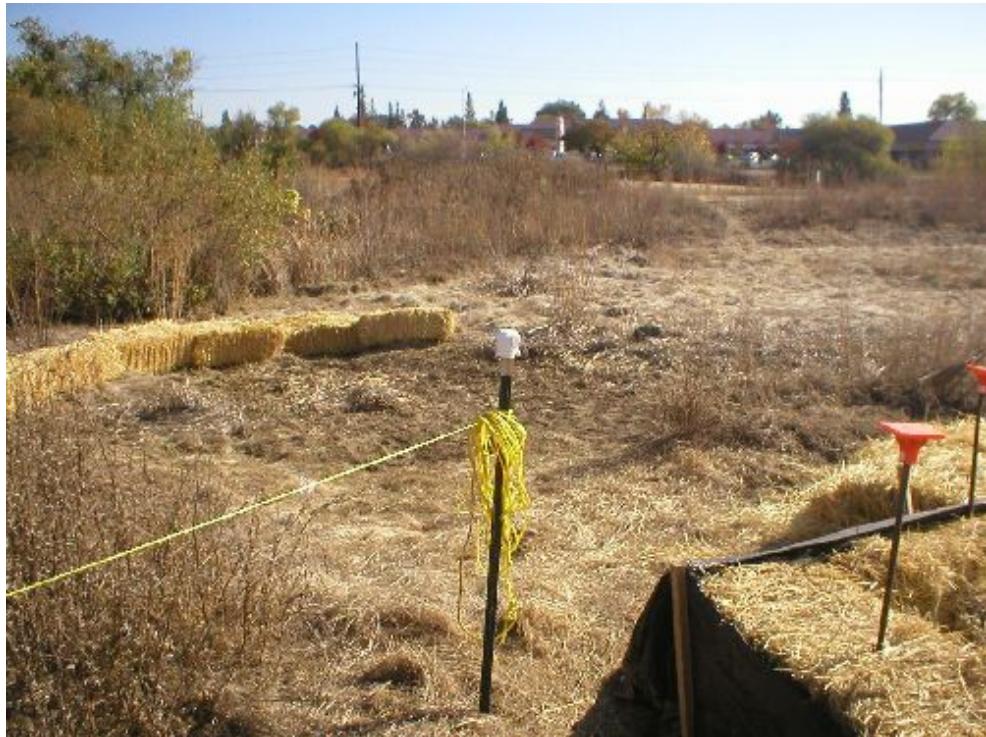
Figure 3 - Cleaned frac-out area in Wetland #2, November 21, 2005.

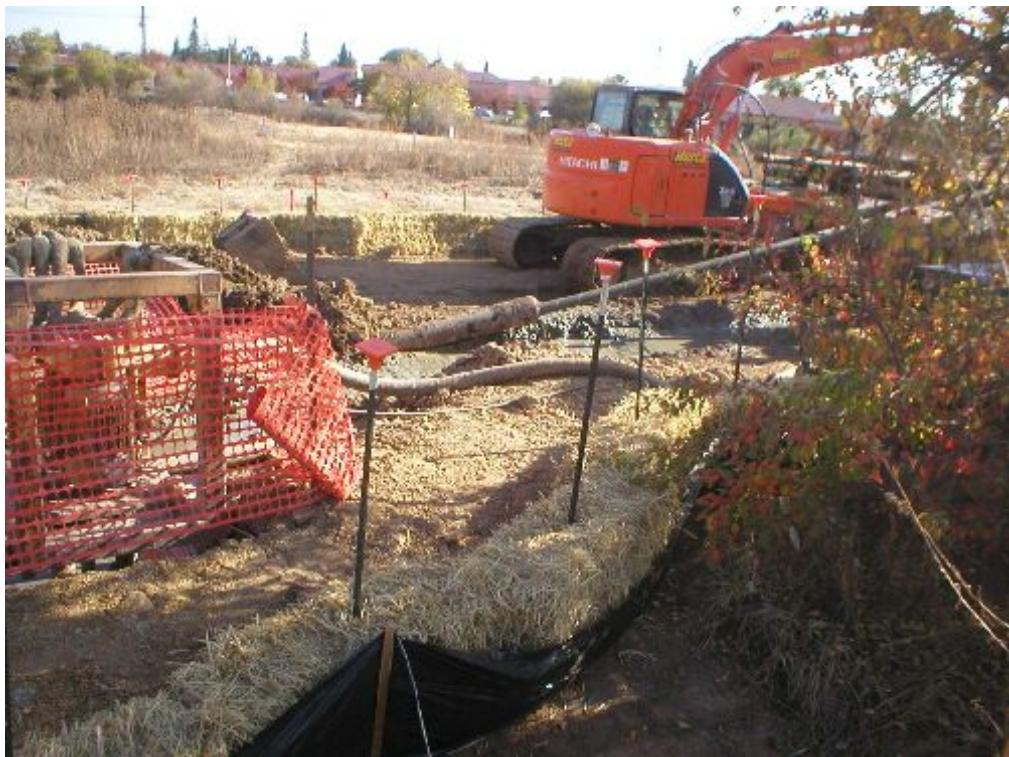
Figure 4 - Bore rig. Note casing pipe around the rod and the flow of bentonite returns, November 21.

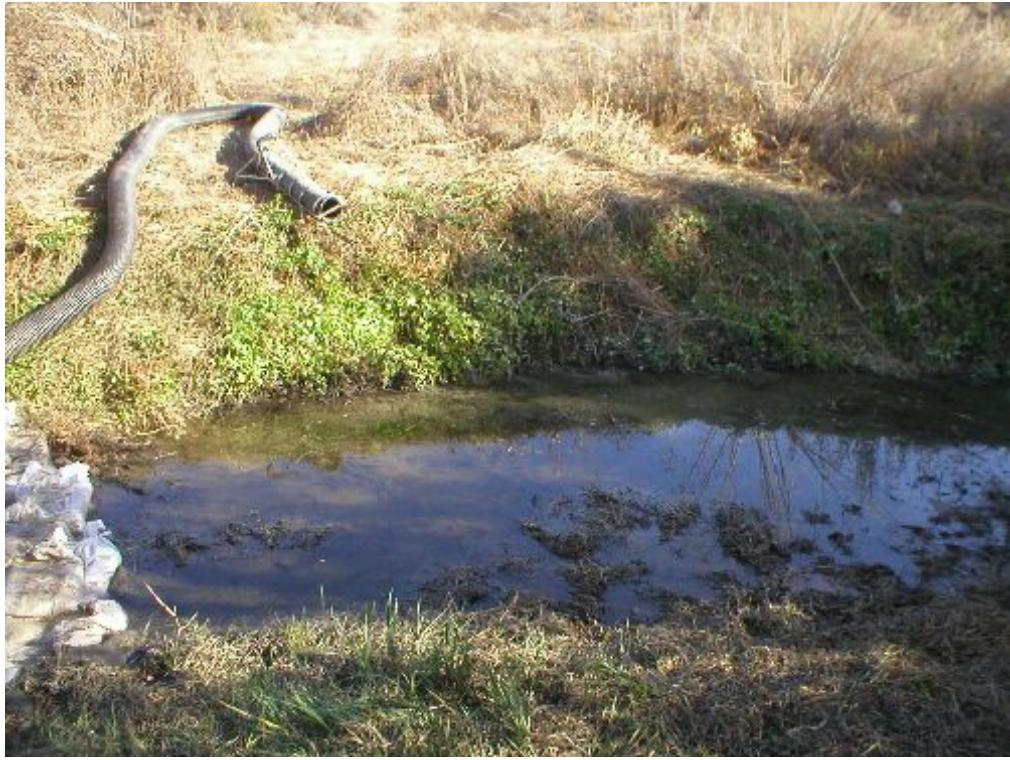
On Saturday November 19, a second frac-out occurred 100 feet off of centerline in Wetland #3. The mud was expelled into an area of standing water. The drilling mud rose to the surface and was immediately identified and removed (see Figure 5). Impacts to Wetland #3 are not covered by the Army Corps permits. Per Essex, both the Army Corp of Engineers and the California Department of Fish and Game were notified of the frac-outs occurring in the resources. A retroactive permit will be obtained from the Army Corps of Engineers. Essex Environmental filed an incident report November 30.

On November 19, a frac-out occurred 100 feet off of centerline in Wetland #3. Impacts to Wetland #3 are not covered by the Army Corps permits. Both the Army Corp of Engineers and the California Department of Fish and Game were notified of the frac-outs occurring in the resources. A retroactive permit will be obtained from the Army Corps of Engineers and Essex Environmental has filed an incident report.

Figure 5 – Cleaned up frac-out location in Wetland #3, November 21, 2005.

Per Essex, the Army Corps of Engineers and the California Department of Fish and Game were appropriately notified of the frac-out in Wetland #3 on Monday, November 21. Follow-up correspondence and an incident report were submitted November 29.
