PROJECT MEMORANDUM

ANTELOPE TRANSMISSION PROJECT, SEGMENTS 1, 2 AND 3A

To: John Boccio, Project Manager, CPUC
Justin Seastrand, Project Manager, ANF
From: Vida Strong, Aspen Project Manager
Date: June 18, 2009
Subject: Weekly Reports 72 and 73: May 24 to June 6, 2009.

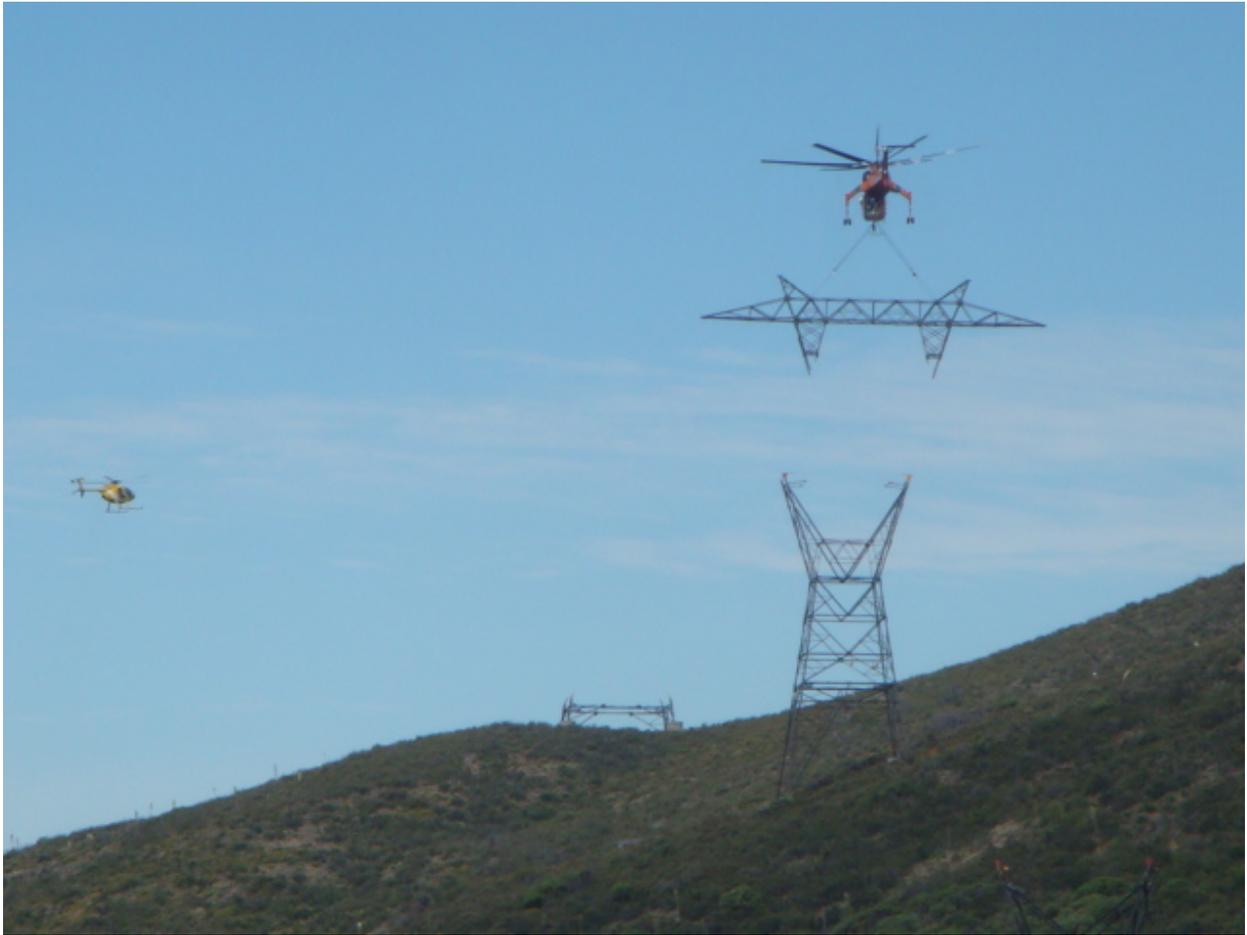
Figure 1: Tower assembly on the ANF using the Ericsson Sky Crane, Segment 1, Section 2.

1. Brush clearing crews completed clearing vegetation in disturbance areas to be used during the Sky Crane operations on the ANF.
2. The heavy lift helicopter, an Ericsson Sky Crane, completed the second round of tower assembly on the ANF between June 1 and June 10 (see Figure 1). All remaining towers in the ANF were installed during this period despite delays caused by fog and mechanical problems.

3. Tower sections were flown into place using the Ericsson Sky Crane from the Hydrant and Reitano Yards. The tower sections were flown into place on top of tower bases; the bases were already installed at each tower location using the medium lift K-Max helicopter.

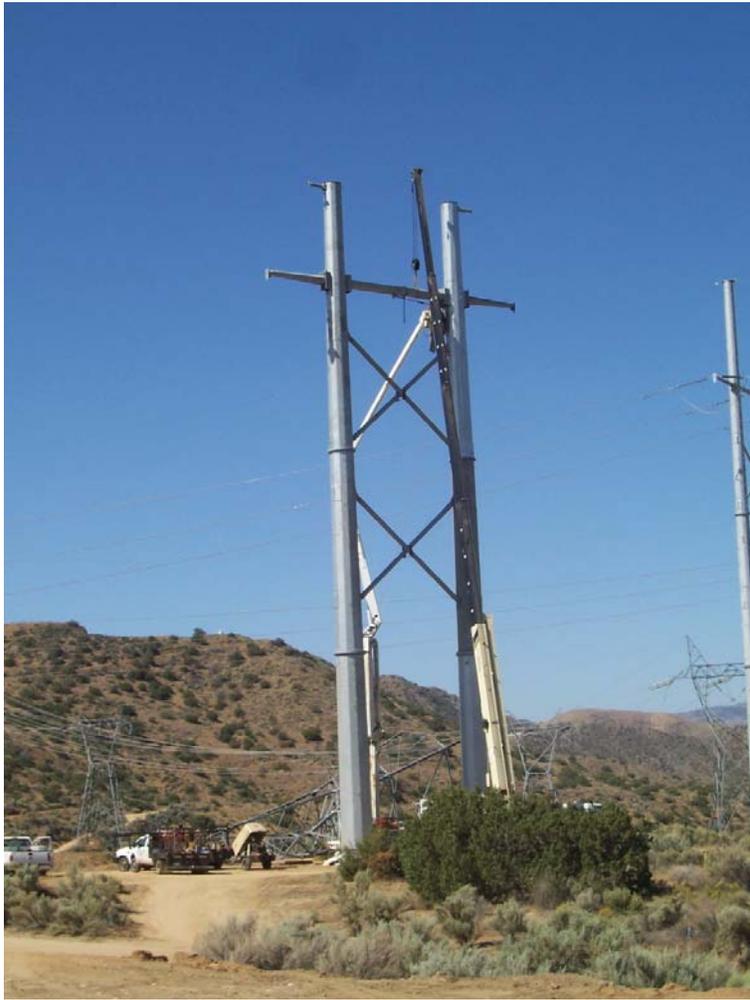
Figure 2: Sagebrush Transmission Line Modification, Segment 2, by the Vincent Substation.

1. PAR crews completed work on the existing Sagebrush Transmission Line Modifications at three locations: North of Elizabeth Lake Road, North of Sierra Highway, and Vincent substation. These modifications are required in order to construct Segment 2 (see Figure 2).

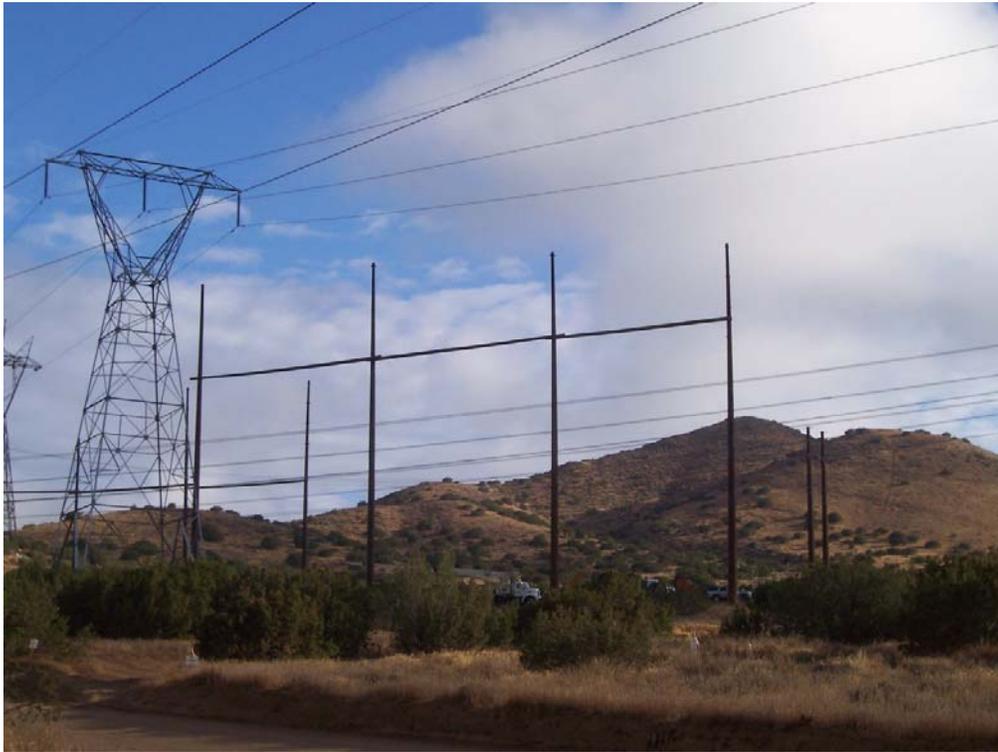
Figure 3: Guard pole structure between Towers 106 and 107, Segment 2.

3. Guard pole installation occurred on both sides of the LADWP corridor to prepare for the wire stringing between Towers 106 and 107 (see Figure 3).
4. One Temporary Extra Workspace request was approved by the CPUC EM on June 2nd for additional staging of equipment in a disturbed area near Tower 106.

5. During the set up of the guard pole structures between Towers 106 and 107, PAR construction crew intruded into the Environmental Sensitive Area (ESA) when one of the stacked guard poles rolled outside of the disturbance area and crushed part of a juniper tree.

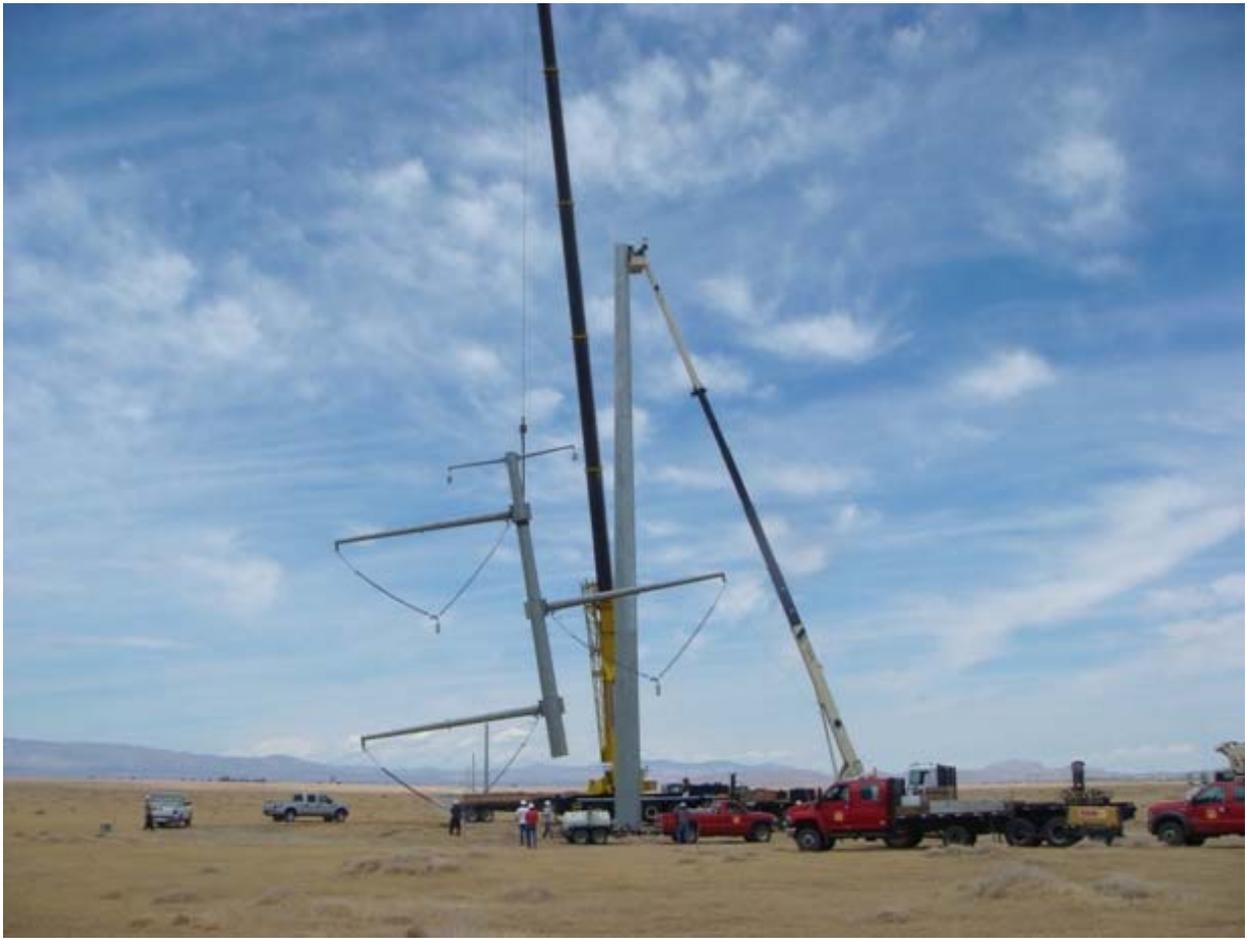
Figure 4: Reveals and pad extension, Segment 2.

8. Steel assembly continued along all areas of Segment 2.
9. PAR construction crews started working on reveals and expanding the crane pads at Towers 20, 75-78, 82, 83, and 92.
