Figure D.12-12A
Key Viewpoint 11
Summit Drive
Existing View

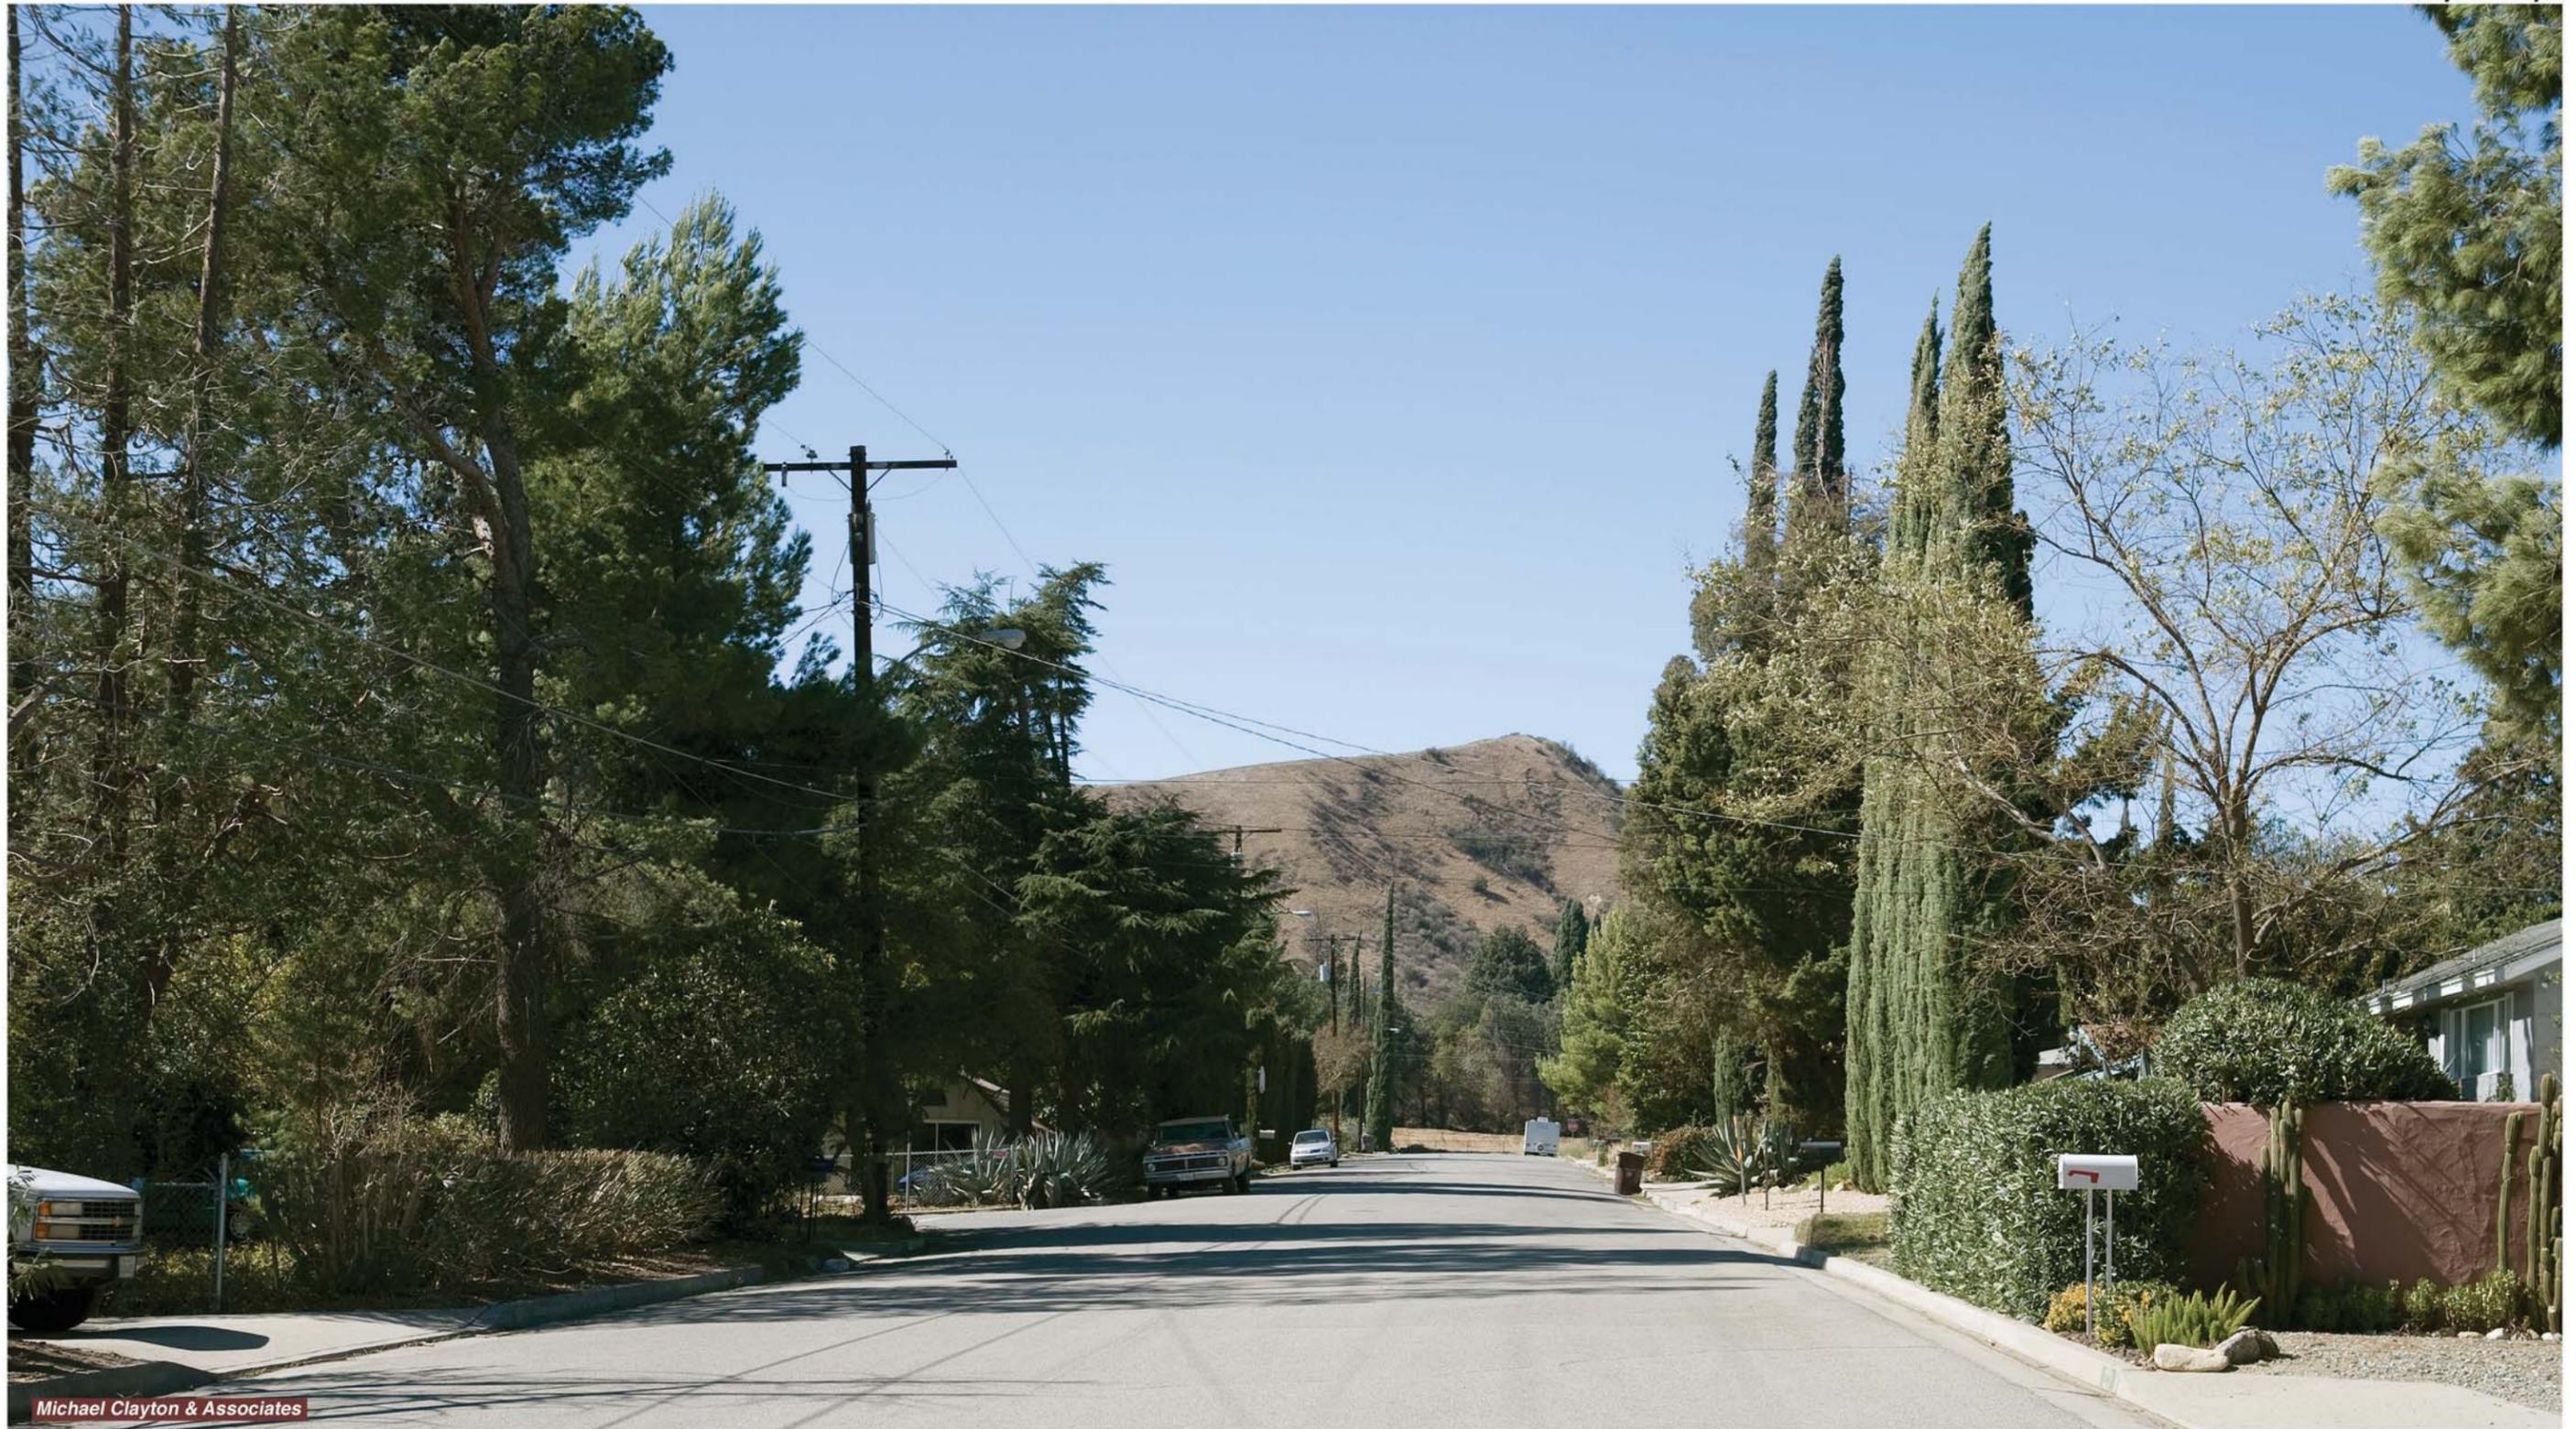
The **existing view** to the west down Summit Drive in the City of Banning. The Route Alternative Option 3 would replace the existing wood pole distribution line that runs along the south side of Summit Drive with a steel pole 115 kV subtransmission line with a distribution underbuild. This view captures the suburban residential character of the neighborhood. Though unsightly with numerous overhead lines, the existing wood pole distribution line does not substantially contrast with the existing residential landscape and is a typical suburban landscape feature of older residential areas.
