From: Kelly Fuller <kelly@kellyfuller.net>
Sent: Friday, March 07, 2014 4:54 PM
To: CNFMSUP
Subject: SDG&E Master Special Use Permit (POC Comment Attachments, 2 of 2)
Attachments: POC_Footnote12b_2006_APLIC_Guidelines.pdf

Suggested Practices for Avian Protection On Power Lines: The State of the Art in 2006

PIER FINAL PROJECT REPORT CEC-500-2006-022

Avian
Power
Line
Interaction
Committee

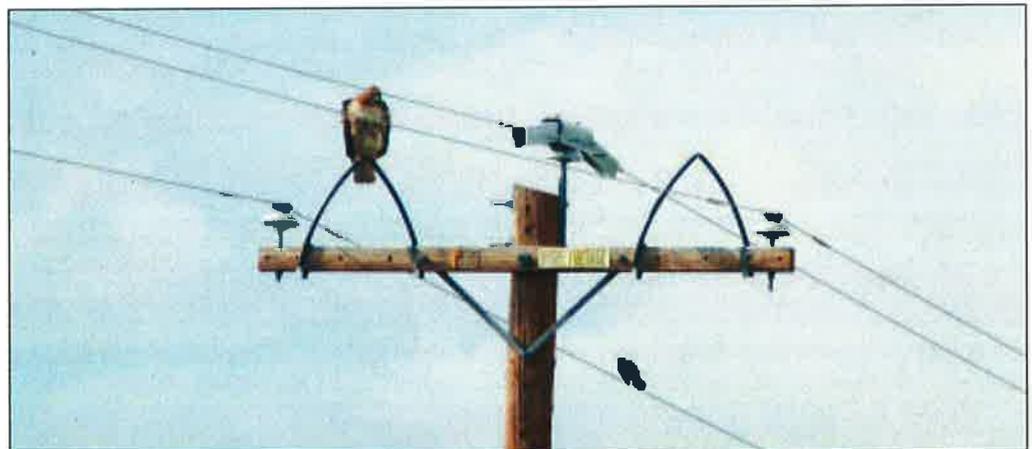
FIGURE 2.5: Perch discouragers have been installed on utility poles to prevent raptors or corvids from preying upon sensitive species. However, this is not recommended, as perch discouragers are intended to manage where birds perch, not to entirely prevent perching.

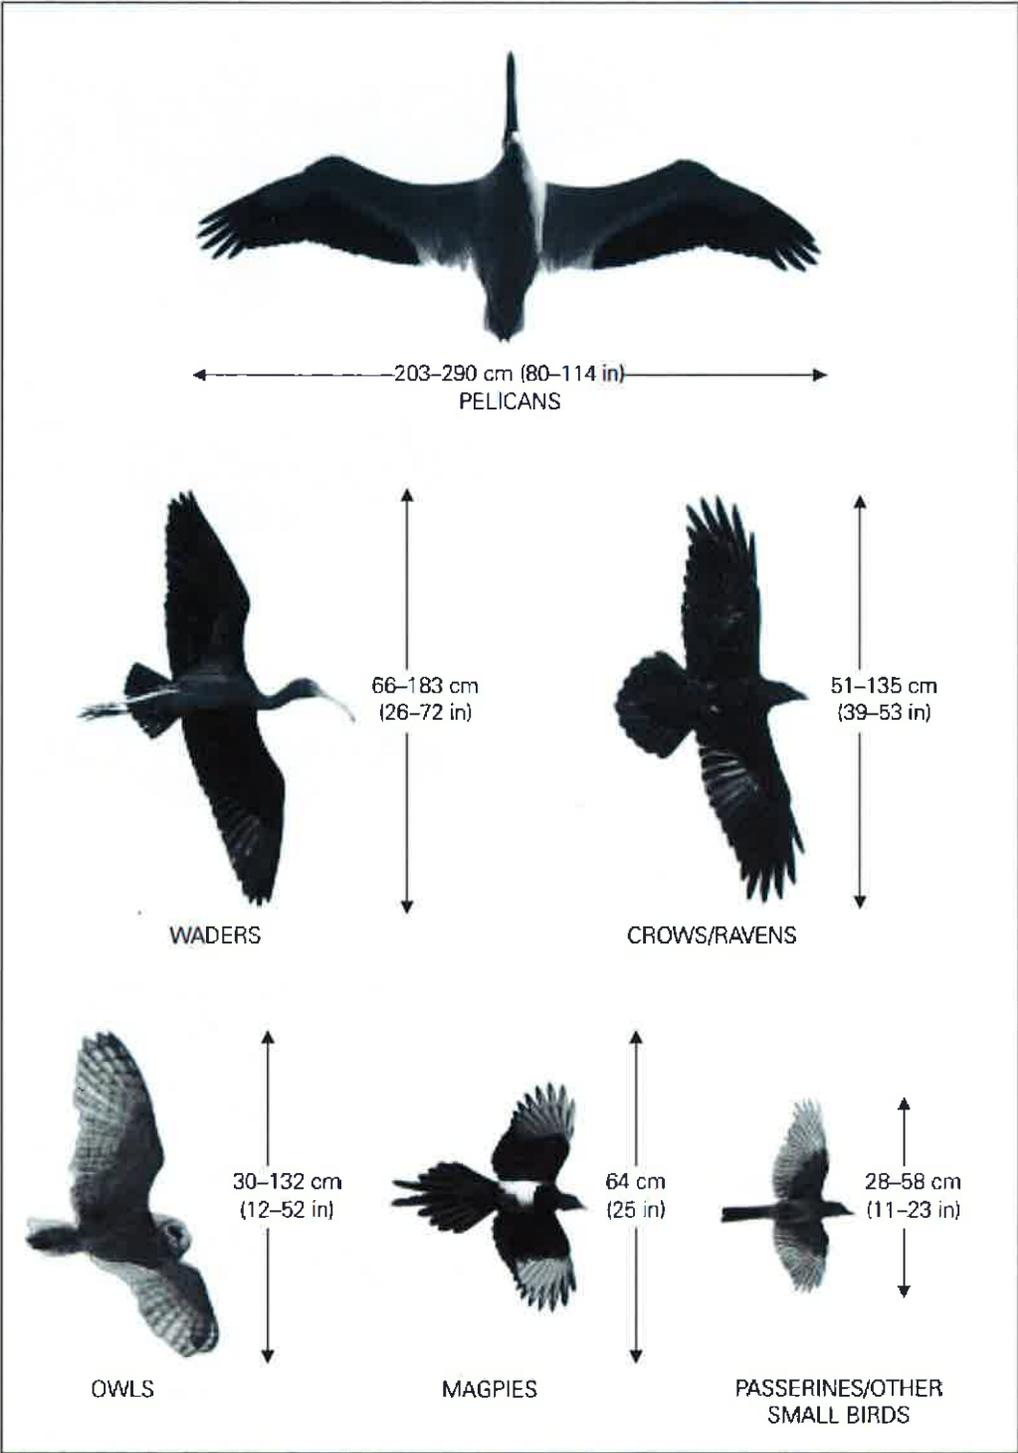
FIGURE 4.12: Wingspan comparisons of selected birds.

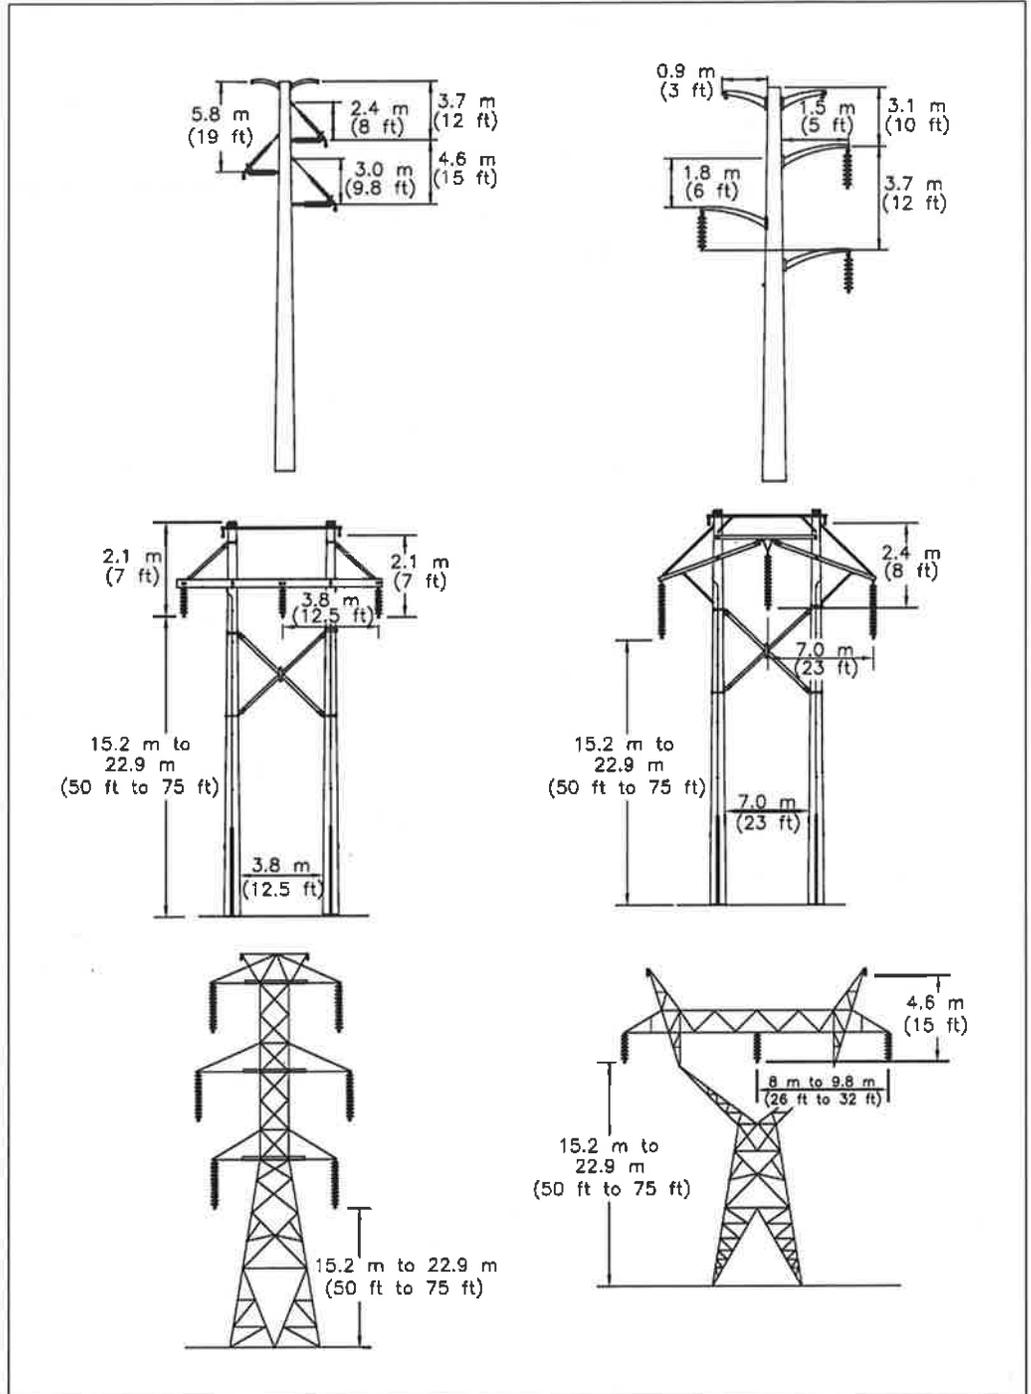
FIGURE 5.4: Examples of transmission structures.

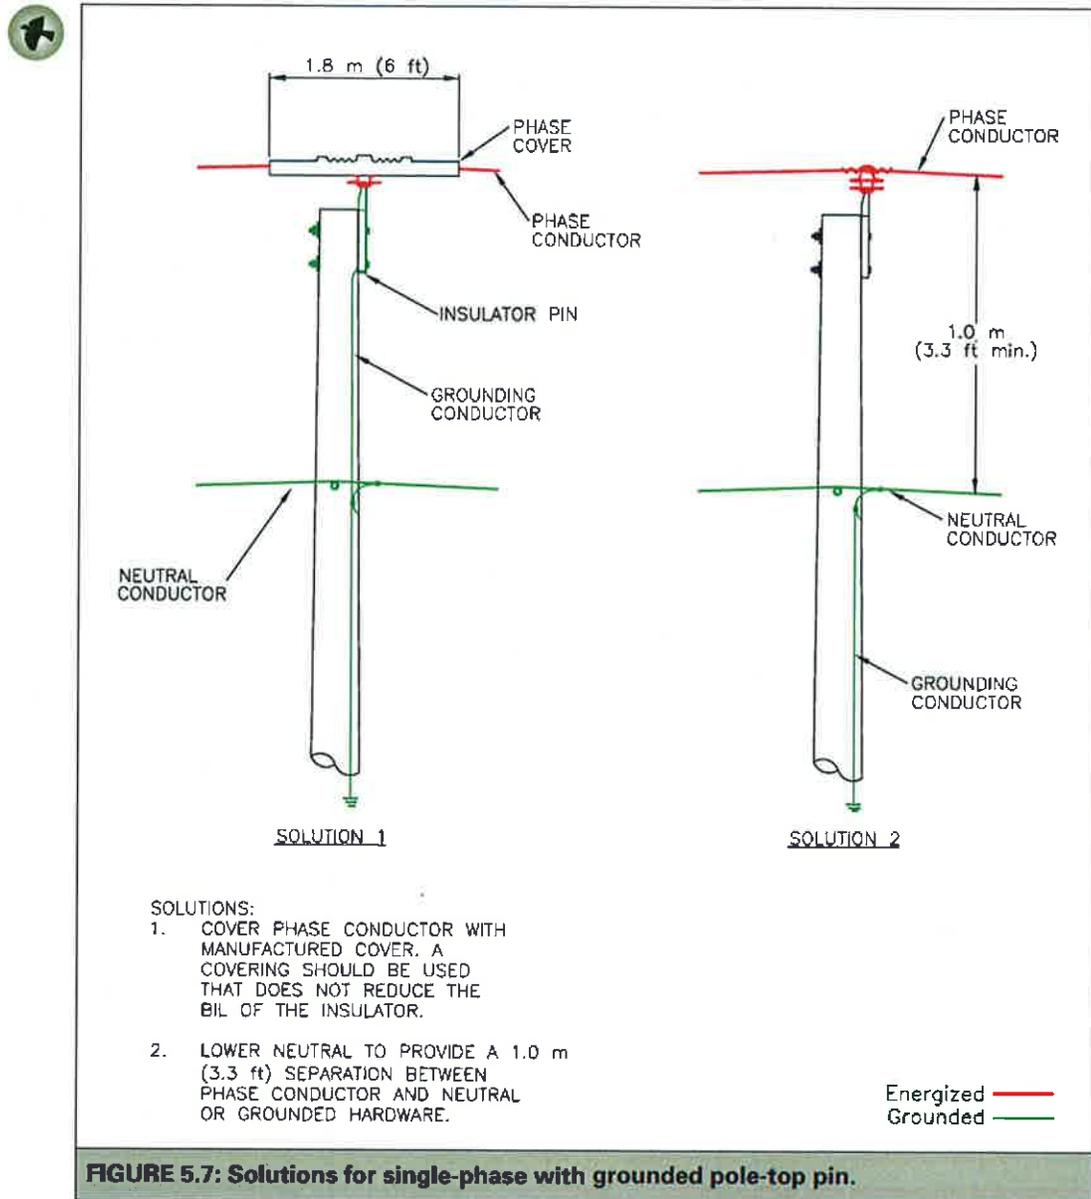
FIGURE 5.7: Solutions for single-phase with grounded pole-top pin.

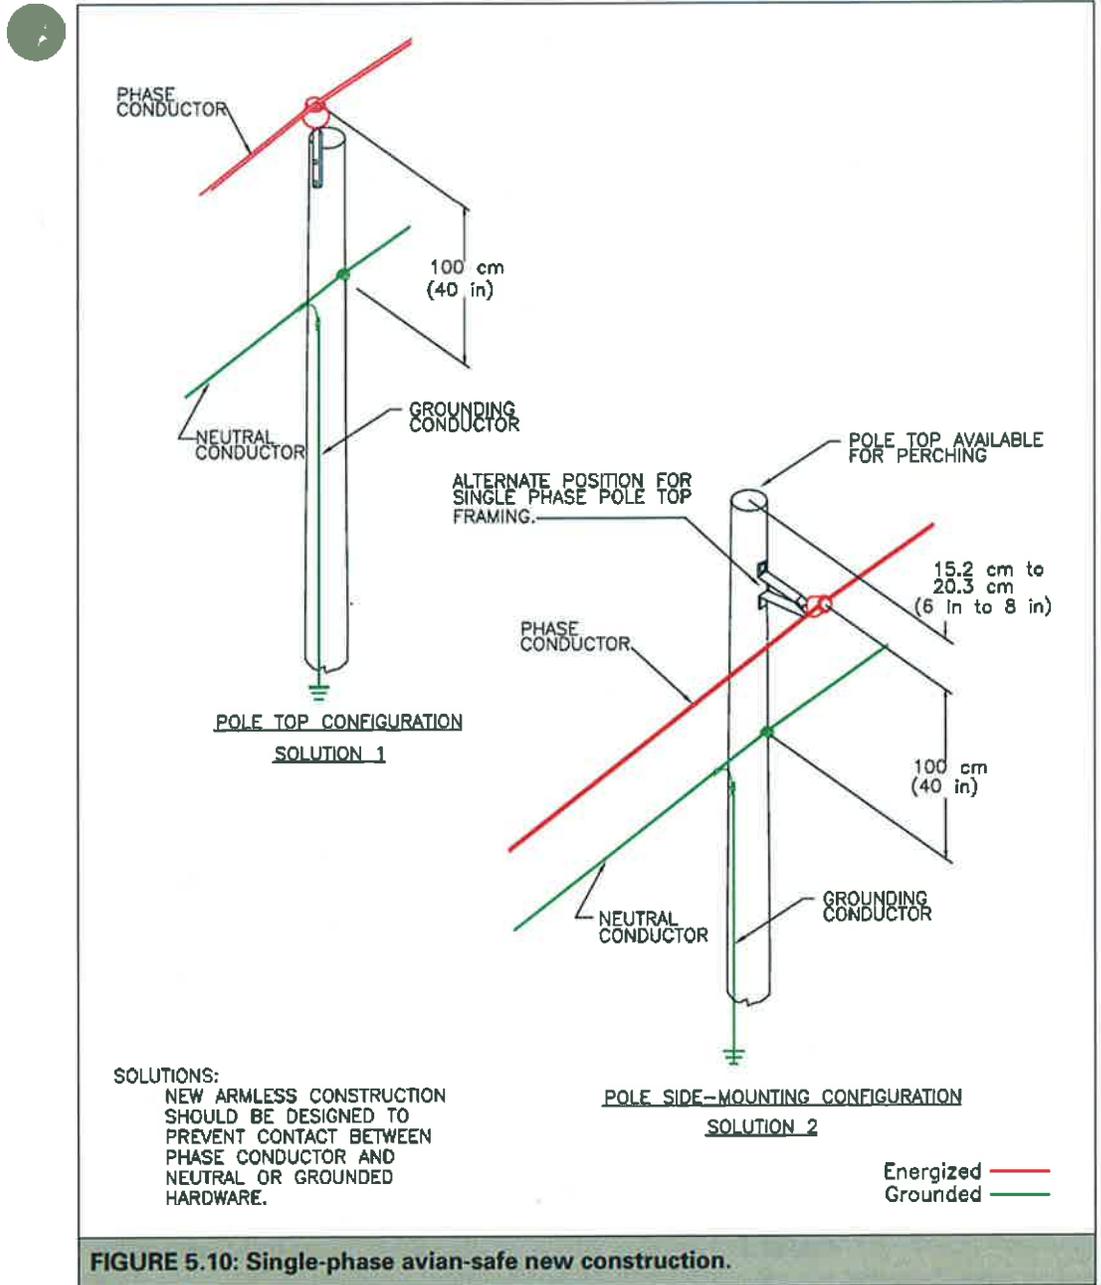
FIGURE 5.10: Single-phase avian-safe new construction.

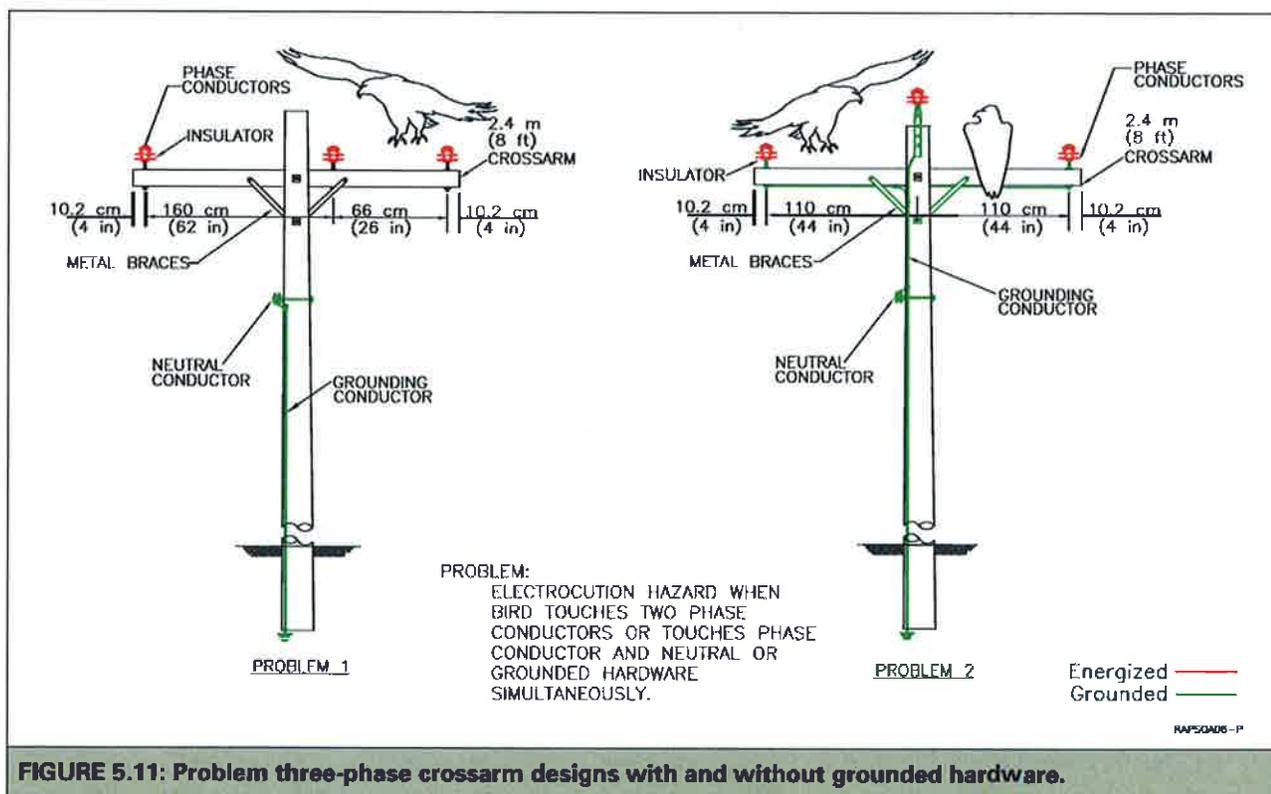
FIGURE 5.11: Problem three-phase crossarm designs with and without grounded hardware.

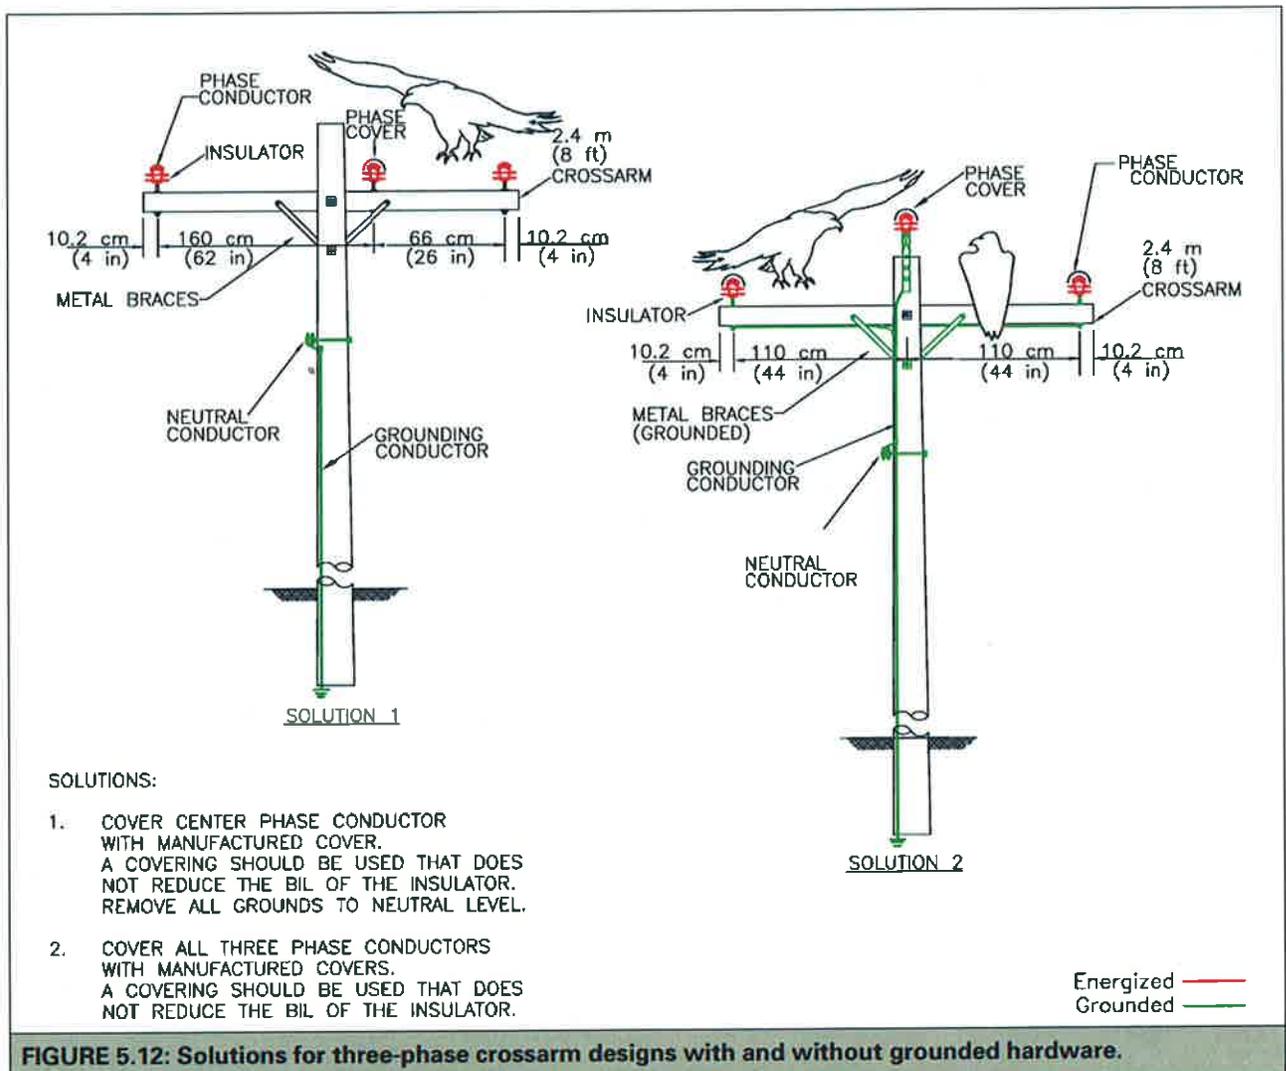
FIGURE 5.12: Solutions for three-phase crossarm designs with and without grounded hardware.

- Install covers over the insulator and conductor on the center phase and remove bonding down to the neutral (Figure 5.12, Solution 1). For further information on the use of cover-up products, see [Precautions](#) (page 102).
- If bonds are not removed, install phase covers over all three insulators and conductors (Figure 5.12, Solution 2).
- For pole-top pin construction, the crossarm can be lowered and/or replaced with a longer crossarm (Figure 5.13).²⁸ A 2.4-m (8-ft) crossarm should be lowered 104 cm (41 in) to achieve 150-cm (60-in) conductor separation. A 3-m (10-ft)

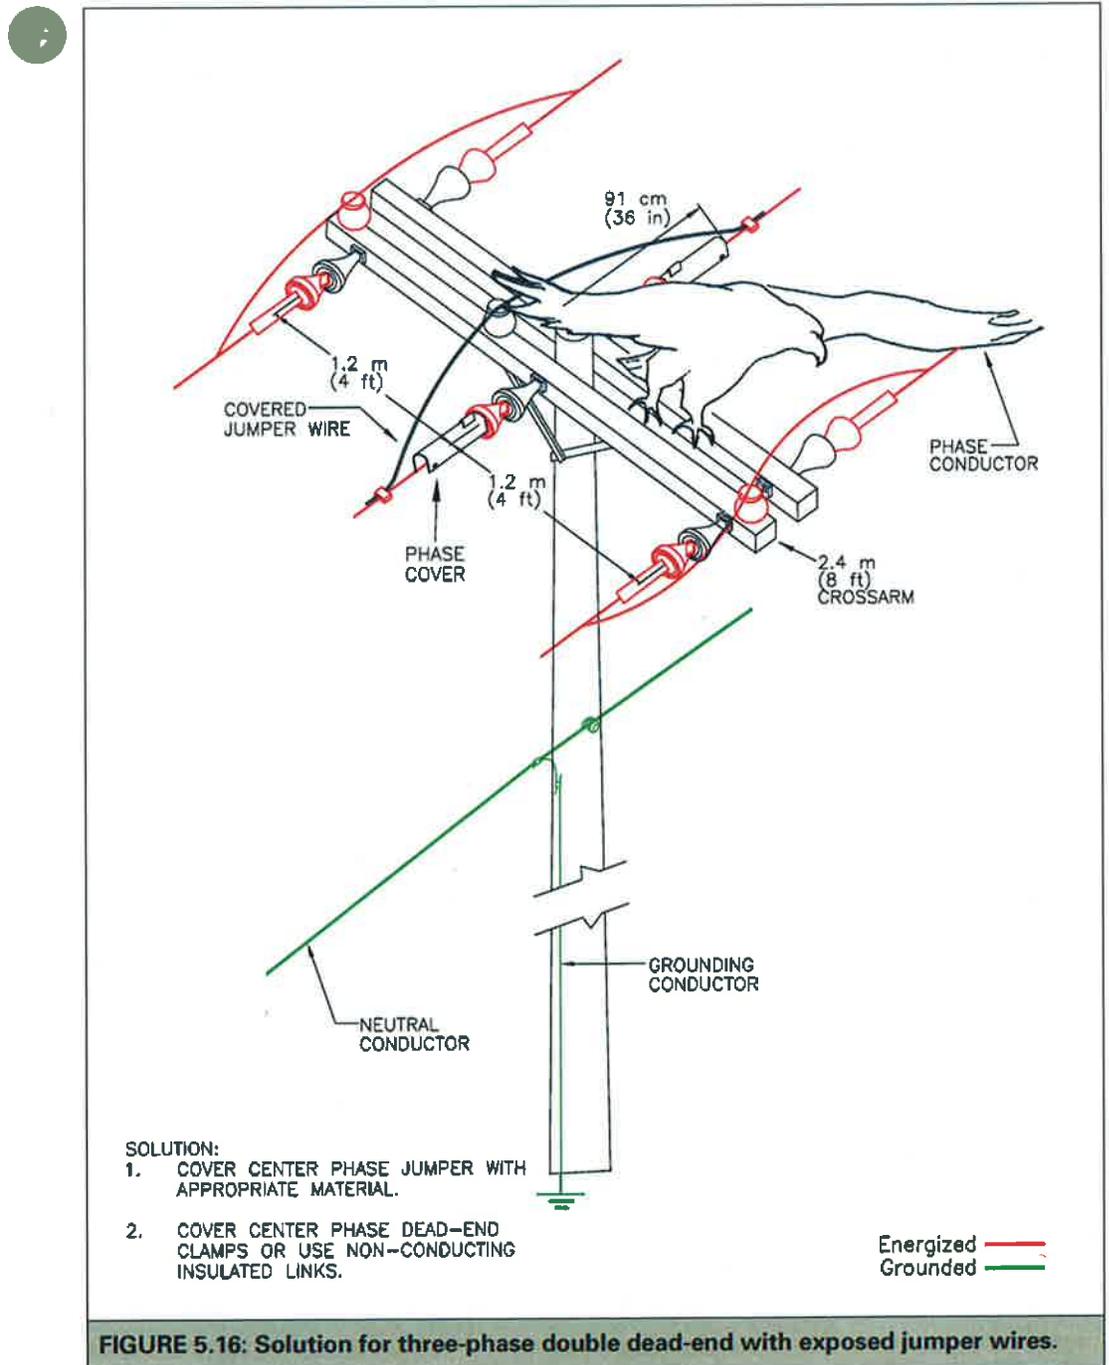
FIGURE 5.16: Solution for three-phase double dead-end with exposed jumper wires.

and cover the center phase jumper wire with a material designed for the purpose. A covered conductor can also be used (Figure 5.16), as

can insulated links or insulators that move the energized conductor 91 cm (36 in) from the center of the pole.

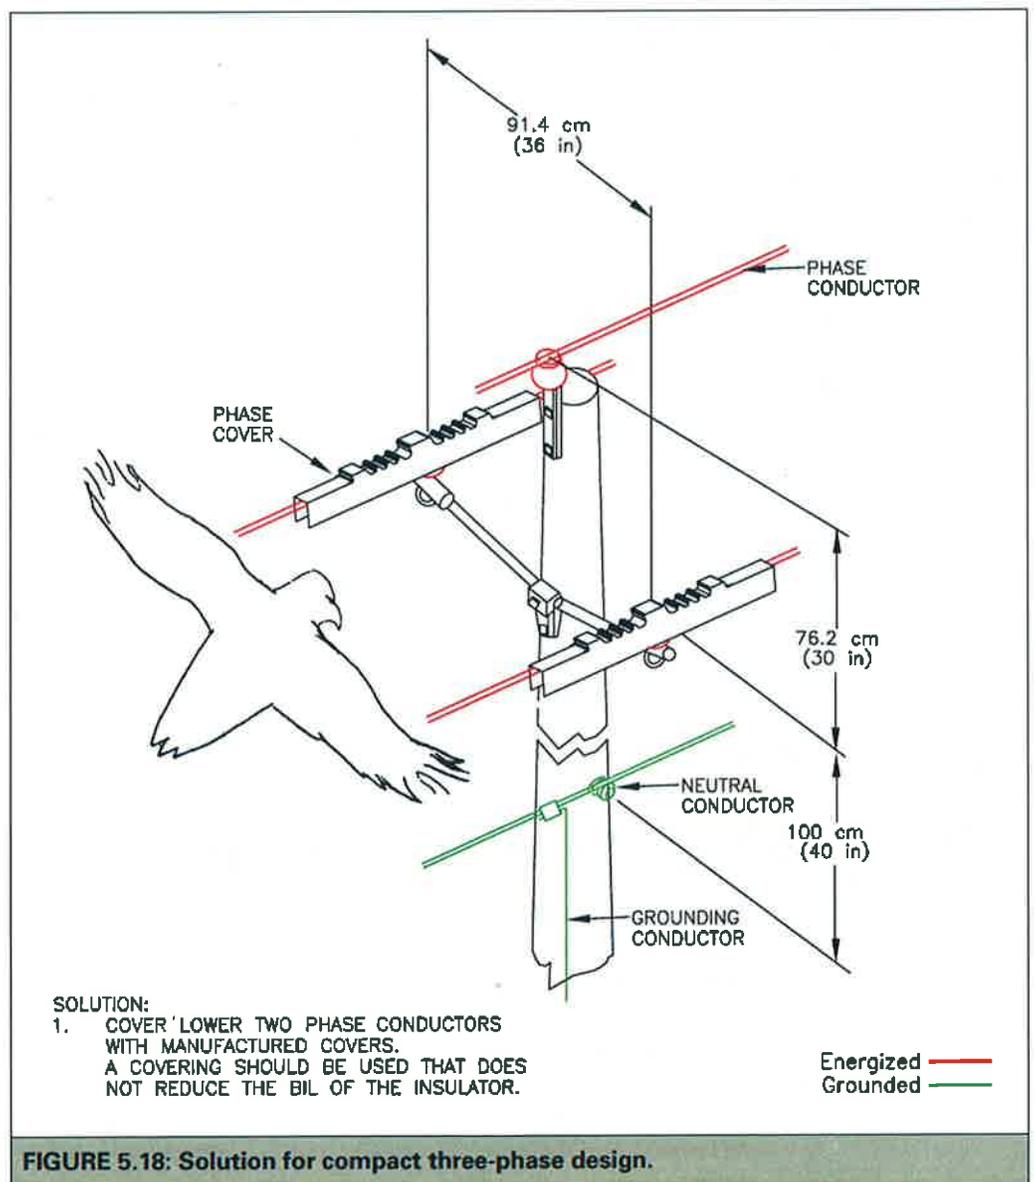
FIGURE 5.18: Solution for compact three-phase design.

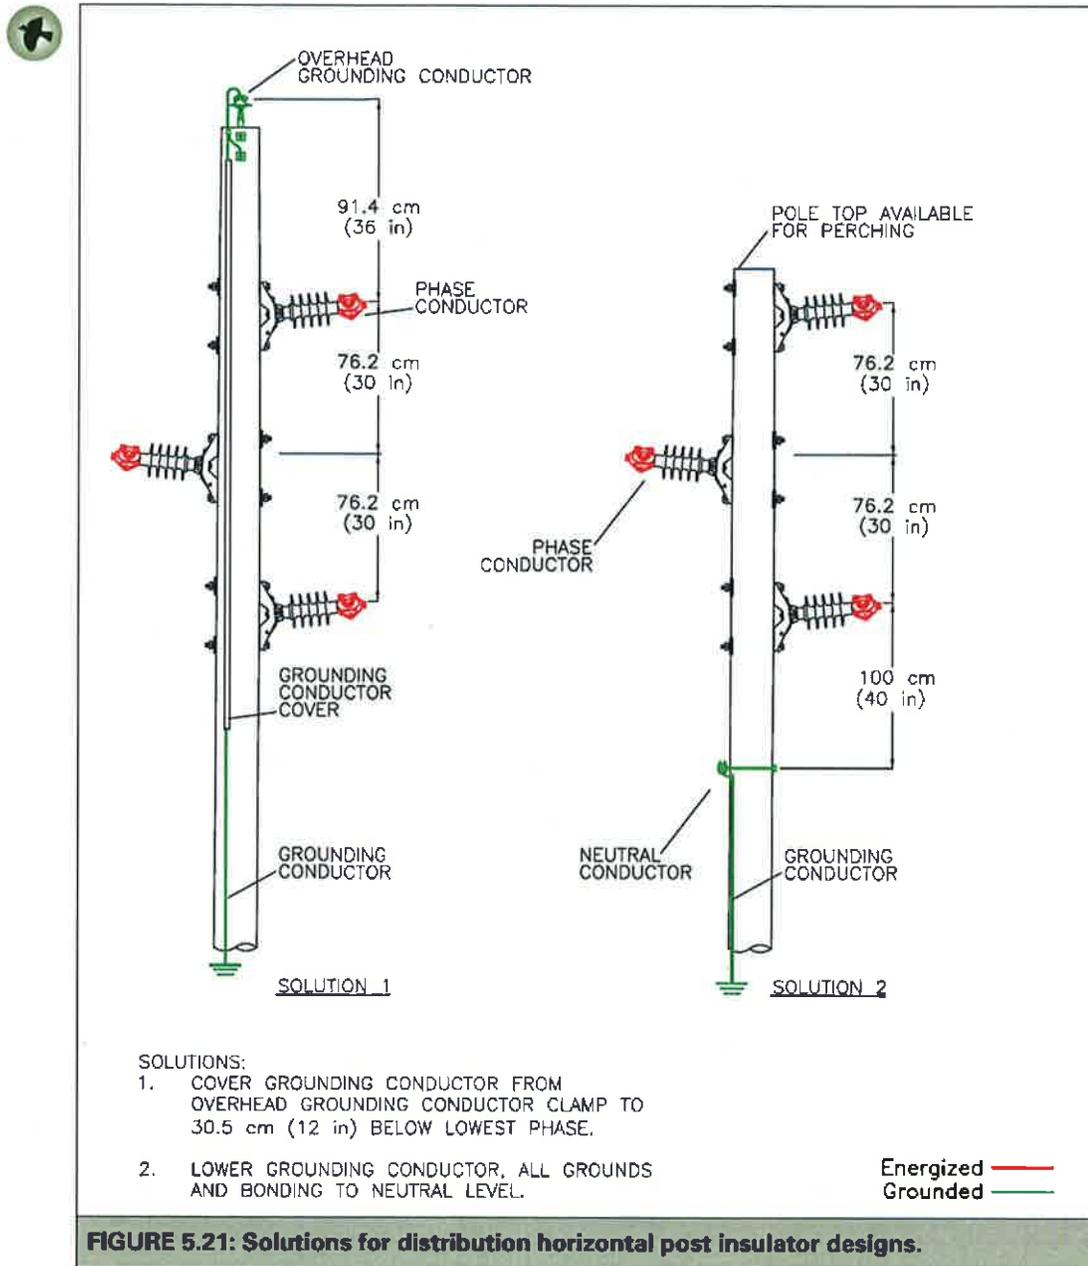
FIGURE 5.21: Solutions for distribution horizontal post insulator designs.

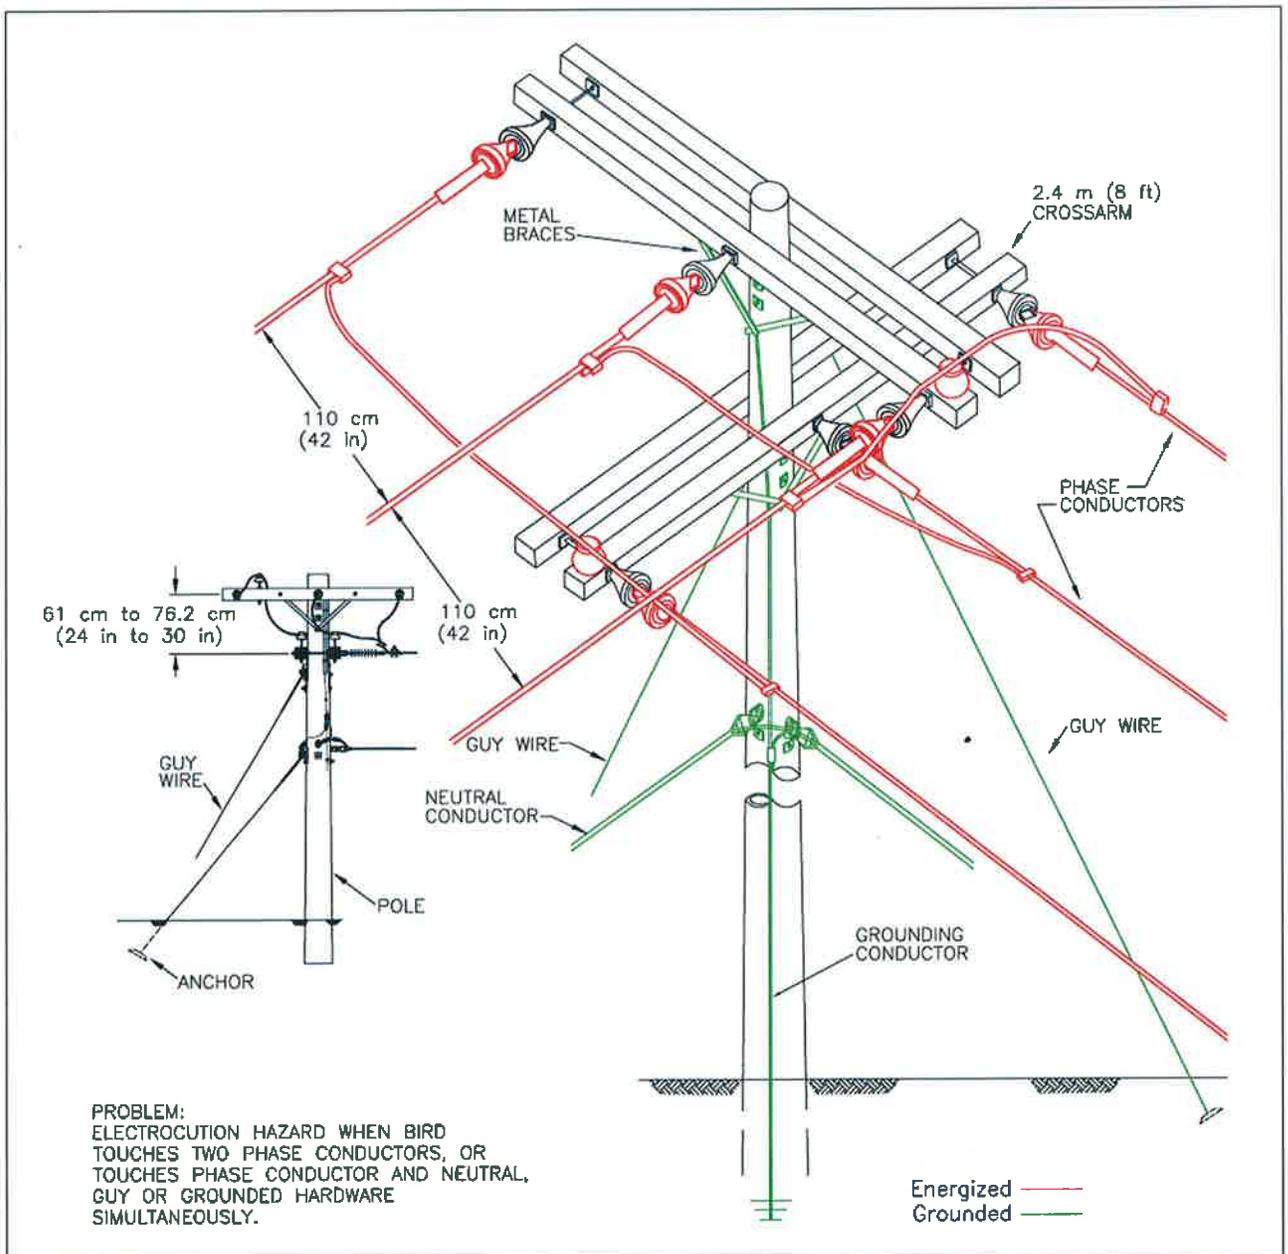
FIGURE 5.22: Problem three-phase distribution corner configuration.

On corner poles, the center phase conductor can be attached to the top set of crossarms with additional insulators or

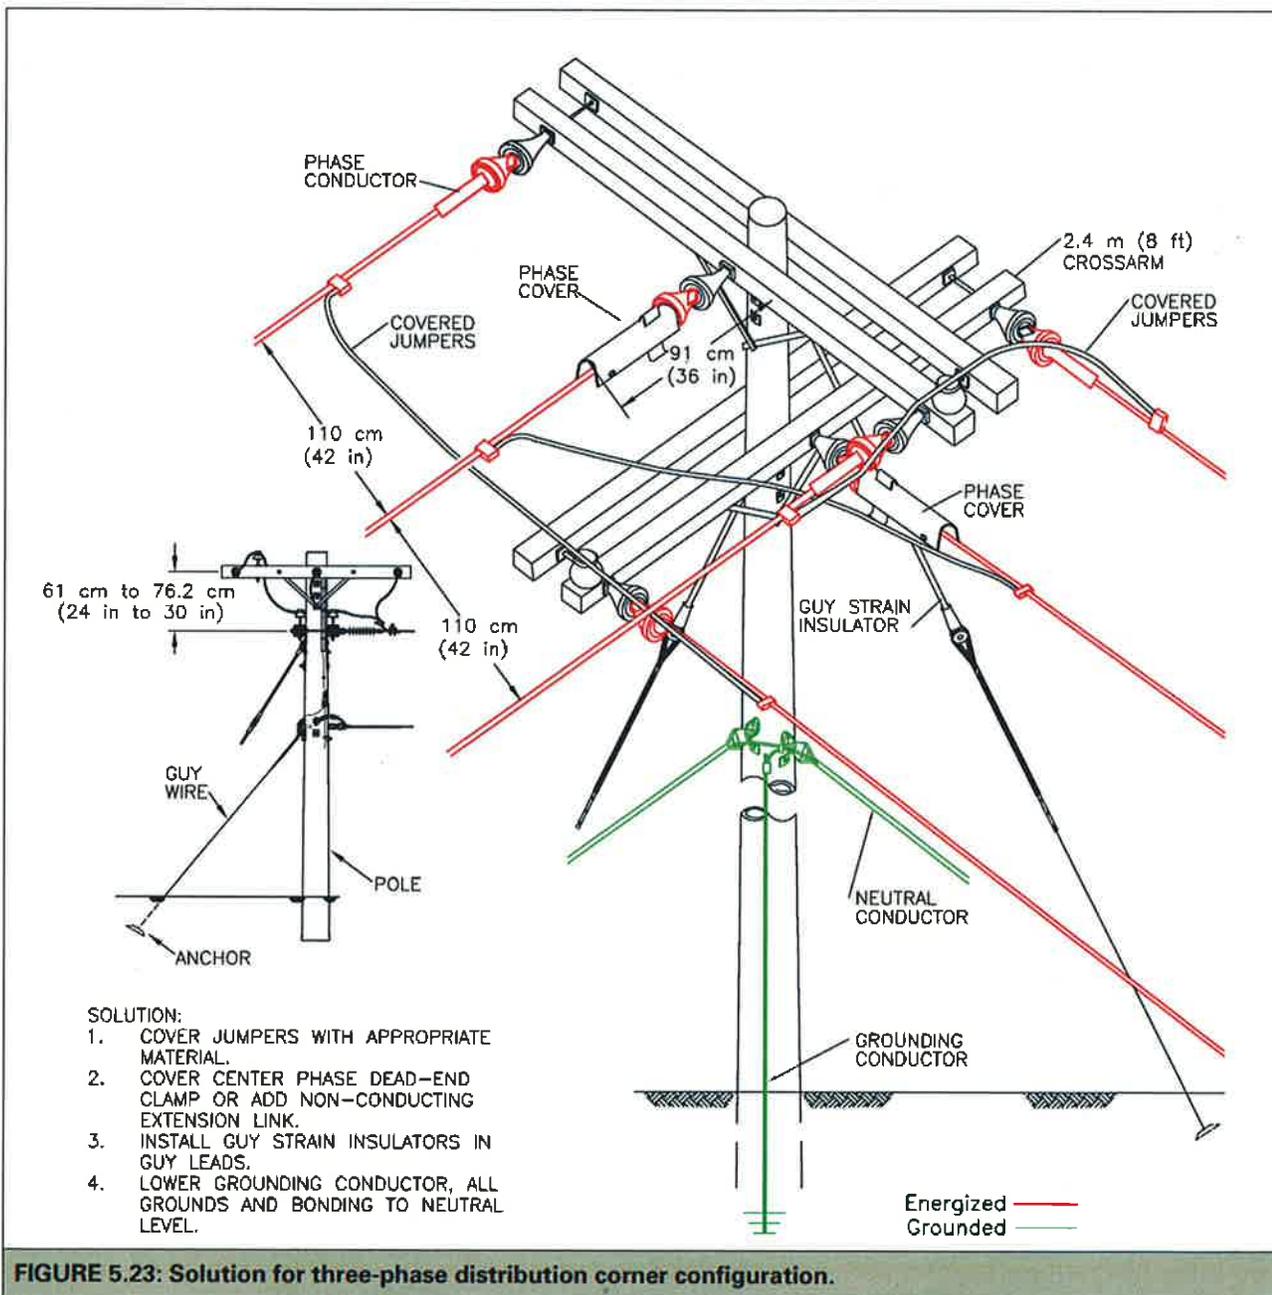
FIGURE 5.23: Solution for three-phase distribution corner configuration.

91 cm (36 in) from the pole to the conductor. Bare jumper wires should be covered with a material designed for the purpose or replaced with covered conductors. In addition, all down guy-wires should have guy strain

[8-ft] arms) that provide 150 cm (60 in) of phase-to-phase separation. Conventional corner poles can be constructed in the manner depicted in Figure 5.23. Other alternatives are the vertical designs shown in Figures 5.24

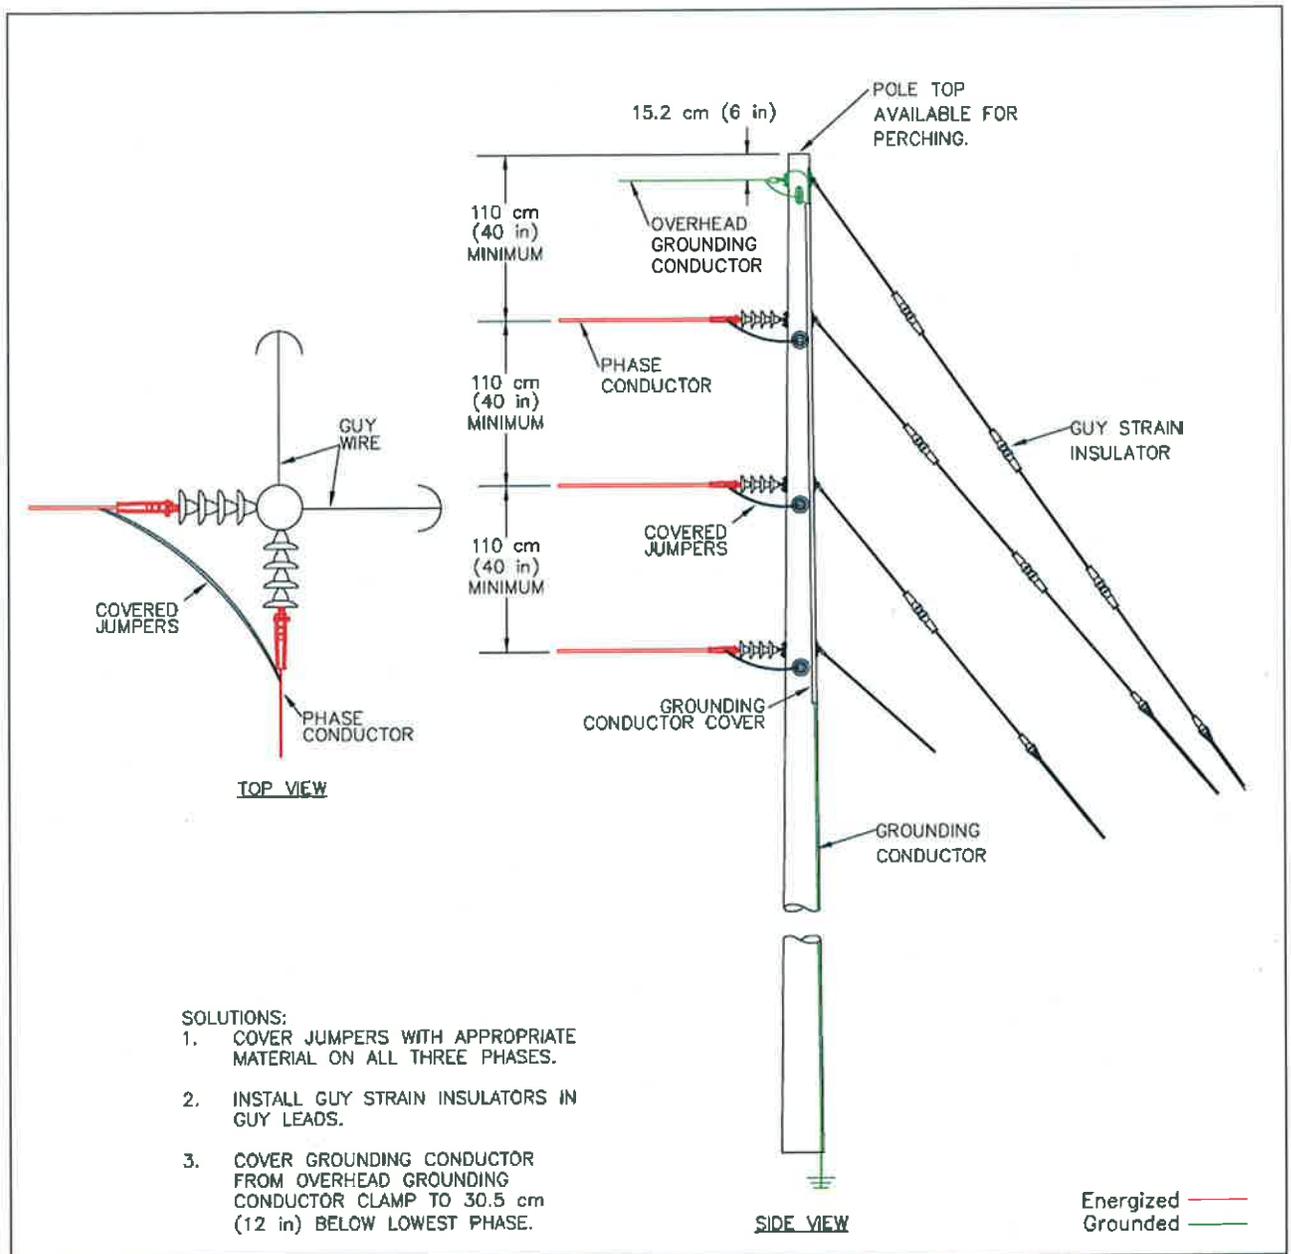
FIGURE 5.24: Three-phase vertical corner configuration—overhead grounding conductor on pole top.

usually required, but vertical avian-safe corner designs eliminate crossarms and unwieldy jumper wire arrangements. They can also accommodate overhead grounding conductors.

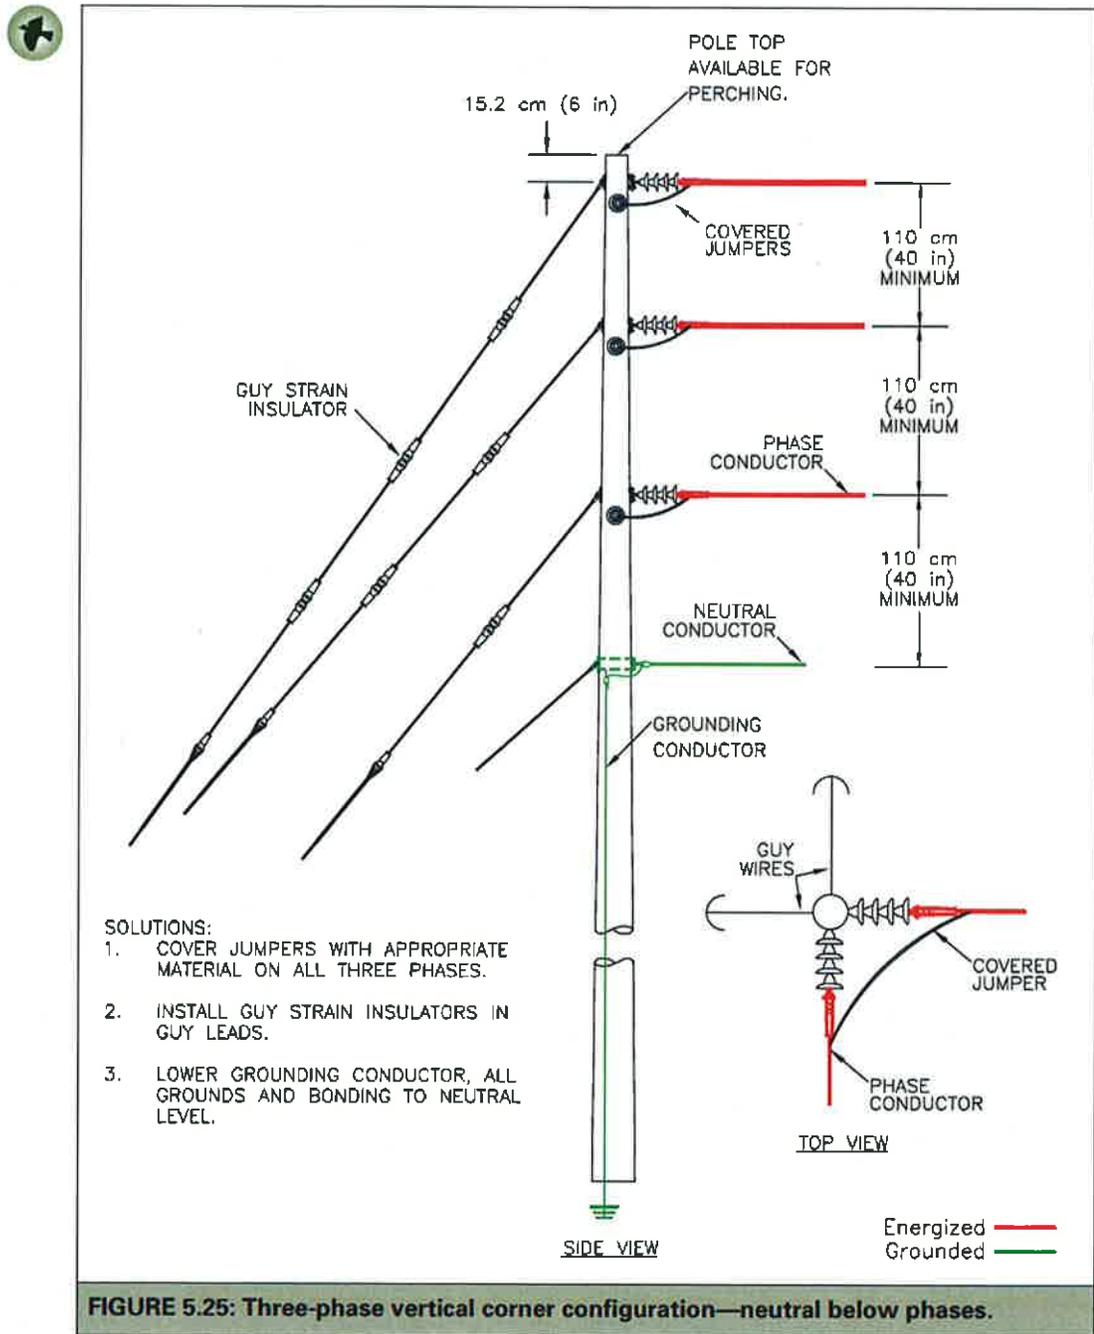
FIGURE 5.25: Three-phase vertical corner configuration—neutral below phases.

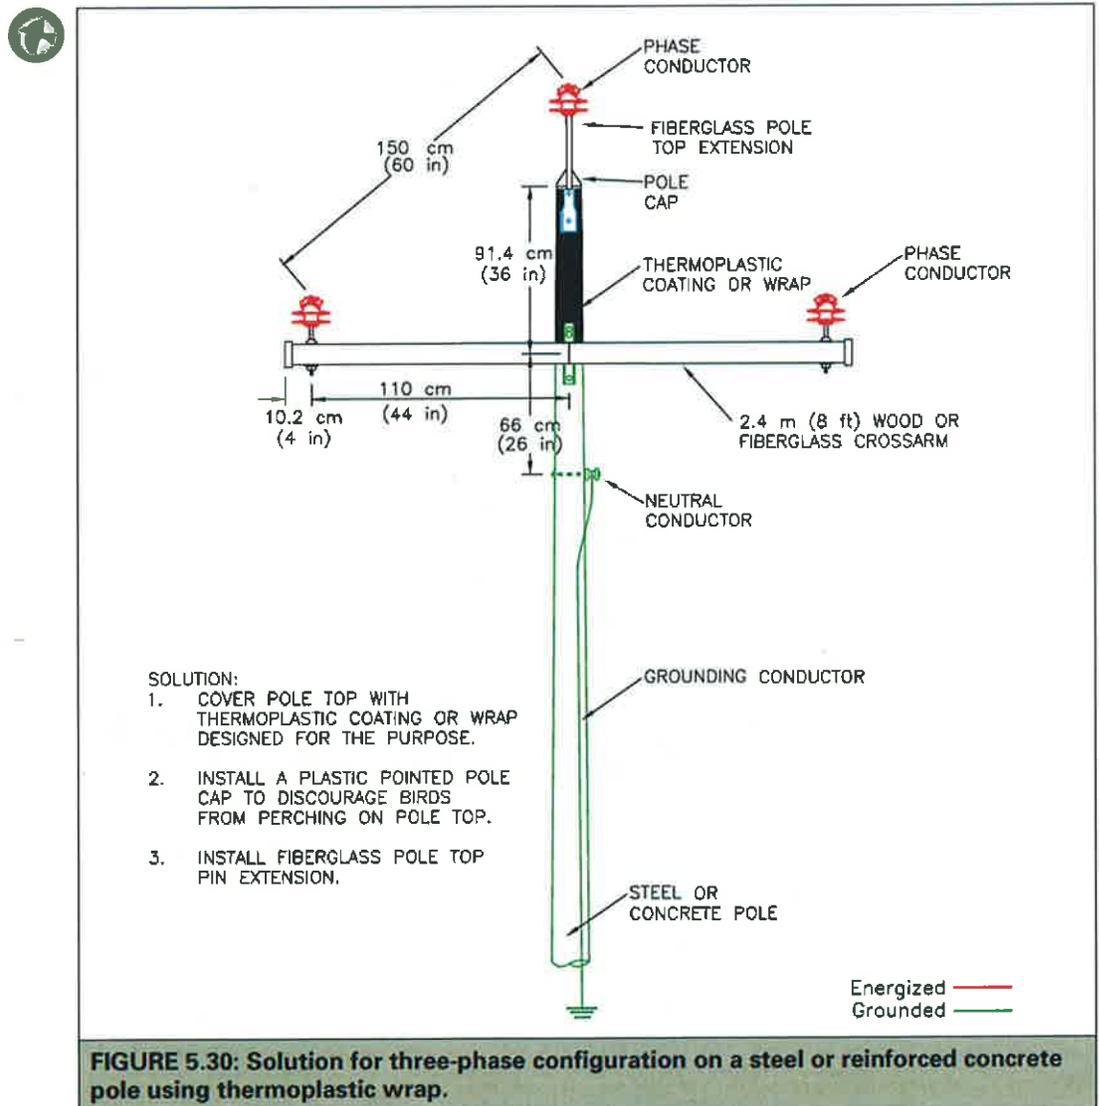
FIGURE 5.30: Solution for three-phase configuration on a steel or reinforced concrete pole using thermoplastic wrap.

to cover the pole from the crossarm to the pole top with a material designed for this purpose (Figure 5.30). This can be achieved by wrapping a band of 40-mil thermoplastic polymer membrane backed with a pressure-sensitive adhesive around the pole from the crossarm up to and including the top of the pole, or by spraying the same area with a protective coating that has sufficient dielectric strength. A utility performed a dielectric test of a thermoplastic wrap, and determined that

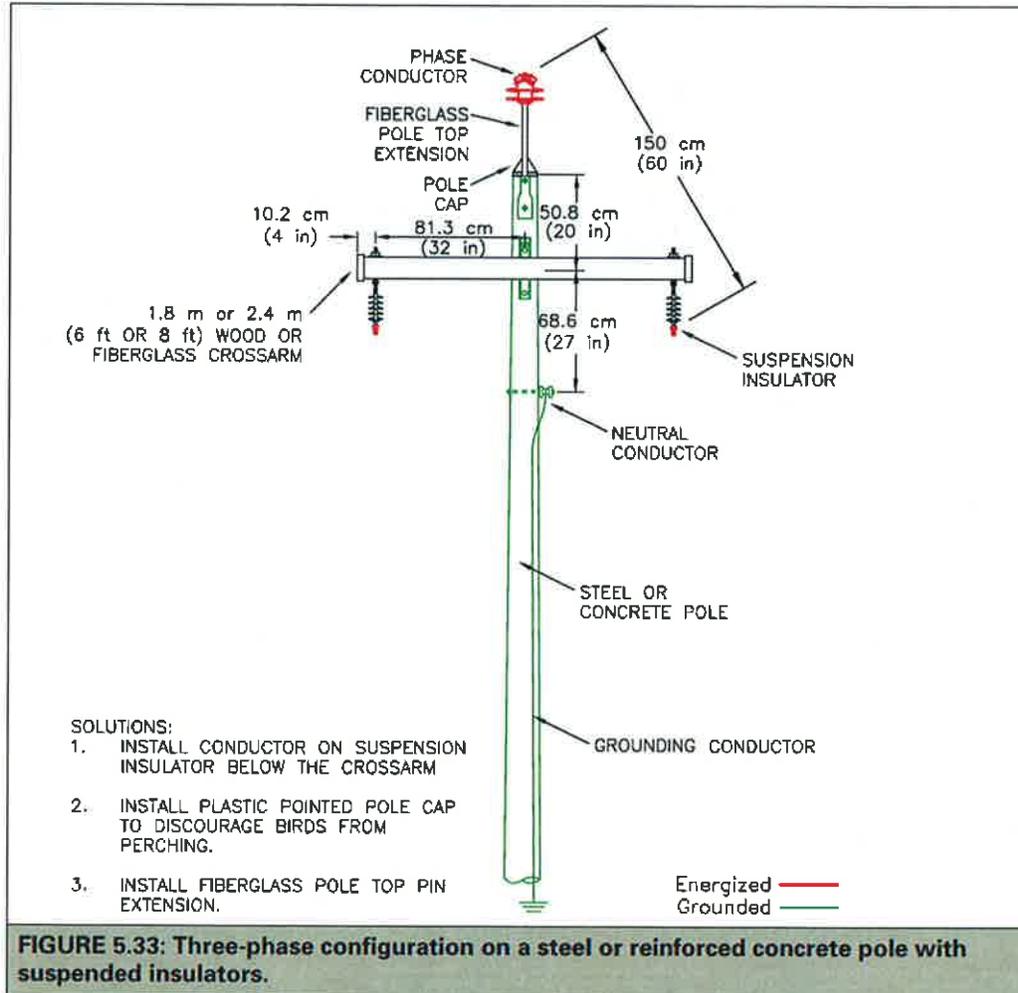
FIGURE 5.33: Three-phase configuration on a steel or reinforced concrete pole with suspended insulators.

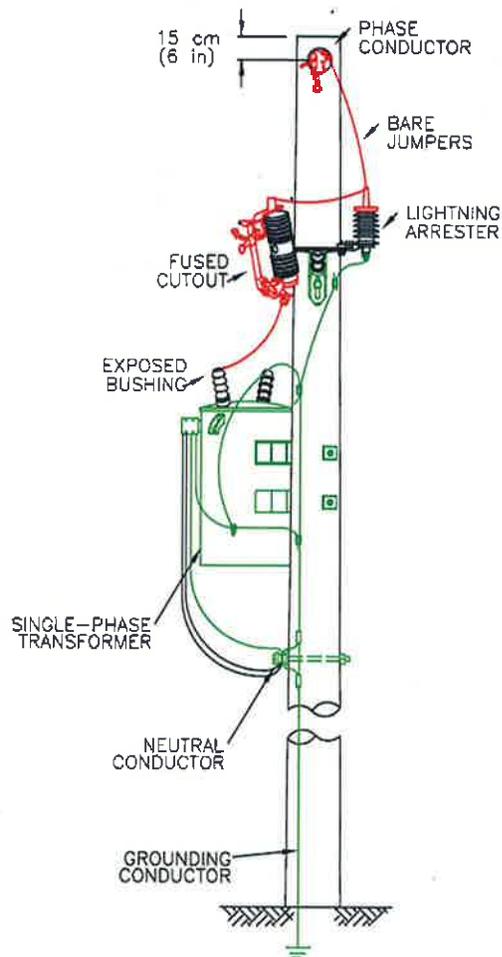
PROBLEM:
ELECTROCUTION HAZARD WHEN BIRD TOUCHES ENERGIZED JUMPERS OR EQUIPMENT AND GROUNDED HARDWARE OR GROUNDING CONDUCTOR SIMULTANEOUSLY.
