From: Kelly Fuller <kelly@kellyfuller.net>
Sent: Friday, March 07, 2014 4:54 PM
To: CNFMSUP
Subject: SDG&E Master Special Use Permit (POC Comment Attachments, 2 of 2)
Attachments: POC_Footnote12b_2006_APLIC_Guidelines.pdf

Suggested Practices for Avian Protection On Power Lines: The State of the Art in 2006

PIER FINAL PROJECT REPORT CEC-500-2006-022

Avian
Power
Line
Interaction
Committee

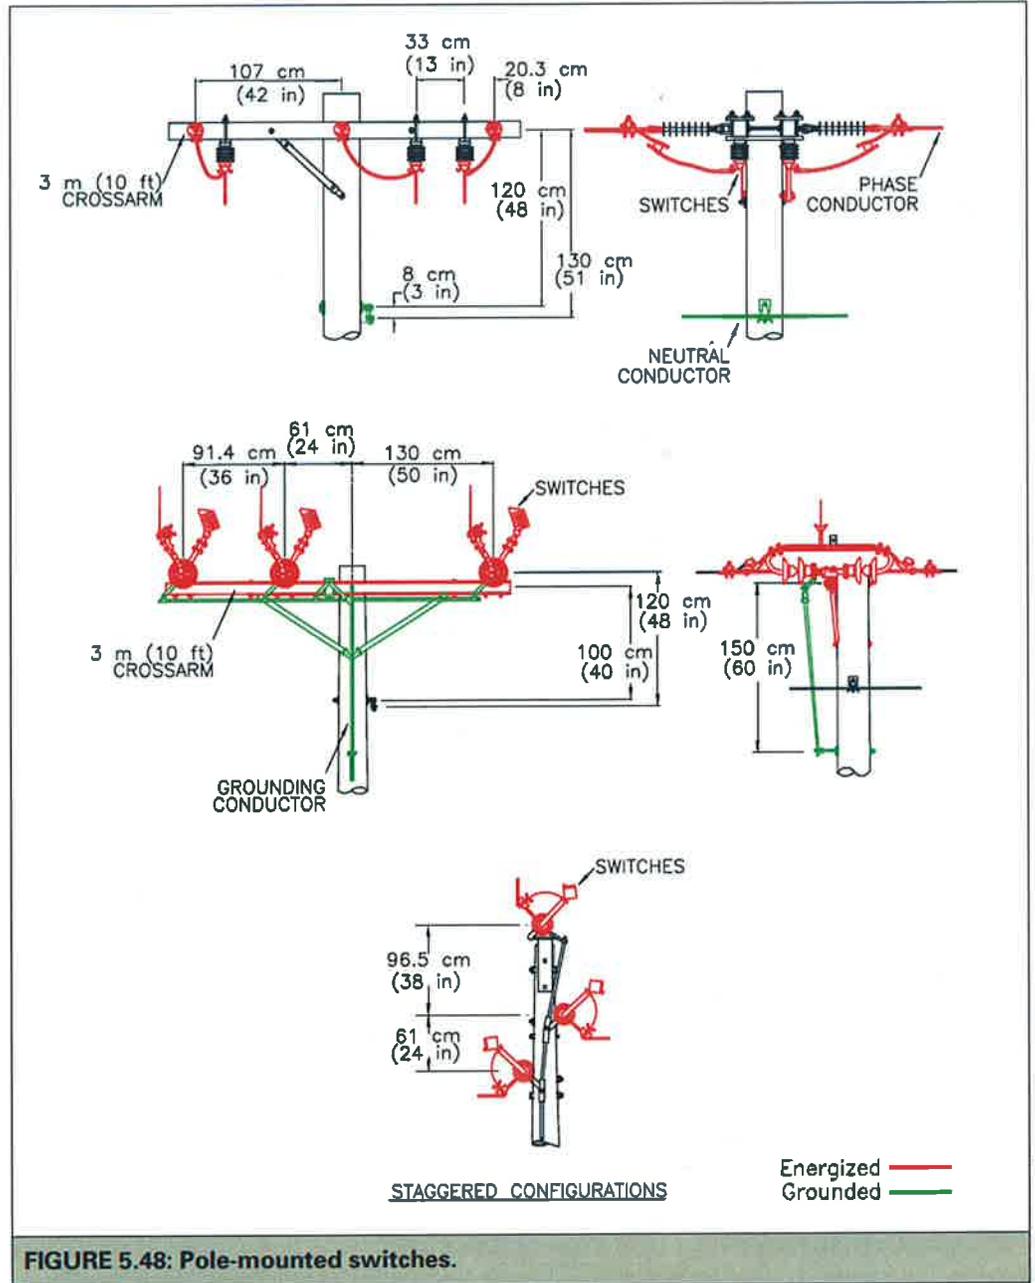
FIGURE 5.48: Pole-mounted switches.

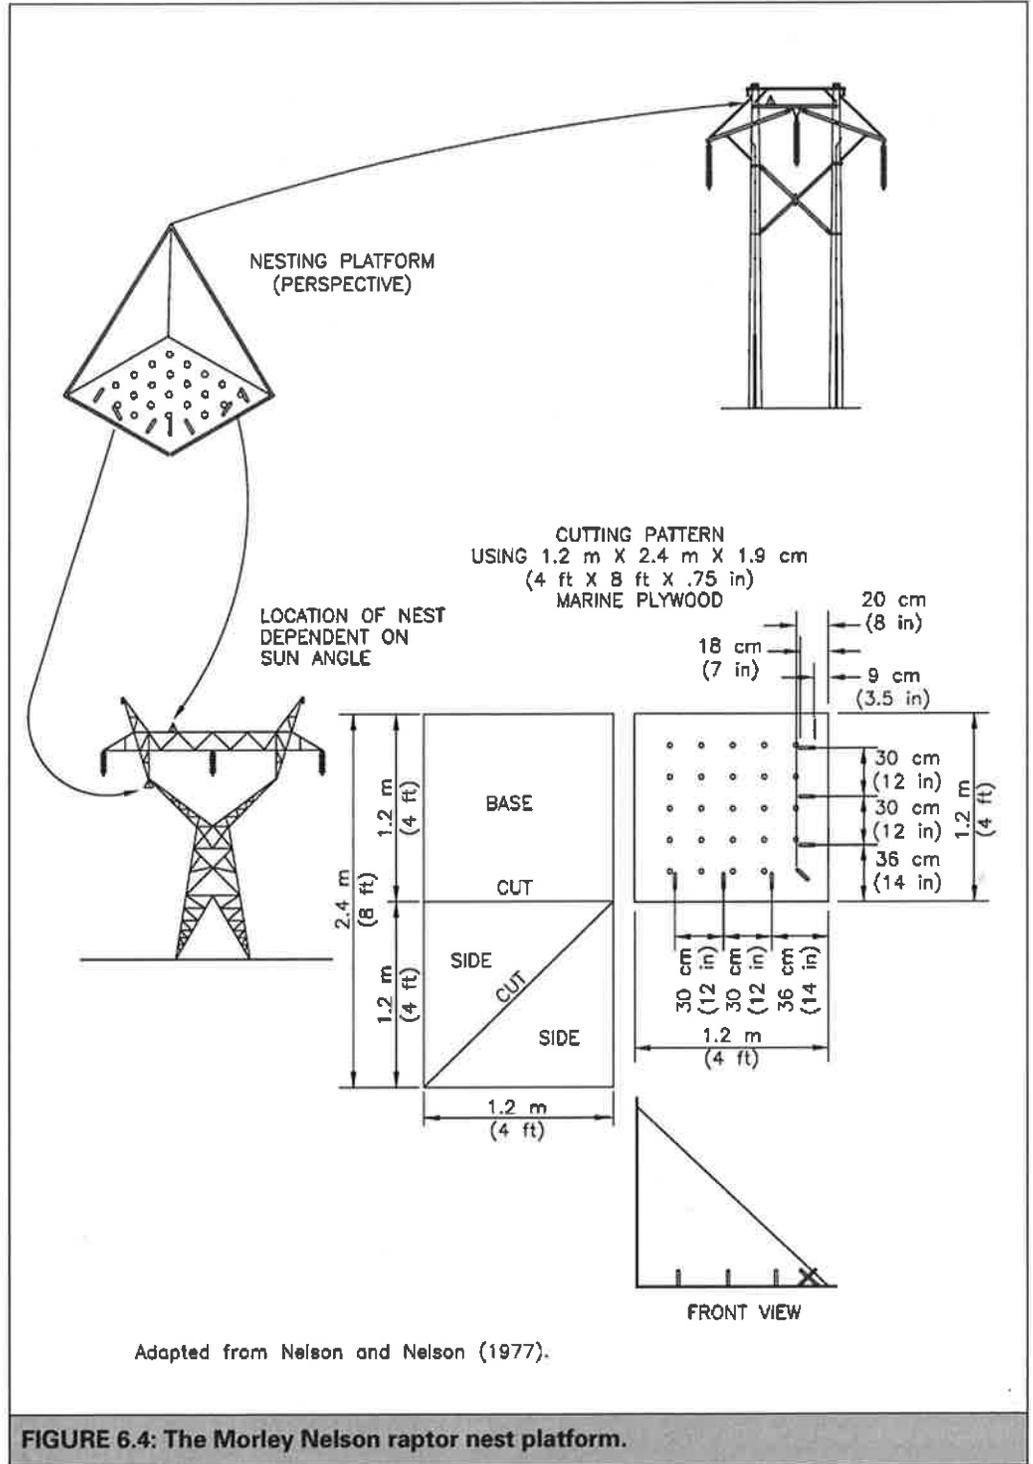
FIGURE 6.4: The Morley Nelson raptor nest platform.

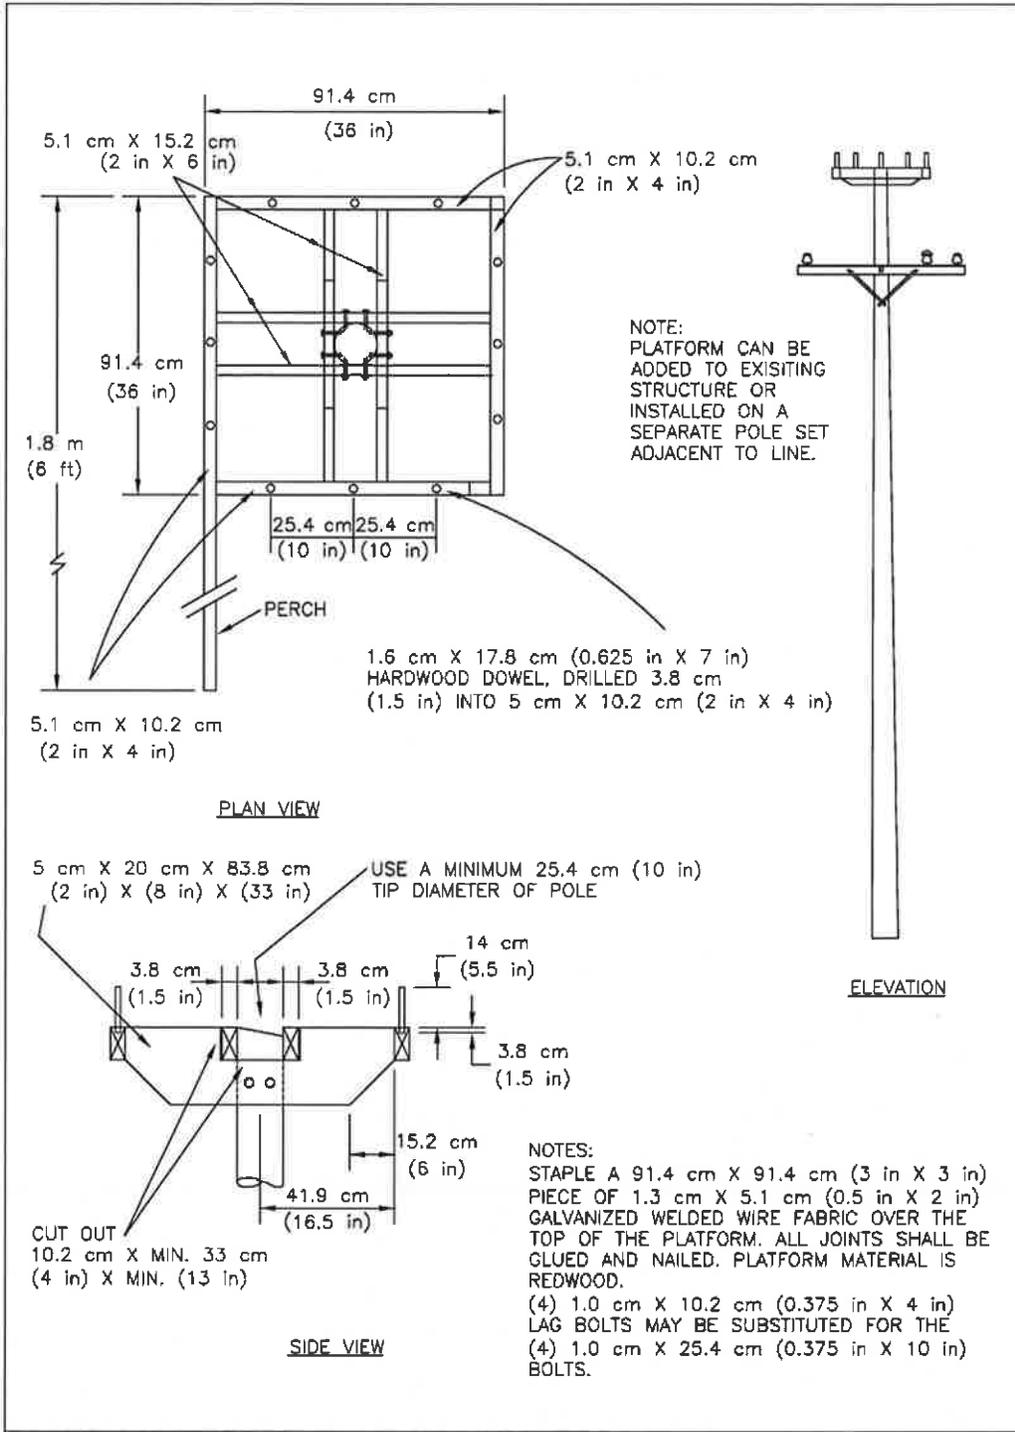
Figure 6.12: Osprey nest platform details (Idaho Power Company, PacifiCorp).

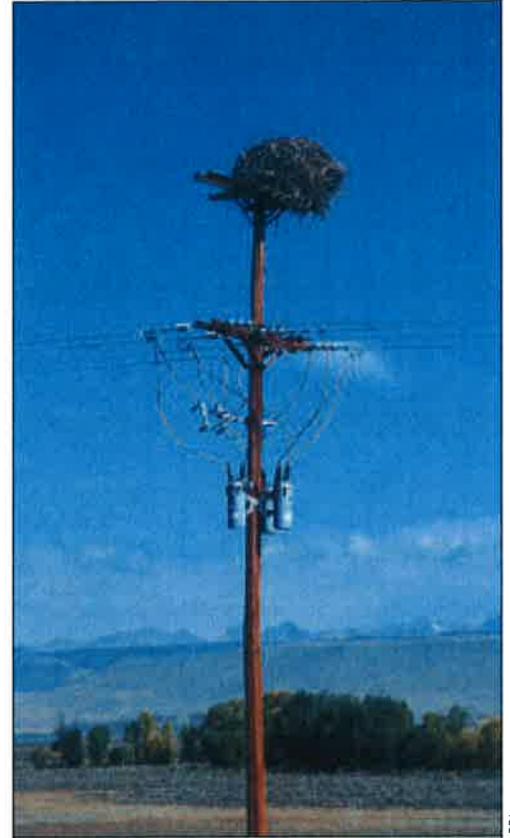
FIGURE 6.16: Osprey nest in Wyoming atop double dead-end pole. Nesting material that may drop onto the conductors or equipment poses fire, outage, and equipment damage risks.

prey remains dropping onto conductors or energized equipment (Figure 6.16). Installing a platform on a nearby non-energized pole reduces these risks.

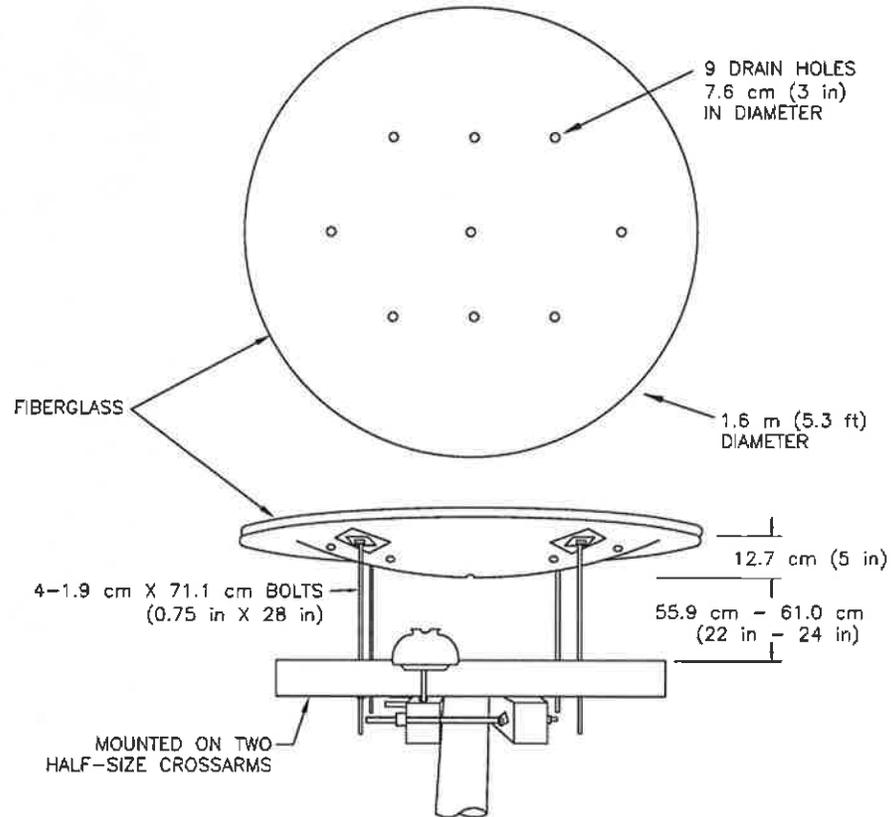
NOTE:
RAISING PLATFORM ABOVE ENERGIZED CONDUCTORS PREVENTS INJURIES TO OSPREYS AND ALSO REDUCES OUTAGES AND EQUIPMENT DAMAGE. PLATFORM SHOULD BE LARGE ENOUGH TO COVER ANY ENERGIZED EQUIPMENT AND PREVENT CONTACT WITH NEST MATERIALS.

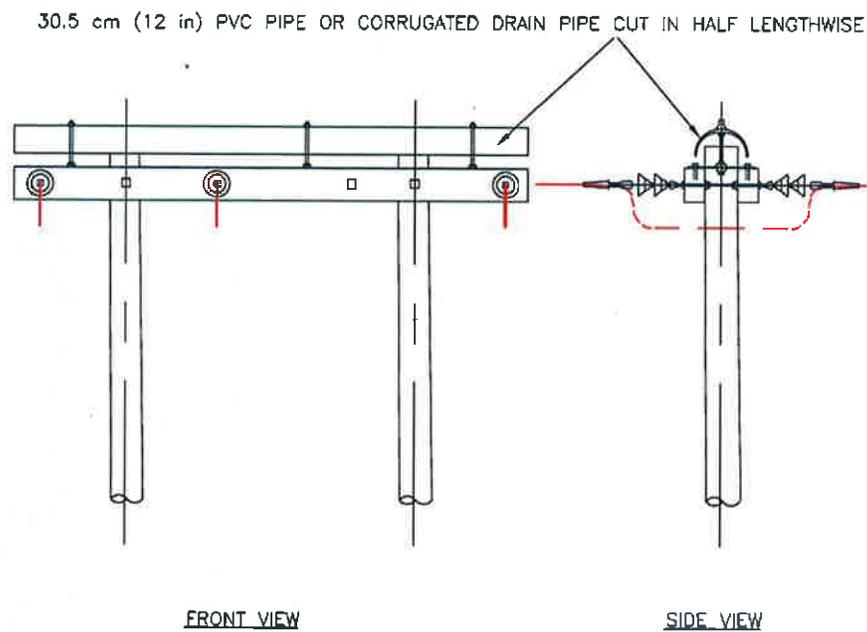
FIGURE 6.21: Nesting discourager (PacifiCorp).
