# CALIFORNIA PUBLIC UTILITIES COMMISSION

### Incident Investigation Report

**Incident Number:** G 20200801-3091

**Utility:** Southern California Gas Company (SoCalGas)

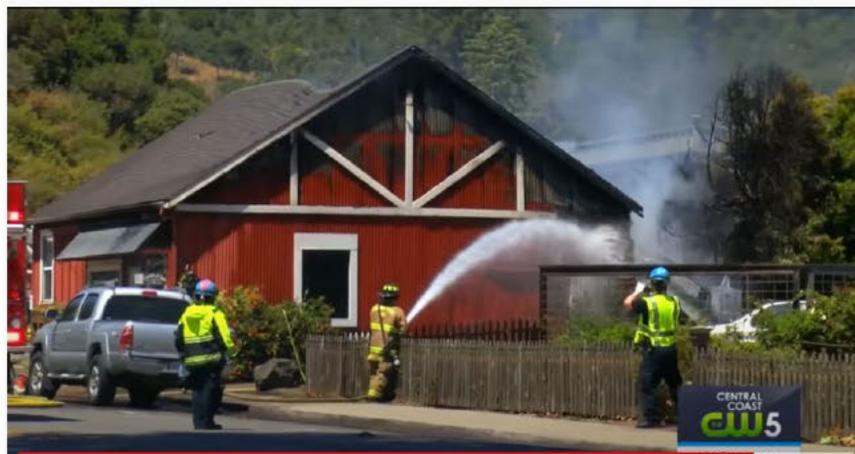
FIRE SUPPRESSION August 01, 2020

Satellite photos of the incident site shows the MSA located at 'A Matter of Taste' store building wall in a corner of the parking lot and cinderblock property wall adjacent to an alley. Photos at the time of the incident fire suppression show a pickup truck resting partially on the business structure wall, on top of the protecting bollards and MSA, with the front wheels hanging over into the alley. The SoCalGas final reports the vehicle lost control and crashed into the left corner of the business. The impact of the crash, bent the bollards protecting the MSA, breaking a nipple downstream of the service valve, thus causing a gas release and ignition. Photos of the incident site shortly after occurrence corroborate the SoCalGas report.

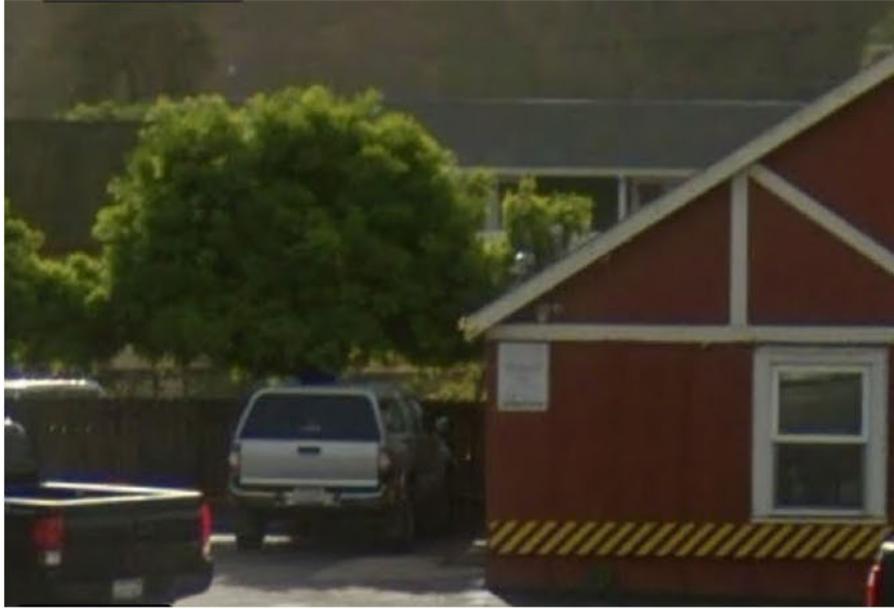
PRIOR TO FIRE – View from Main Street toward ‘A Matter of Taste’ parking lot

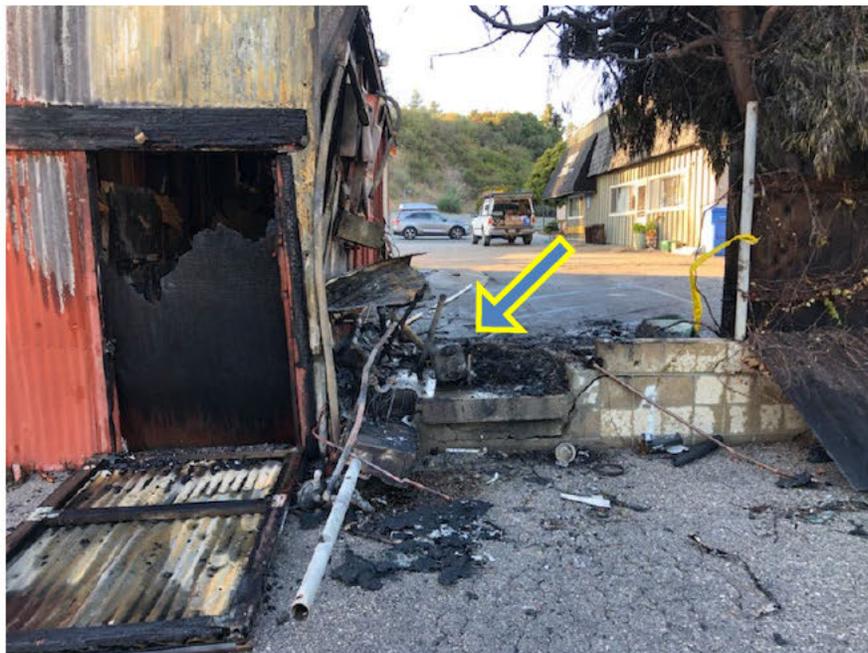
Looking from Museum Alley toward Main Street. Arrow to damaged MSA

The impact of the crash bent the bollards protecting the MSA, breaking a nipple downstream of the service valve, resulting in gas release and ignition.
