**SUBJECT: General Order (GO) 167-C Audit of North Sky River,
Audit Number GA2025-13NS**

**CPUC AUDIT FINDINGS OF
NORTH SKY RIVER
OCTOBER 27 – OCTOBER 30, 2025**

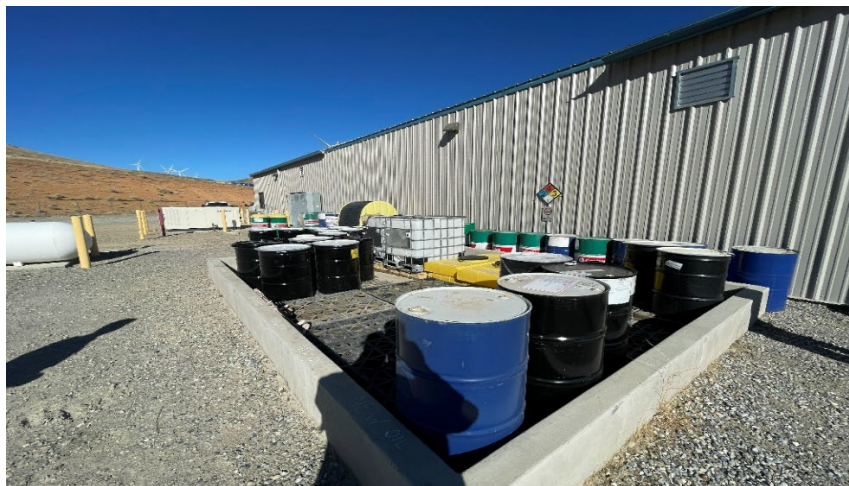
ESRB inspectors observed that the hazardous waste collection area behind the main operations building contained several empty oil drums that were not clearly marked as empty. Proper labeling is essential to maintain compliance and ensure that any material is handled with the care it needs for safety. Drums and storage containers must be clearly marked to ensure any approaching personnel can clearly identify if the drum is empty or not. It is also essential that any approaching personnel can identify the materials enclosed in full drums and can understand the risks associated with it.

Figure 1: Hazardous waste collection area with improperly marked empty drums.

NSR personnel labeled the drums during the audit, remedying this finding while ESRB inspectors were on site. Although NSR personnel labeled the drums during the audit, the lack of initial labeling could result in improper storage practices, confusion regarding container status, or mismanagement of hazardous waste materials. NSR must ensure that all containers in the hazardous waste collection area, including empty oil drums, are clearly labeled to indicate their contents or confirm that they are empty. NSR must also implement a process to routinely verify stored barrels are properly labeled.

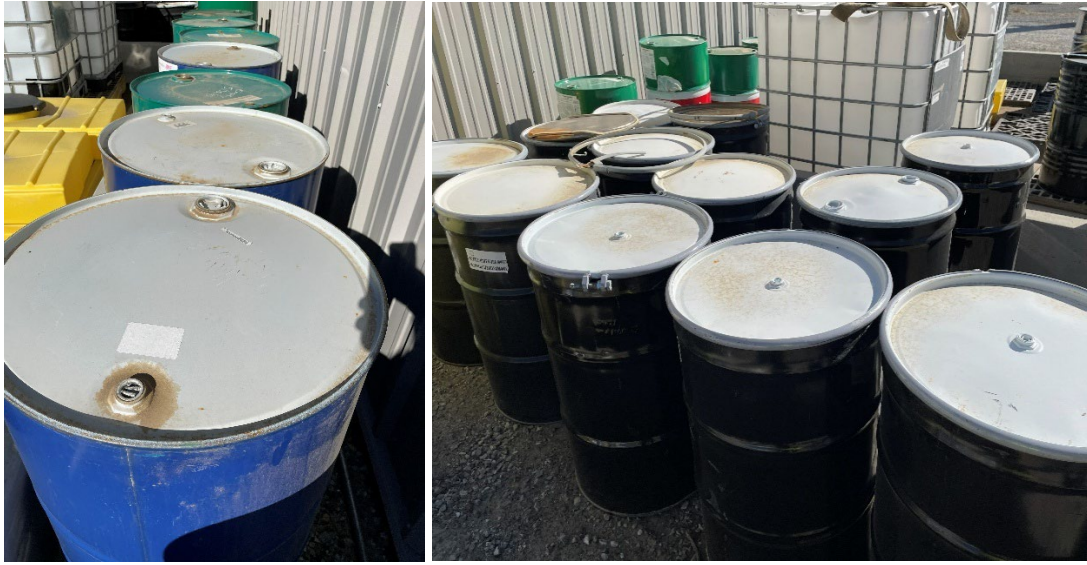
Figure 2: Improperly marked empty drums.

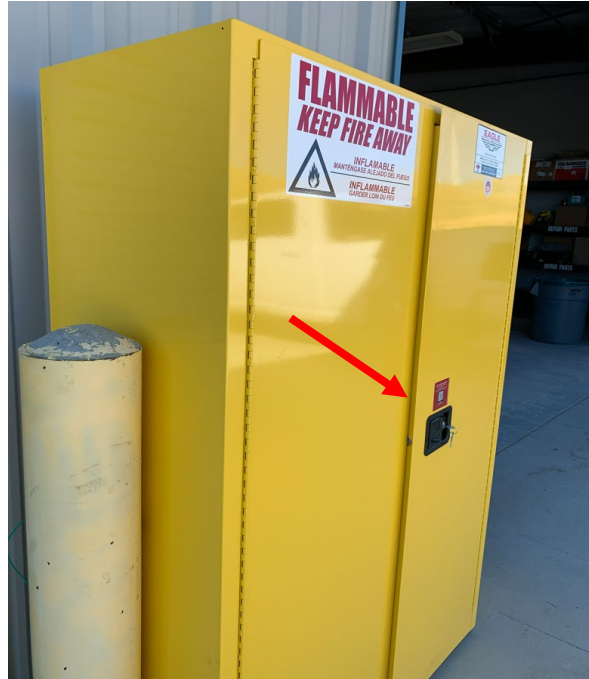
During the audit, ESRB inspectors observed that the flammable materials storage cabinet located outside the operations building did not fully latch when the self-closing mechanism was engaged. A cabinet that does not properly latch fails to meet NFPA requirements and may not provide the intended level of fire protection. After ESRB inspectors identified the issue, NSR personnel corrected the deficiency while inspectors were on site, and the cabinet was observed to fully latch upon reinspection.

Figure 3: Flammable storage cabinet not latching.

NSR must ensure that the cabinet’s self-closing and self-latching mechanism remain functional. NSR must also implement routine inspections of all flammable materials storage cabinets to ensure continued compliance with NFPA 1 Section 60.1.2.23(d). NSR must submit documentation describing the method that will be used to perform and document these inspections to ESRB for review and verification.

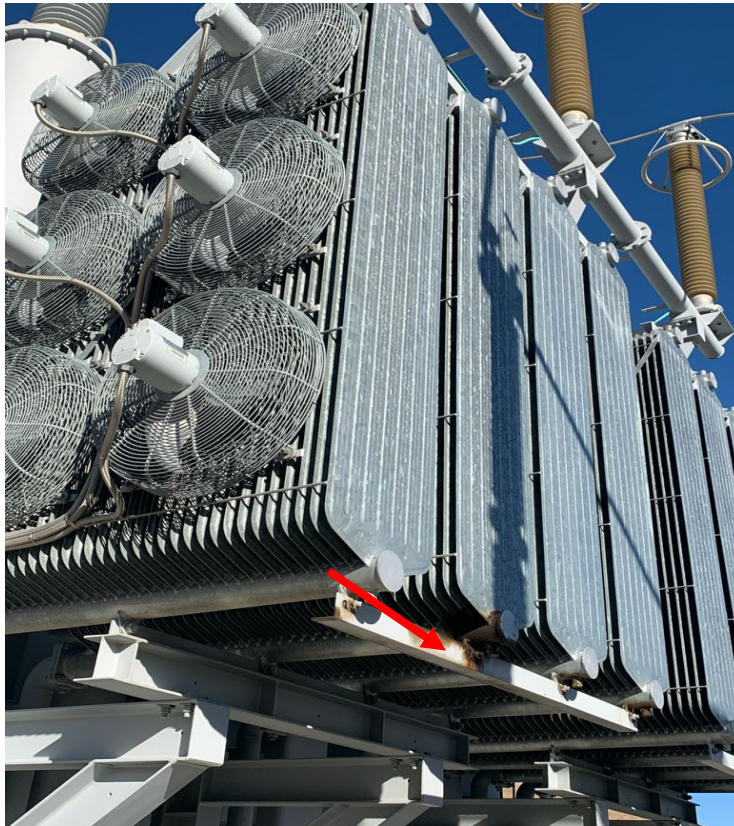
During the site inspection, ESRB inspectors observed signs of an oil leak on the GSU

transformer located at the NSR substation. NSR staff did not provide documentation indicating that the leak had been previously identified, tracked in the work order management system, or evaluated for corrective action. Oil leaks on HV equipment must be promptly investigated and tracked, as they can indicate issues that may affect transformer reliability.

Figure 4: Evidence of oil leak on the substation GSU transformer.

NSR must properly track this GSU oil leak by creating a work order that documents the condition, the investigation performed, and any corrective actions required. NSR must also develop and submit a plan with a timeline describing how and when the leak will be evaluated, repaired, or otherwise addressed. NSR must provide ESRB with the work order and the corrective action plan for review and verification.

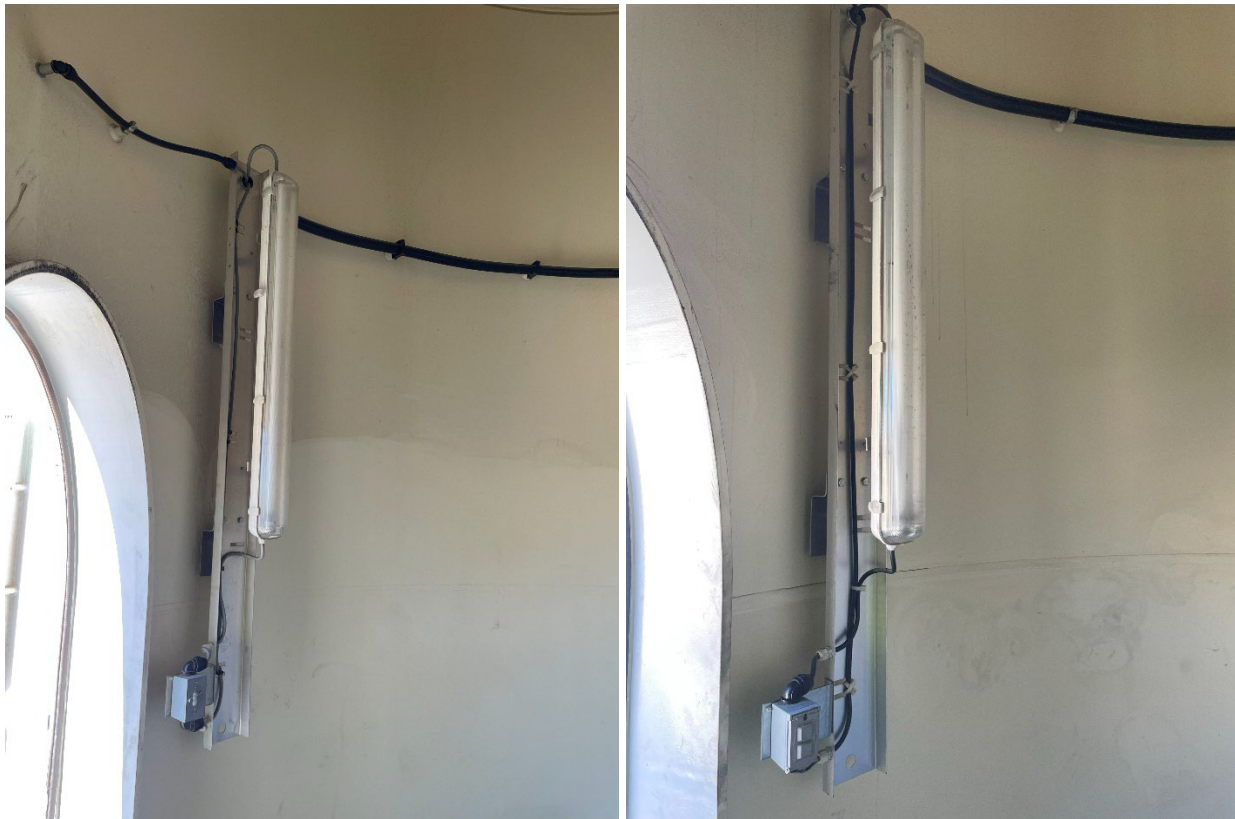
During the audit, ESRB inspectors observed that multiple NSR wind turbines had non-operational interior lighting in the lower portion of several towers. Proper interior lighting is essential for safe access, egress, and performance of maintenance activities within turbine towers. NSR must inspect all turbines for lighting deficiencies, repair or replace non-operational interior lights, and document the corrective actions taken. NSR must also incorporate turbine lighting inspections into its preventive maintenance program to ensure ongoing compliance with safety and maintenance standards.

Figure 5: Non-operational lighting on turbines 1-0056 & 1-0064.

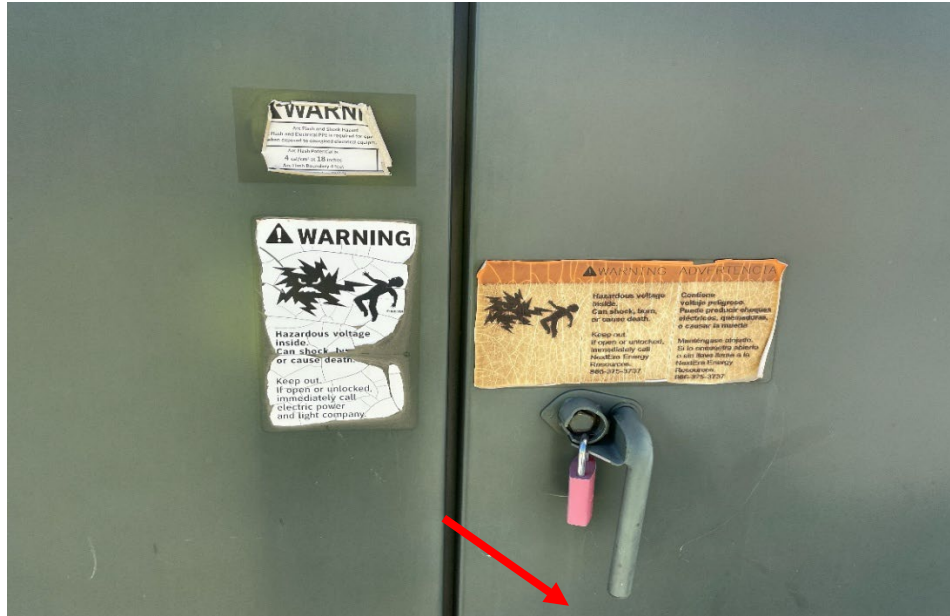
ESRB inspectors observed that multiple NSR turbine pad mount transformers had arc flash labels that were sun faded and unreadable. Clear and legible arc flash labels are essential for hazard communication and for ensuring personnel can accurately assess electrical hazards prior to performing work. Faded or damaged labels reduce the visibility of critical safety information

Figure 7: Sun faded and damaged arc flash label on pad mounted transformer 1-0064.

NSR began replacing the damaged labels during the audit with appropriate, durable arc-flash stickers. NSR must complete the replacement of all degraded labels, ensure that all pad mount transformers have fully legible and compliant arc flash labeling, and incorporate periodic verification of label condition into its preventive maintenance program.

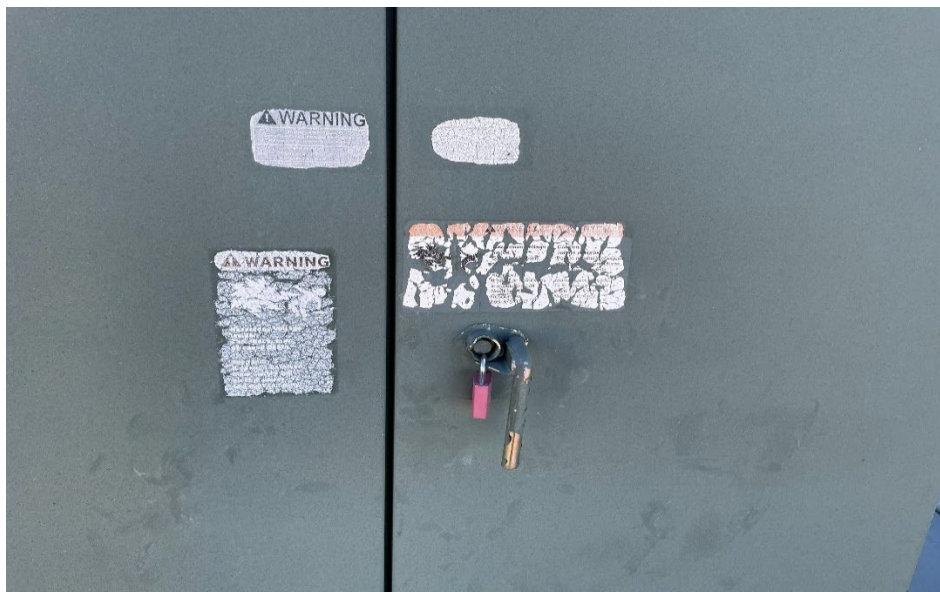
Figure 8: Sun faded and damaged arc flash label on pad mounted transformer 1-0056.

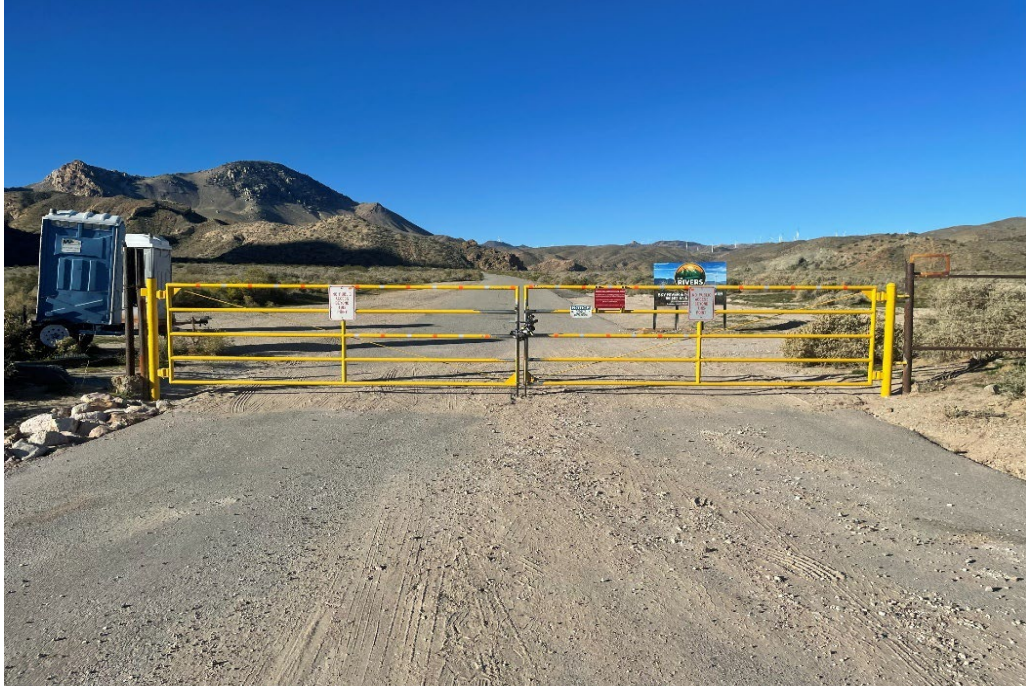
ESRB inspectors observed that NFPA 704 hazard placards were not posted at the main NSR site entrance, the auxiliary second entrance gate, and at the gate leading to the Operations and Maintenance (O&M) building. NFPA 704 hazard placards must be visible when visitors and first responders enter the site so that the dangers present are known before they are approached. NSR must install compliant NFPA 704 placards at the sites entrance, the auxiliary second entrance gate, and at the gate leading to the O&M building.

Figure 9: Main entrance gate into the site.

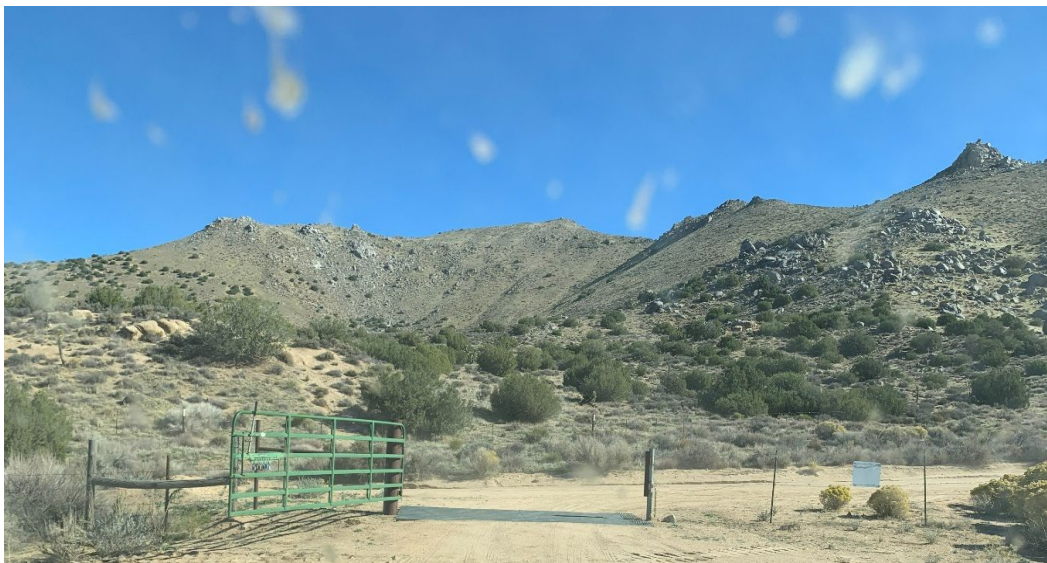
Figure 10: Auxiliary entrance into the site.
