PUBLIC UTILITIES COMMISSION

SA2025-1423

SUBJECT: Electric Substation Audit of PG&E Concord Headquarters

CPUC SUBSTATION AUDIT FINDINGS
PG&E Concord Headquarters
November 3 – 7, 2025

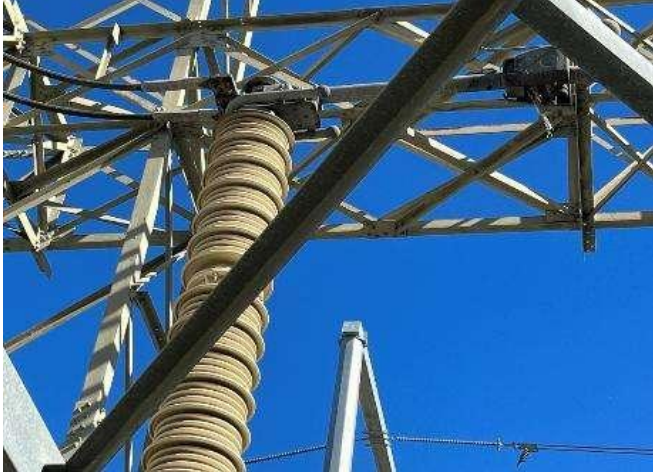
1.7 Bird Nest Near Circuit Breaker 400 Bus Work, Existing Station Bird's Nest LC Tag#131966674

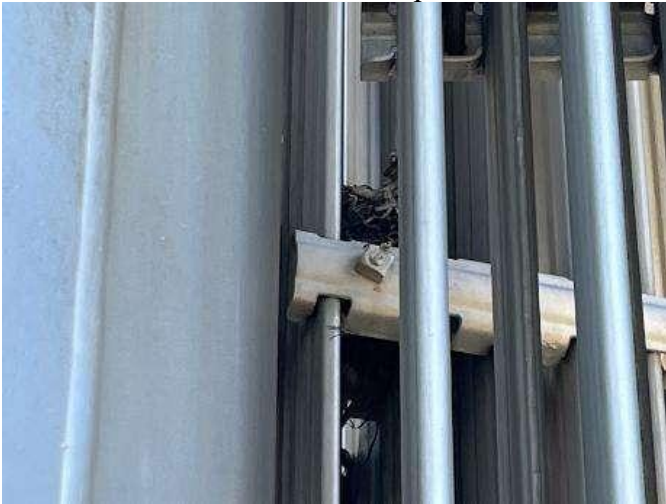
2.1 Transformer Bank 1A Birds/Wasp Nest in Radiator Existing LC Tag#131956890

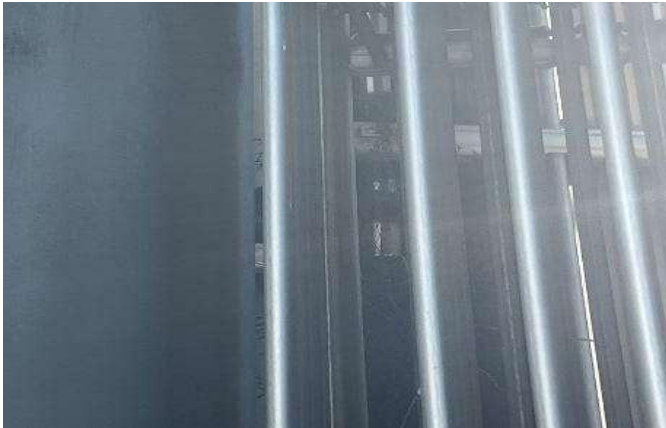
2.2 Transformer Bank 1B Birds Nest in Radiator Existing LC Tag#131957160

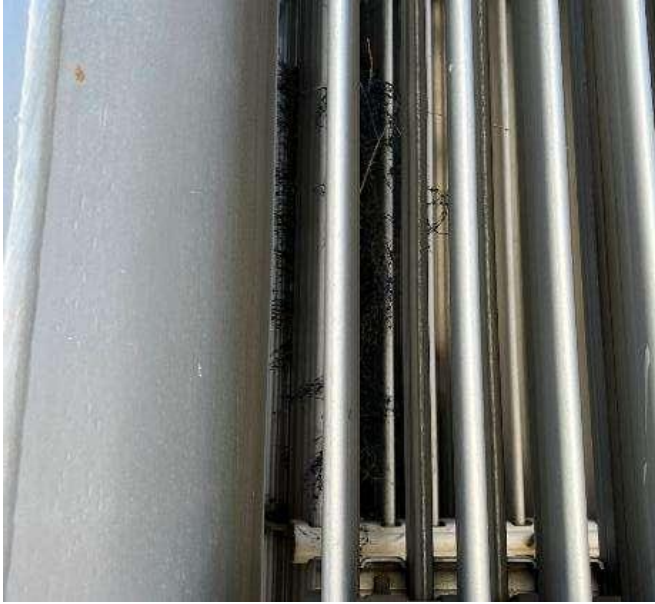
2.3 Transformer Bank 1C Birds Nest in Radiator Existing LC Tag#131957859

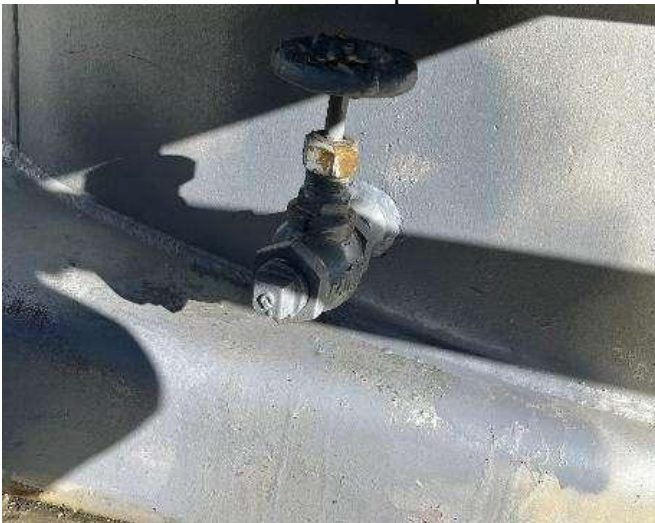
2.4 Transformer Bank 1C Oil Weep Sample Valve Nut Existing LC Tag #131971833

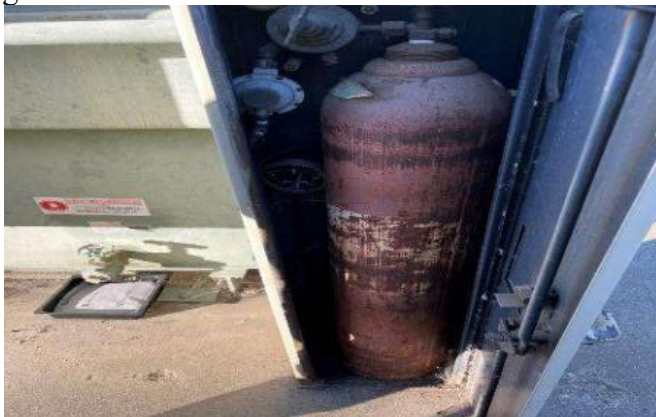
3.2 Transformer Bank 1, Nitrogen Bottle No Straps, Inside Enclosure Existing LC Tag#130942608

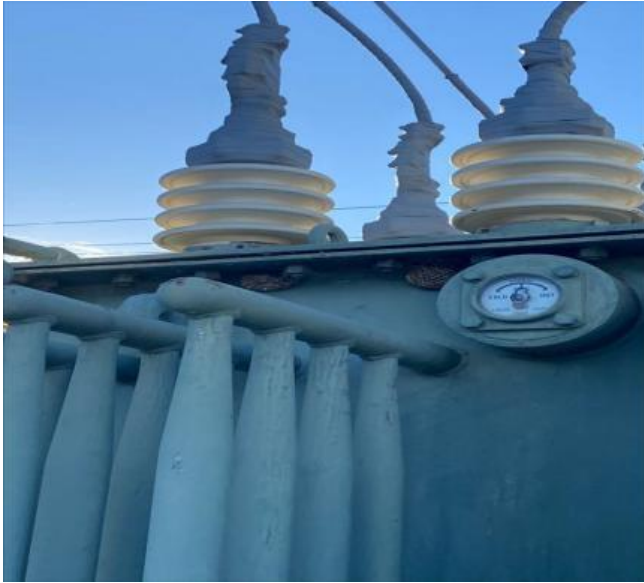
3.3 Voltage Regulator One Wasp Nest - Fixed In Field

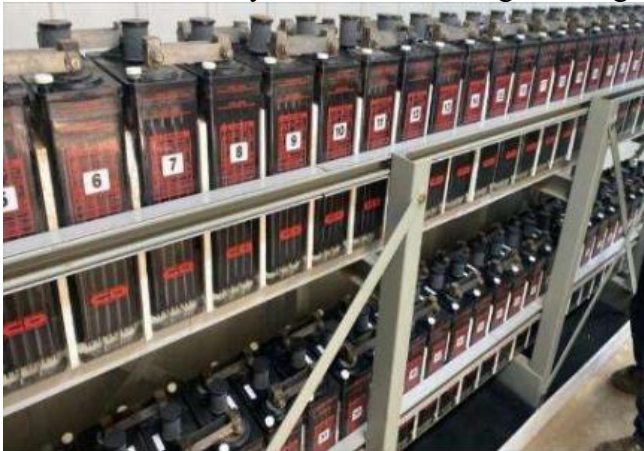
4.1 Fan over Battery Rack Not Working Existing LC Tag#131940536

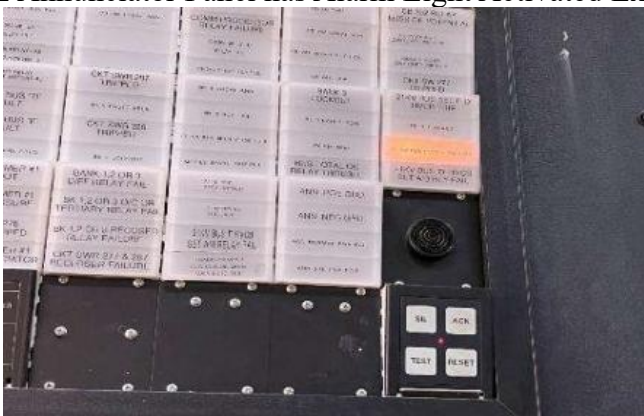
4.2 Annunciator Panel has Alarm Light Activated Existing Capitol Order 74062480

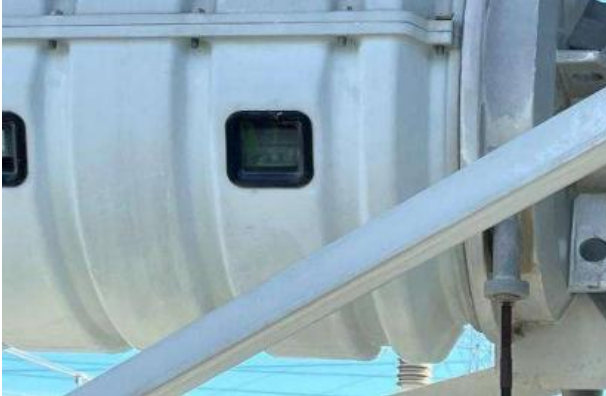
5.1 Circuit Breaker 282 Faded Counter Existing LC Tag#131777490

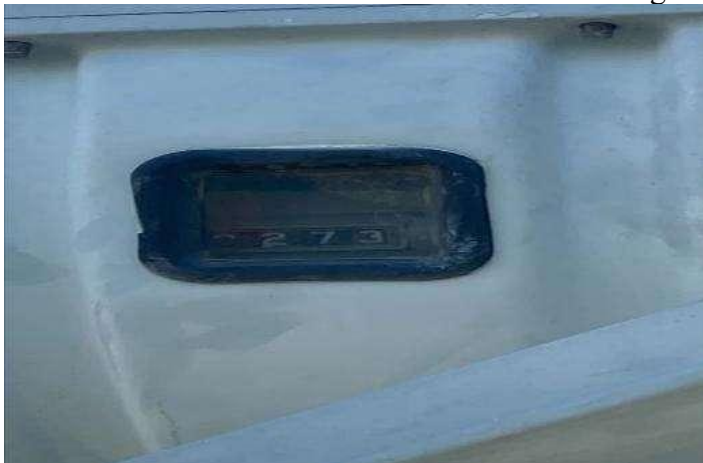
5.2 Circuit Breaker 272 Faded Counter Existing LC Tag#131777449

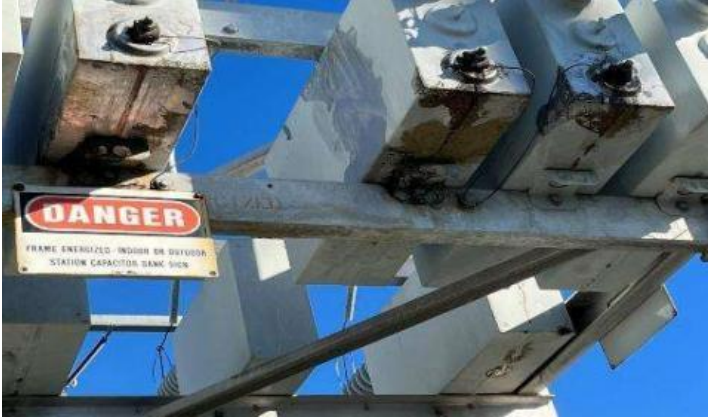
5.3 Capacitor Bank 1 Oil Weep Existing LC Tag #131974721

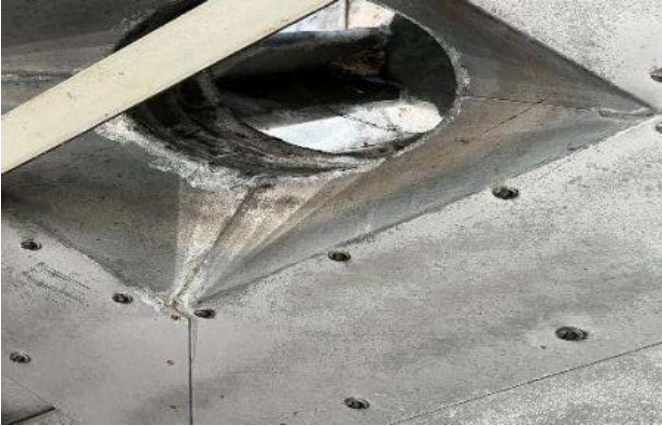
6.1 Observation: No Obstruction to Trapping Hydrogen Gas, but Vent is Dirty with Cobwebs and Needs to Be Cleaned Existing LC Tag#131943938

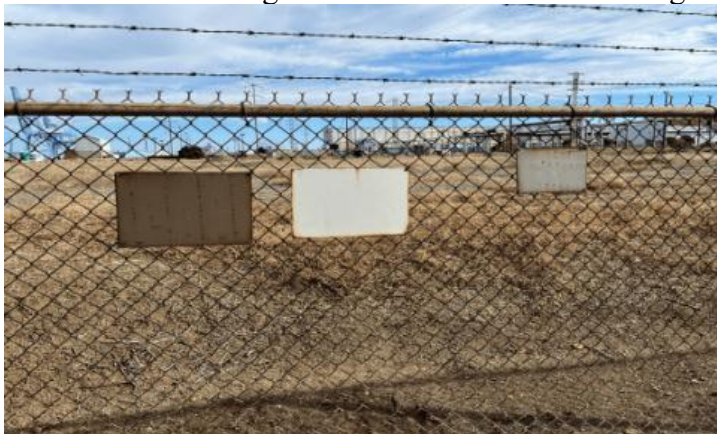
6.9 Perimeter Fence Signs Posted Inside Fence Existing LC Tag#131942491

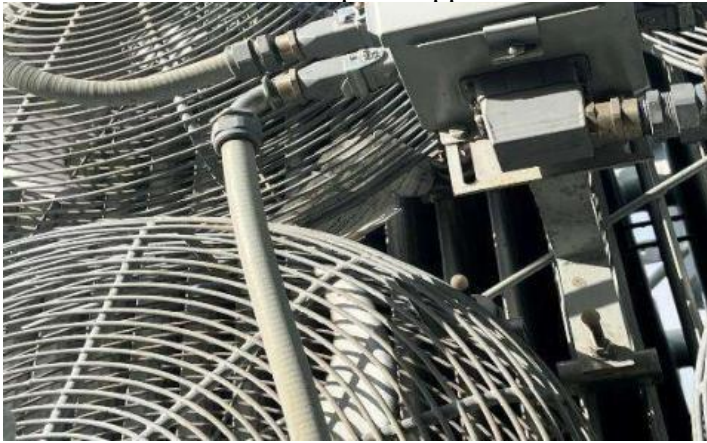
7.1 Transformer Bank 1 Paper Trapped Inside Fan – Fixed in Field

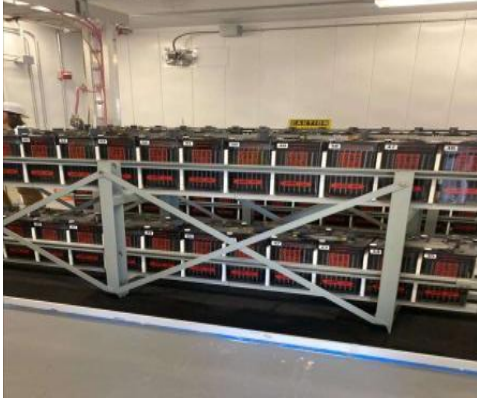
8.2 Battery Room Fan – Need to Perform Demonstration That Fan Works

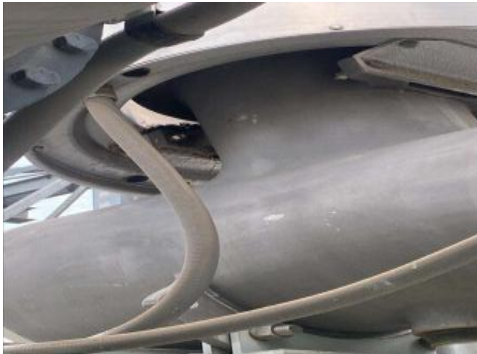
8.3 Circuit Breaker 2052 Birds Nest Existing Tag for Station Birds Nests LC Tag#131966507

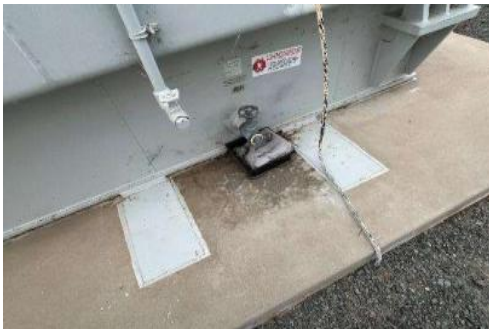
8.4 Transformer Bank 1 Oil Leak Mitigation Existing LC Tag#131966508

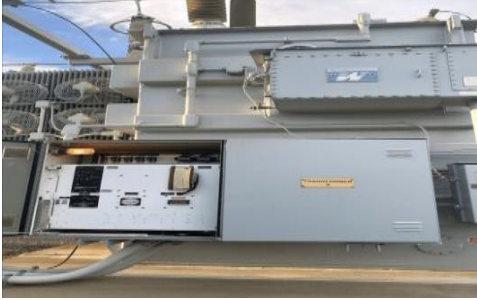
8.5 Transformer Bank 2 Fan Not Working Existing LC Tag#131966542, Oil Leak Mitigation Repair Existing LC Tag#131817786

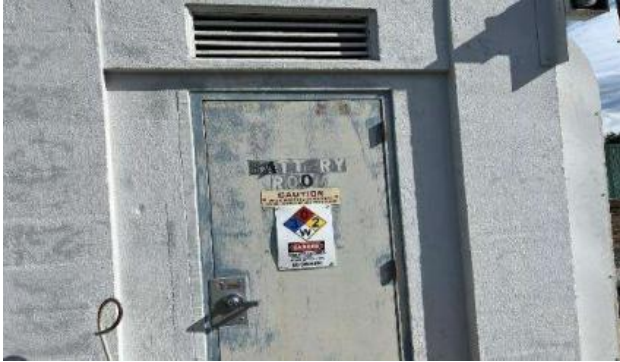
9.1 Battery Room Vent is Dirty and Needs Cleaning Existing LC Tag#131702284

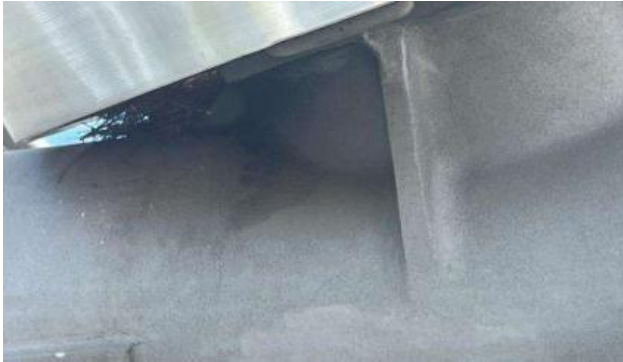
9.2 Circuit Breaker 112 Birds Nest - Substation Birds Nest Tag LC#131966347

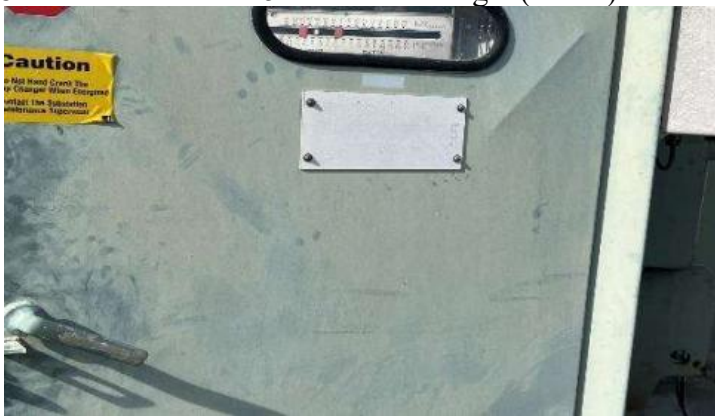
9.8 Transformer Bank 5 Need New Target (Name) Plate Existing LC Tag#131055763

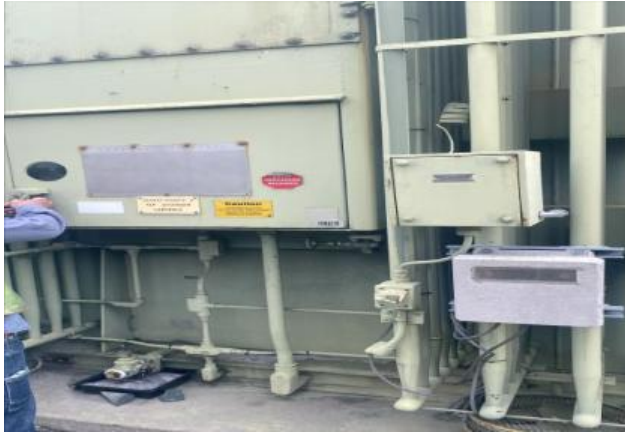
10.1 Transformer Bank 4 Oil Residue Cleanup Existing LC Tag#131945896

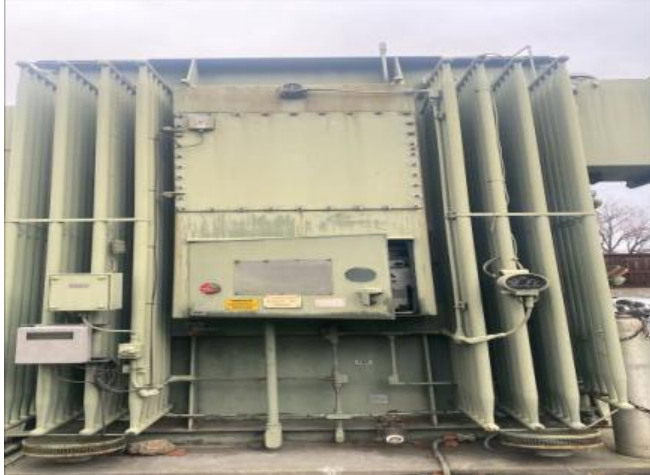
10.2 Transformer Bank 3 Oil Residue Cleanup Existing LC Tag#131945820

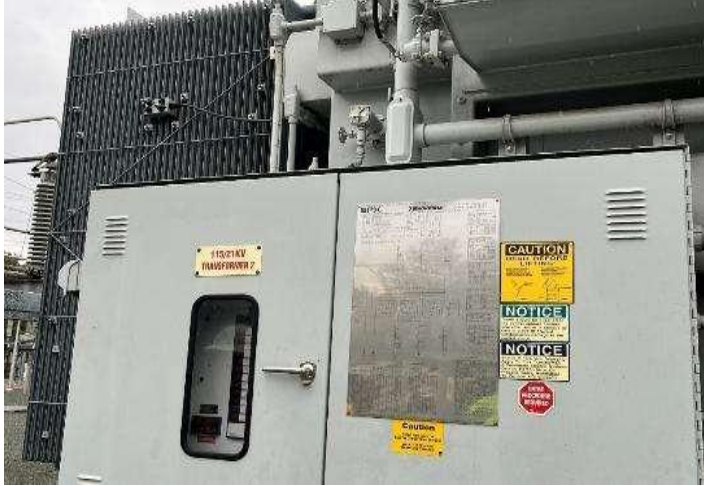
11.5 Transformer Bank 2 Oil Mitigation Residue Clean Up Existing LC Tag#131980258

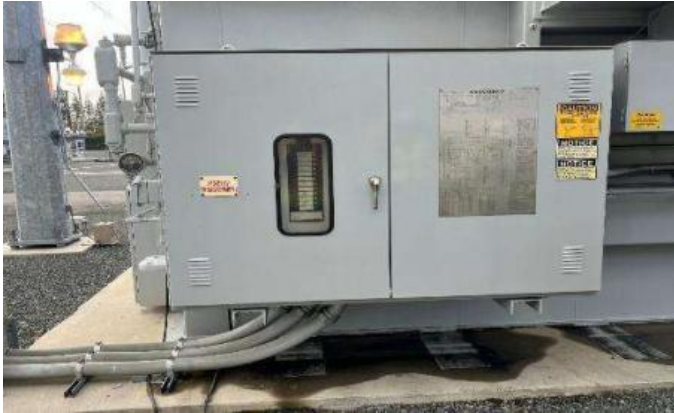
12.3 Transformer Bank 2 Oil Mitigation LC Tag#131984271

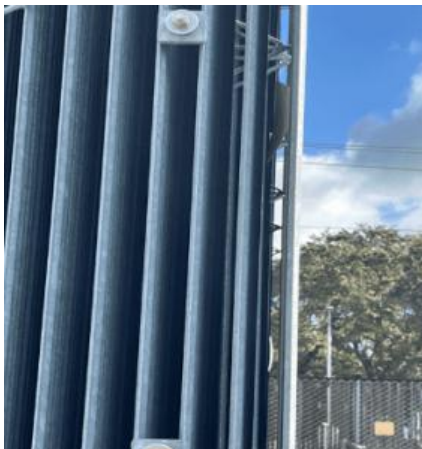
12.7 Transformer Bank 6 Paper Tag in Radiator - Fixed in Field, General Oil Mitigation Existing LC Tag#131966895, Active Oil Leak Top Fill Valve LC Tag#131899391

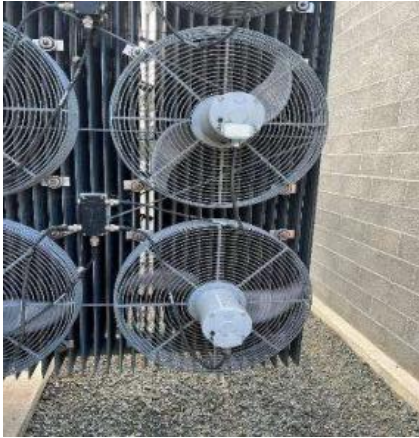
12.8 Transformer Bank 7 Broken Radiator Fans, Middle Right and Top, Bottom Right for Other Radiator, 3 Total Fans Out Existing LC Tag#131985642

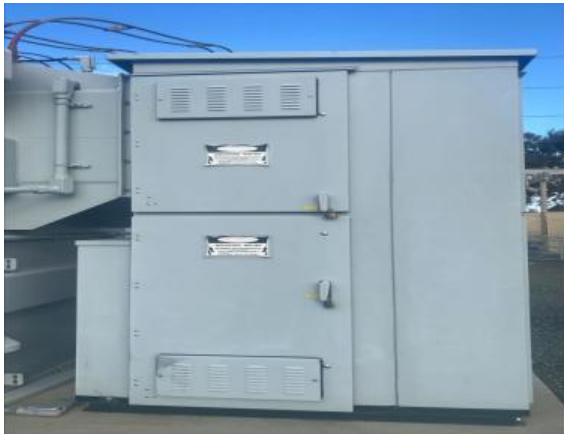
12.9 Transformer Bank 7 Faded High Voltage Labels on Bank 7 and Switch Gear Existing LC Tag#131967225

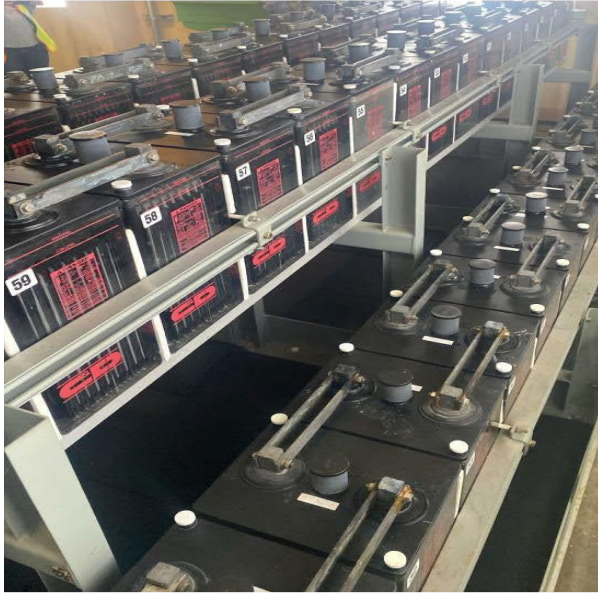
13.1 Observation: No Ventilation Fan for Batteries in Control Room. Have Windows but No Specific Ventilation Plan. Building is Large Enough with Volume to Allow Hydrogen to Disperse as Needed. LC to get engineering to look at venting situation. No current safety issue.

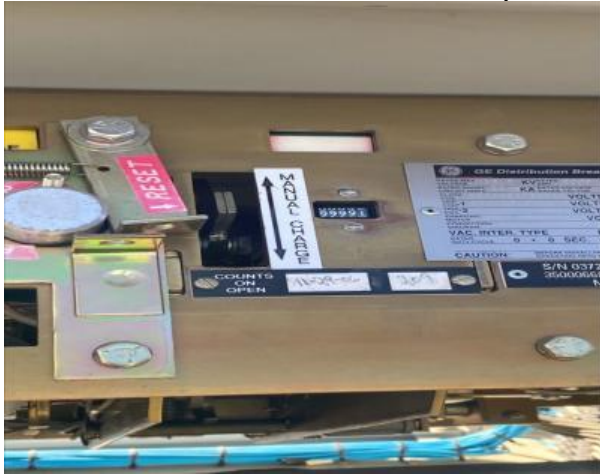
13.4 Circuit Breaker 1100 Faded Semaphore Will Add Sticker - Fixed in Field

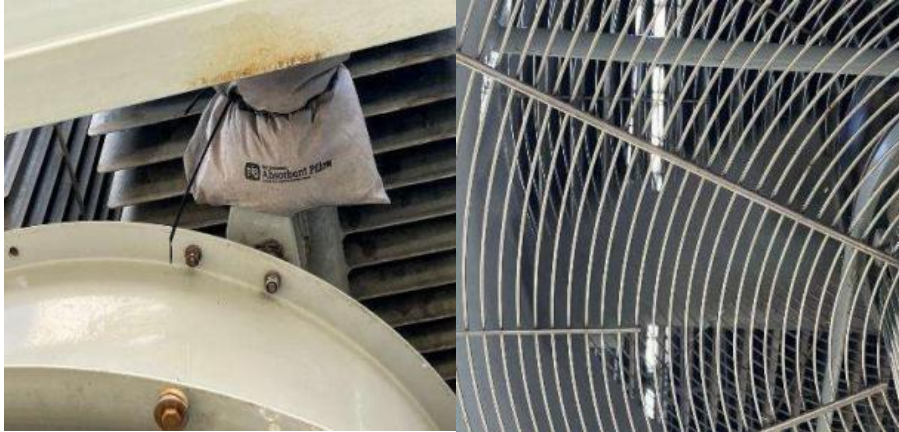
13.6 Transformer Bank 2 Oil Mitigation Tag LC 131984261, Small Piece of Tape in Radiator - Removing Fixed in Field, Birds Nest in Radiator

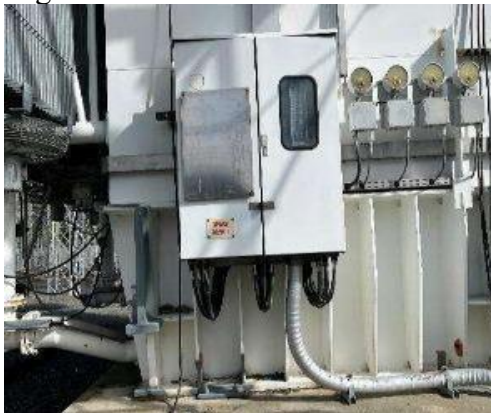
13.7 Transformer Bank 3 Oil Mitigation - A Phase Existing LC Tag#131984263, B Phase LC Tag#131984264, C Phase LC Tag#131984265, Spare LC Tag#131984269; Transformer Bank 3 Birds Nest For A Phase, B Phase, C Phase and Spare Are on Existing LC Tag#131984262. Photo Below Bank 3 Spare.

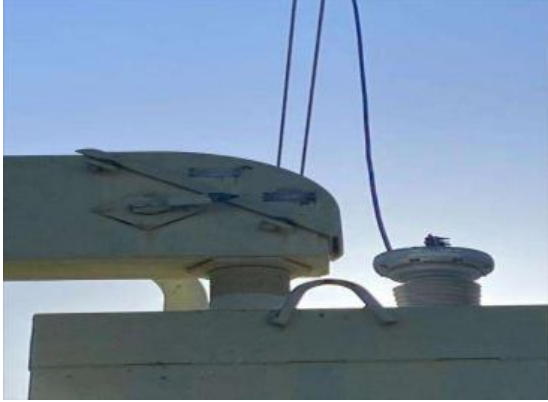
14.1 Circuit Breaker 282 Transmission Oil Breaker, Existing LC Tag #131966209 to Paint Breaker, Open Semaphore is Faded

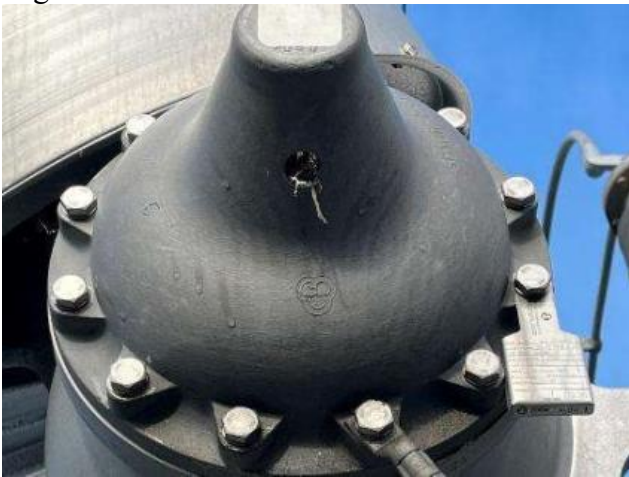
15.2 Circuit Breaker 1232 Birds Nest Existing LC Tag#131961605 and Station Birds Nest Existing LC Tag#131990024

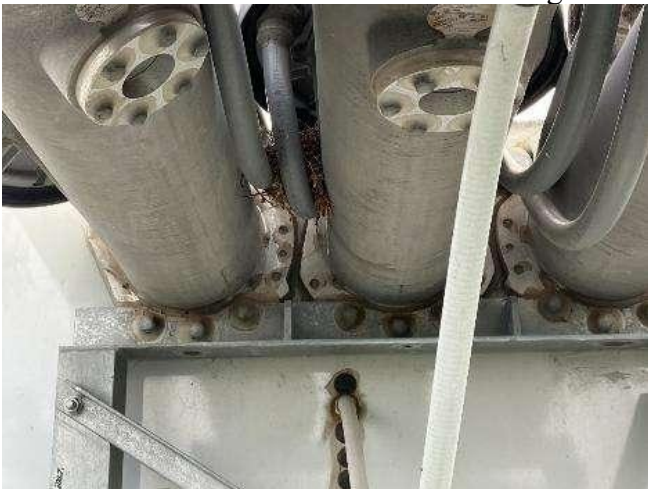
15.3 Circuit Breaker 72 Birds Nest Existing LC Tag#131964230

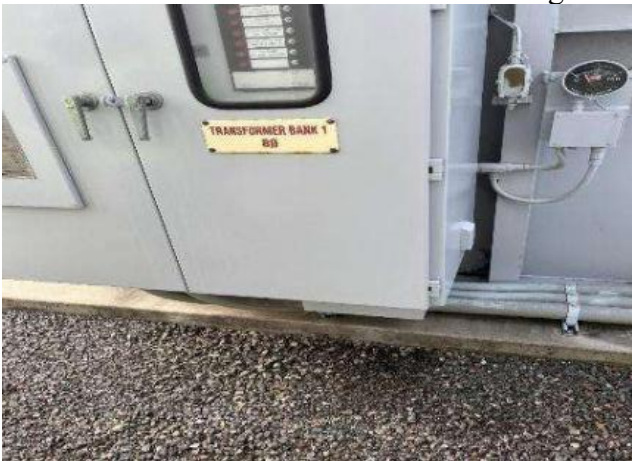
15.5 Transformer Bank 1 B Phase Oil Mitigation Existing LC Tag#131990028

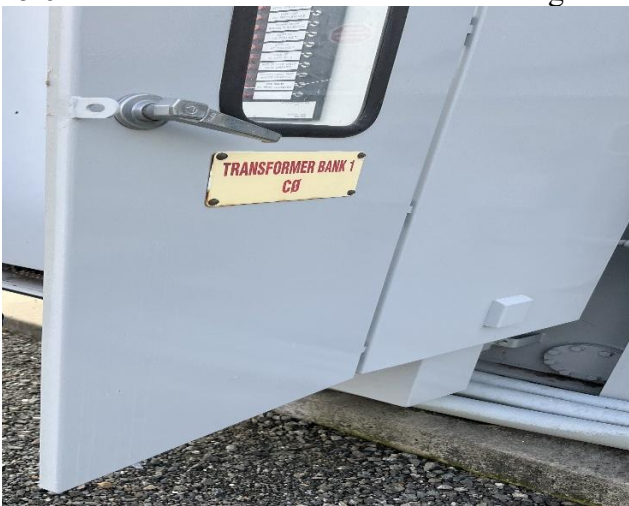
15.6 Transformer Bank 1 C Phase Oil Mitigation Existing LC Tag#131990131

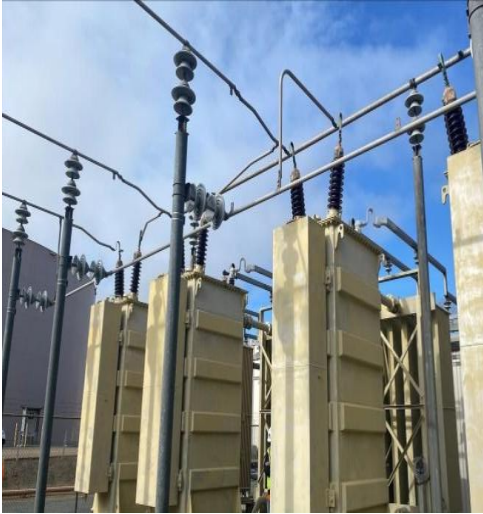
16.1 Transformer Bank 1 Needs to Be Painted Existing LC Tag#131953586

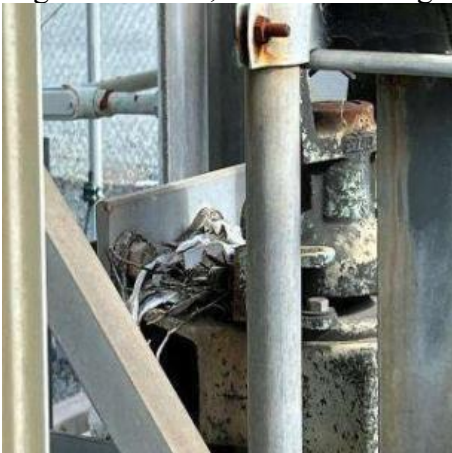
17.4 Transformer Bank 5 Birds Nests A Phase LC Tag#131956200, Near H1 Air Switch LC Tag#131956165, C Phase LC Tag#131990226. Photo Below is Birds Nest Near H1 Air Switch.

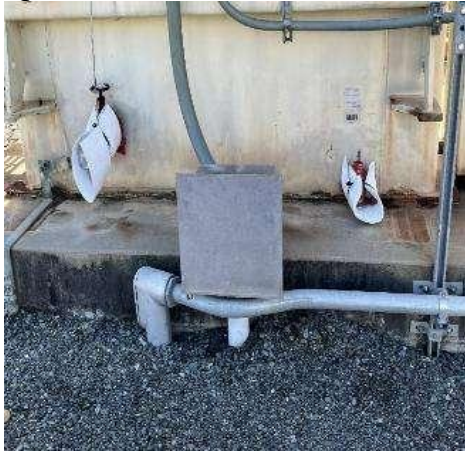
17.5 Transformer Bank 5 – Oil Mitigation A Phase LC Tag#131953638, B Phase LC Tag# 131953656, C Phase LC Tag#131990229, Spare LC Tag#131990356. Photo Below is Bank 5 Spare.

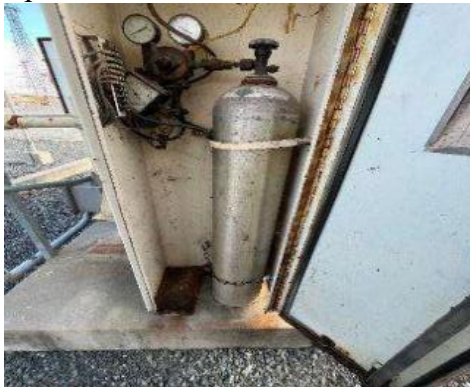
17.6 Nitrogen System - Operational But Old, Being Upgraded: A Phase LC Tag#131953727, B Phase LC 131953729, C Phase LC 131953975, Spare LC 131953723. Photo Below is Bank 5 Spare.

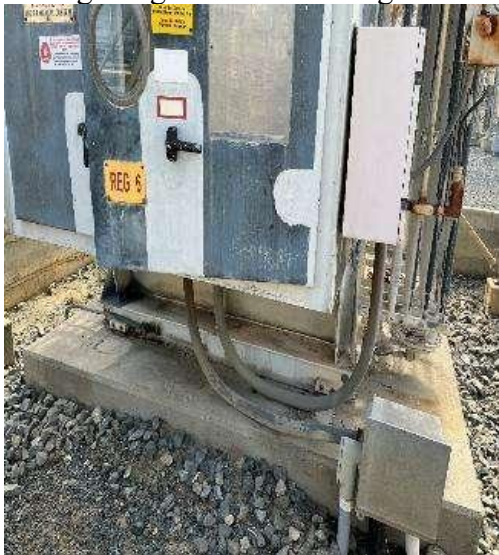
17.7 Voltage Regulator 6 Oil Mitigation Existing LC Tag# 131956054
