Public Housing Broadband Site Visit Report

CALIFORNIA ADVANCED SERVICES FUND
BROADBAND PUBLIC HOUSING ACCOUNT

July, 2019

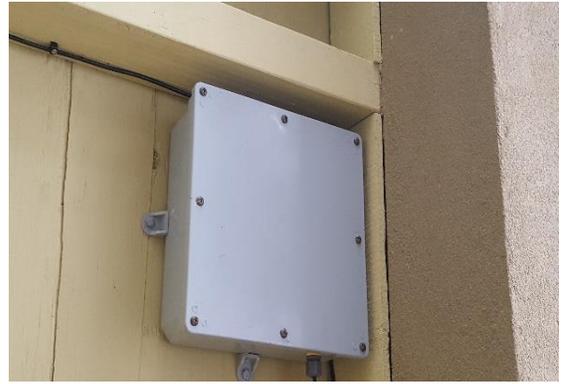
Figure 6: Parc Grove WAP in an enclosure

- Indoor and Outdoor wiring and cables were run through proper conduits
- All outdoor units and network equipment such as WAPs, Repeaters, MDFs, IDF's at all the three sites were properly enclosed, weather protected and secured
- The currently subscribed ISP bandwidth was not adequate to meet the grants minimum internet speed requirement at Parc Grove Commons and Northwest sites
- None of the proper Wi-Fi tools were found that could help the grantee to troubleshoot their network
- None of the monitoring tools were available to measure the performance, availability of the network and could generate a dashboard report for quarterly reporting
- Multiple CalSPEED tests were conducted at all the three sites and the test results meet grant minimum internet speed requirements

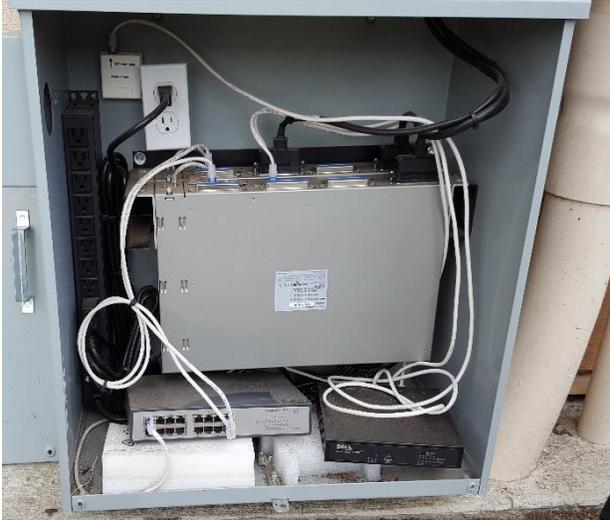
Figure 9: Resident of West Columbus MDF Outdoor Closet

Staff visited this grantee for the following eleven low-performance sites and found that ten sites were maintained well except for one project site i.e. Residence at West Columbus. At West Columbus site staff found a lot of dust over the network equipment inside MPOE/DSLAM MDF, which is an outdoor enclosure and with no ventilation between the network equipment as we can see below in [Figure 9](#) all are stacked one above the other.

- Dust on the network equipment at outdoor MPOE inside the enclosure at West Columbus site
- Network equipment stacked at MPOE one above the other with no proper racking space or vent for the heat generated from the equipment to dissipate at West Columbus, Homer Harrison and, Quincy St. Apartment site

- At West Columbus site, staff advised to either relocate an outdoor MPOE enclosure to a safer location where there's no dust or cover the vent with some filter to evade from the dust getting inside the outdoor enclosure. See picture in [Figure 9](#)

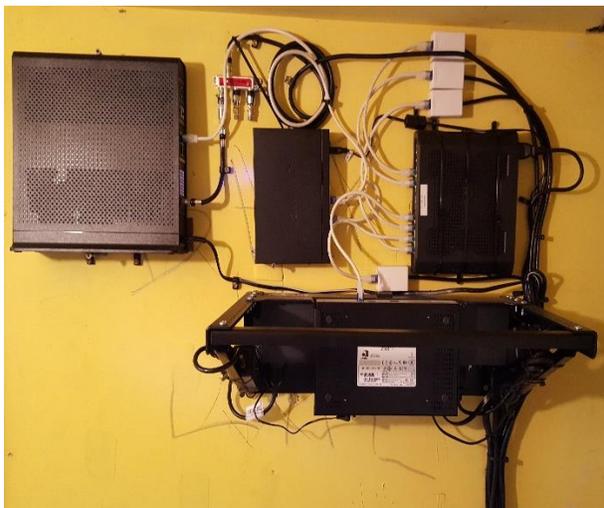
Figure 40: Banneker Homes Apartments MDF Room

- All outdoor units and network equipment such as WAPs, Repeaters, MDFs, IDFs on this site was properly enclosed, weather protected and secured
- At one area of an apartment building, test results were poor and didn’t meet the minimum internet speed requirement

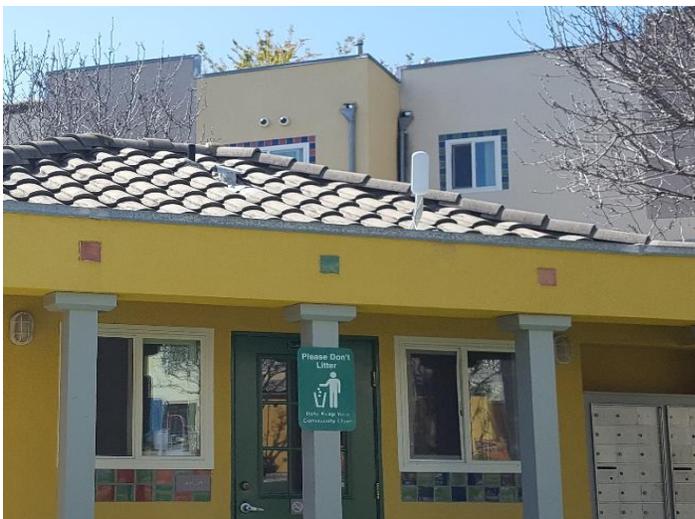
Figure 303: Cedar Nettleton Nano Cell WAP

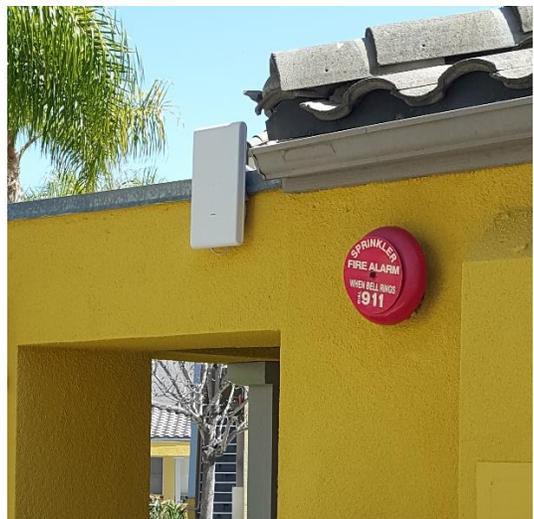
Figure 314: Cedar Nettleton Nano Cell WAP

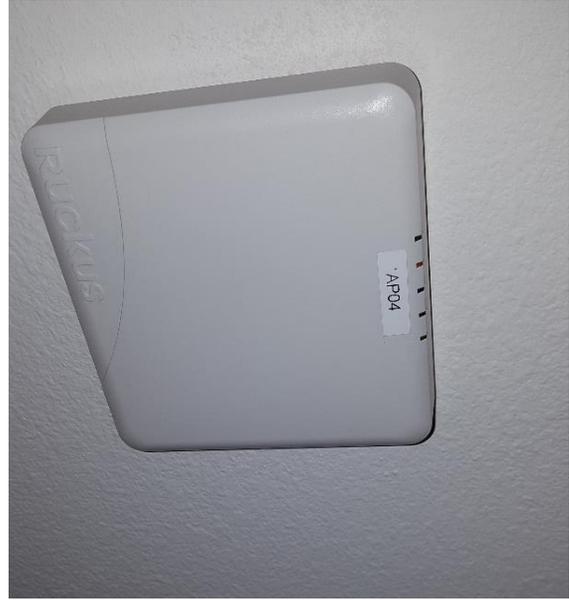
Figure 60: Olivera Senior Apartment WAP

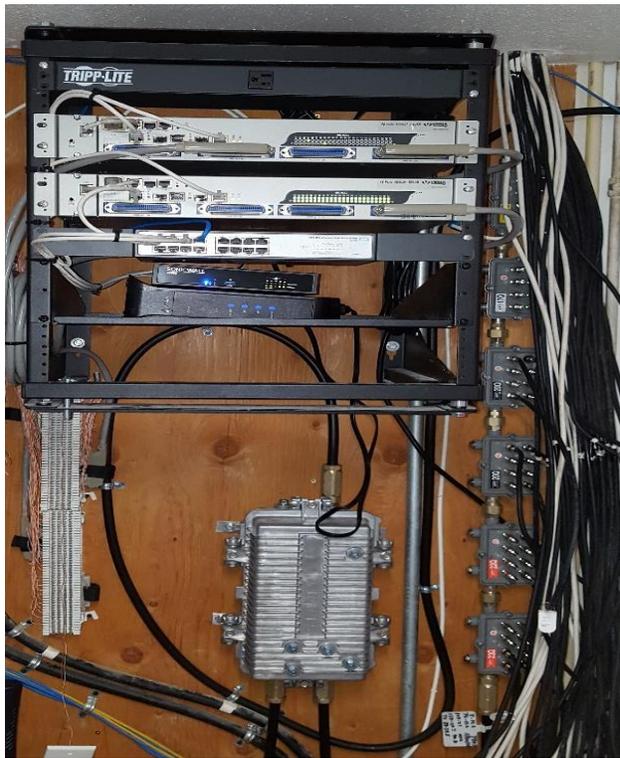
- For both the sites, the grantee had a contract with the network vendor for operations and maintenance (O&M) and quarterly performance reporting
- Indoor and Outdoor wiring and cables were run through proper conduits and 66 blocks at The Orchard and were wired properly but the face cover to the 66 blocks was missing

Figure 61: The Orchard MPOE/MDF Room

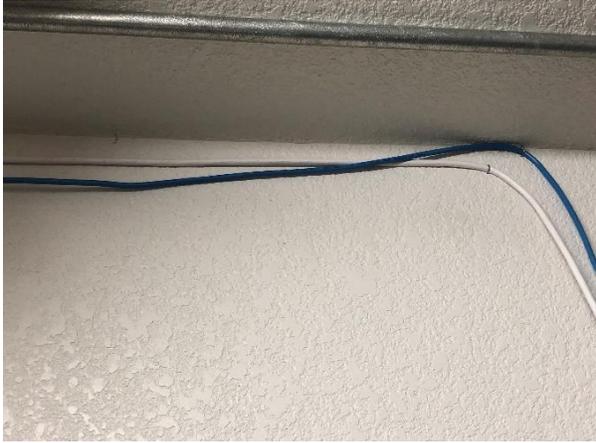
- Poorly wired all indoor and outdoor cables running on the walls and roofs were stapled with no conduits or cable tray ladder used
- On both, the sites ISP bandwidth subscribed were not adequate to meet grants minimum speed requirement and the design calculation used by the network vendor was not correct

Figure 383: Casa Adobe Cabling

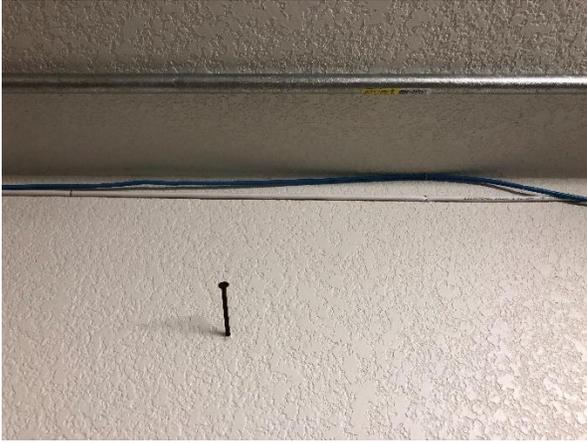
Figure 64: Casa Adobe Cabling

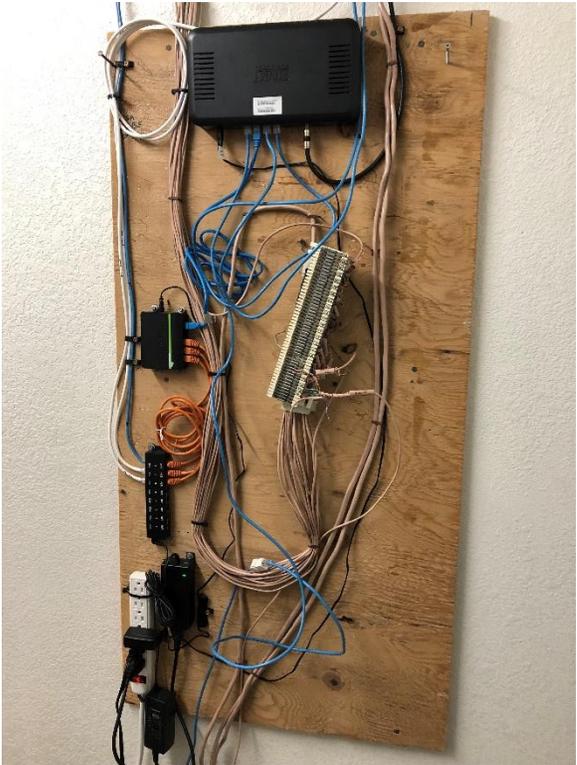
Figure 406: Casa Adobe MPOE

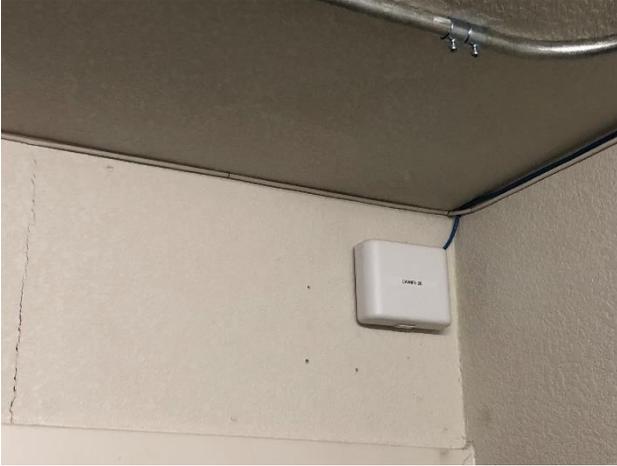
Figure 417: Casa Adobe WAP

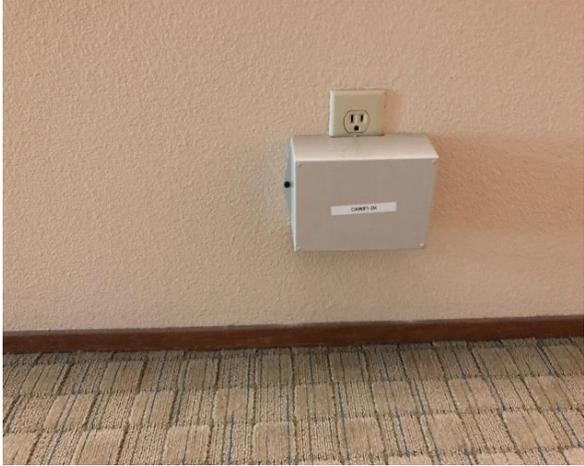
Figure 428: Casa Adobe WAP Repeater

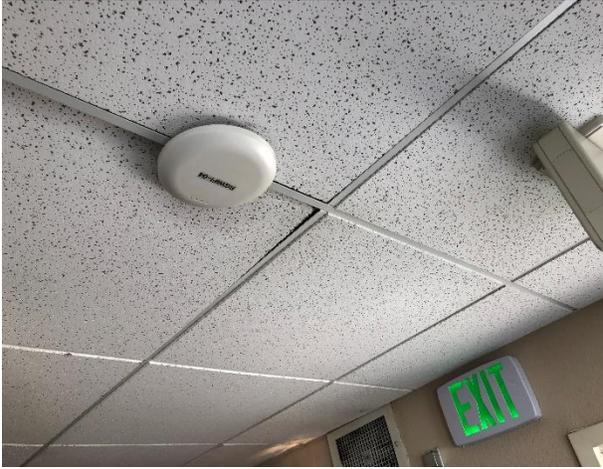
Figure 70: Rodeo Gateway WAP

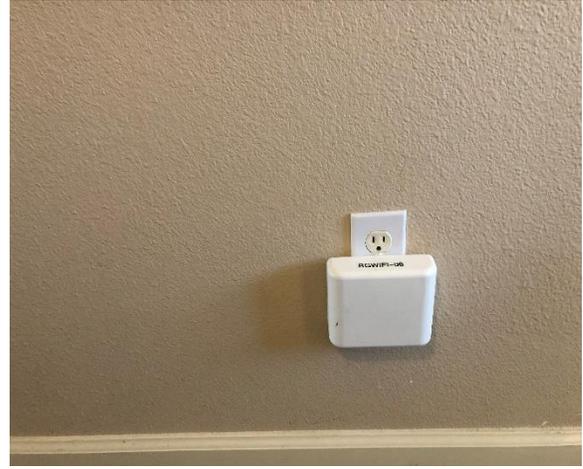
Figure 441: Rodeo Gateway WAP Repeater

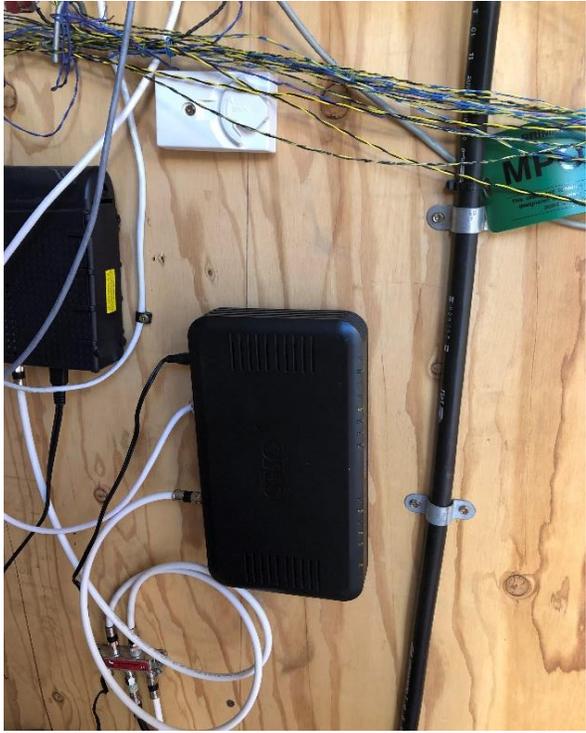
Figure 74: Giant Road MPOE 1B

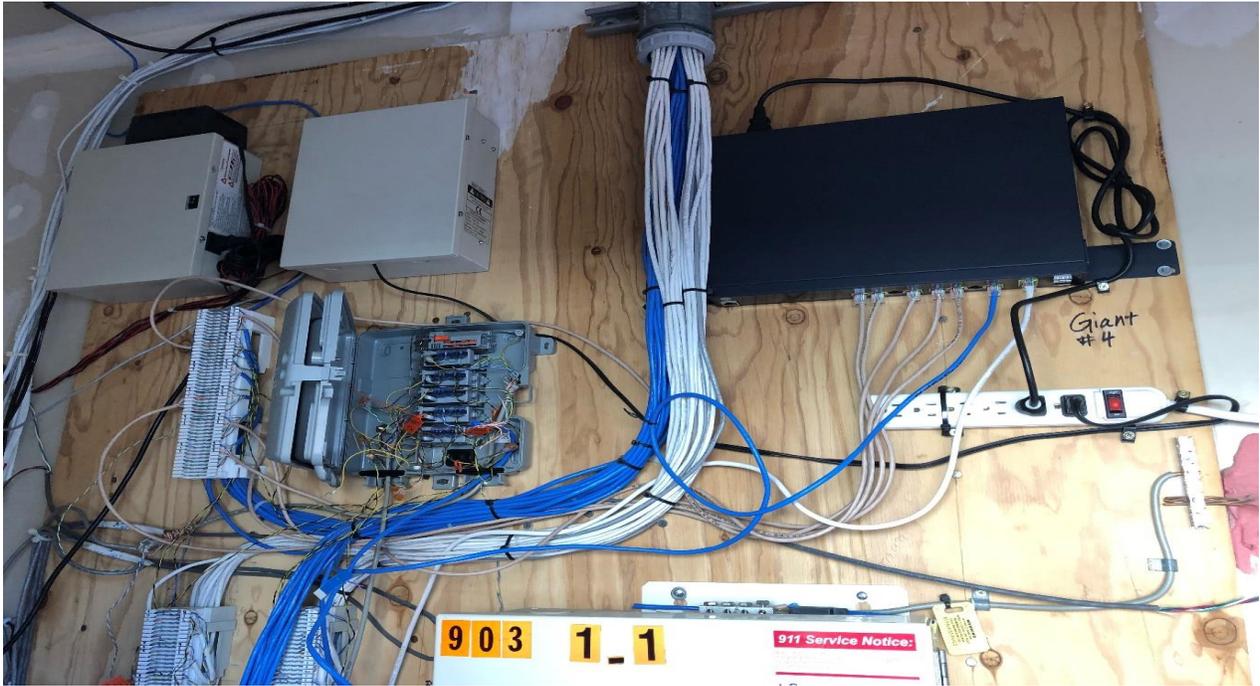
Figure 477: Giant Road MPOE 4

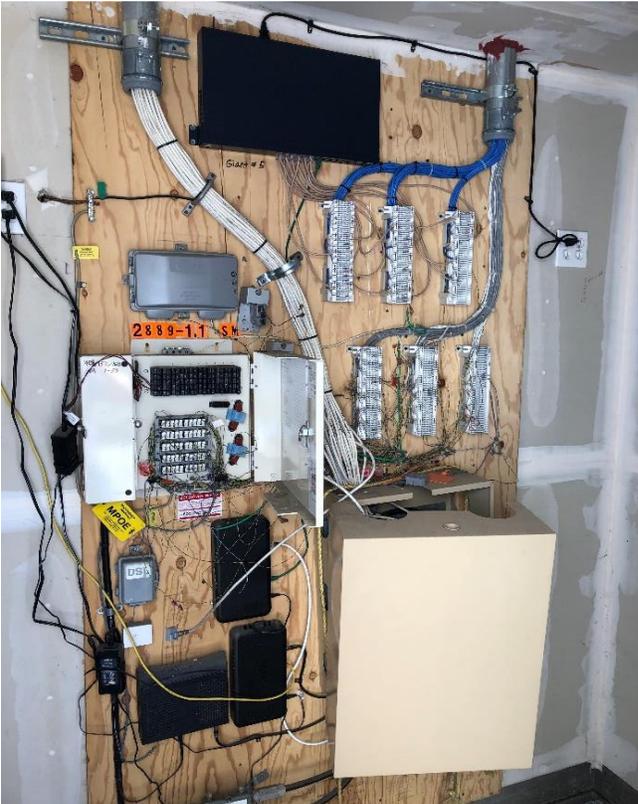
Figure 488: Giant Road MPOE 5

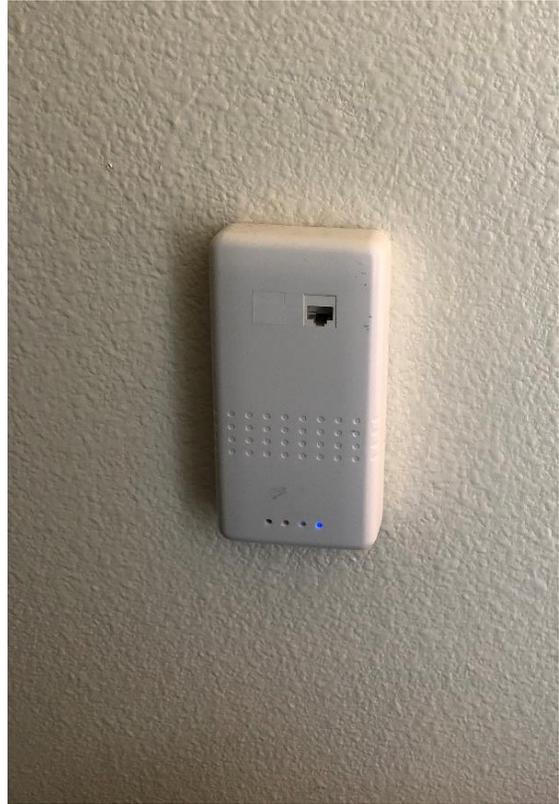
Figure 499: Giant Road WAP inside the Apartment

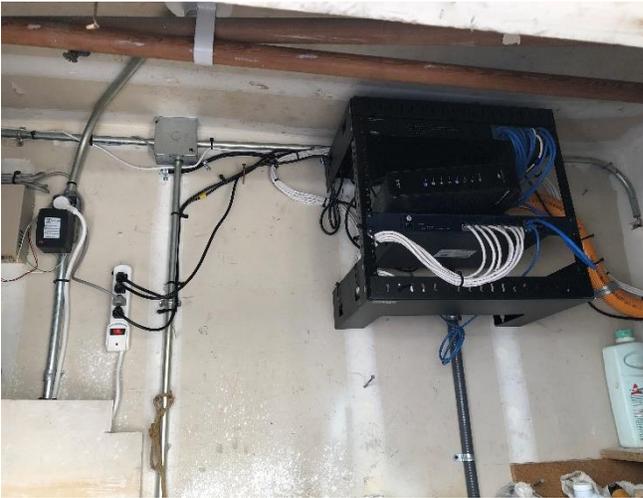
Figure 80: Marcus Garvey MPOE

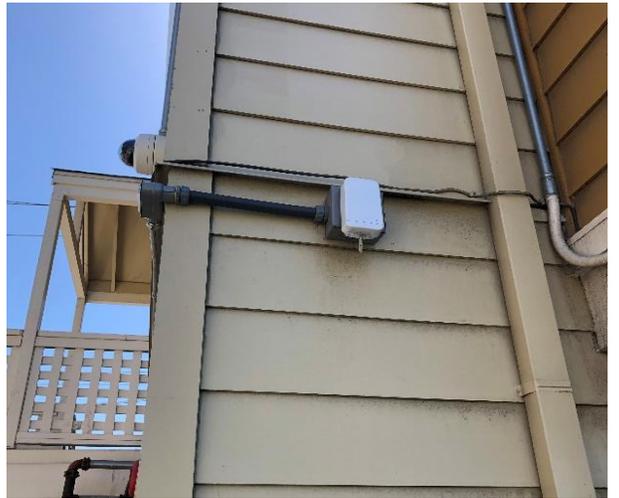
Figure 81: Marcus Garvey WAP

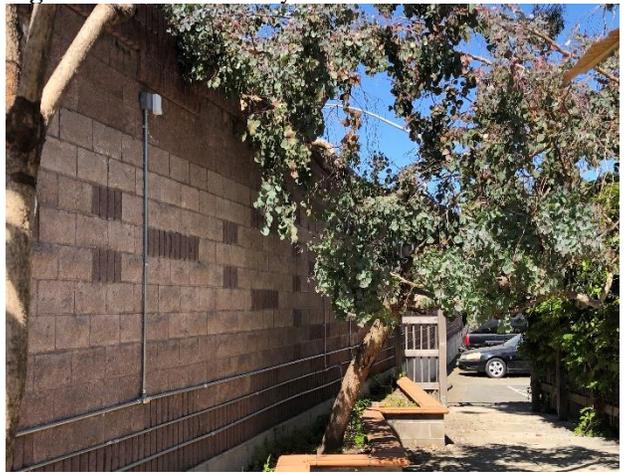
Figure 513: Marcus Garvey WAP

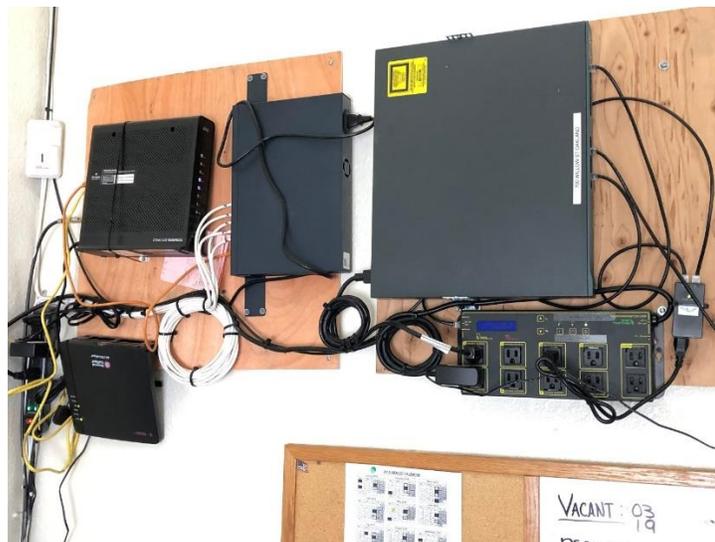
Figure 524: Slim Jenkins MPOE

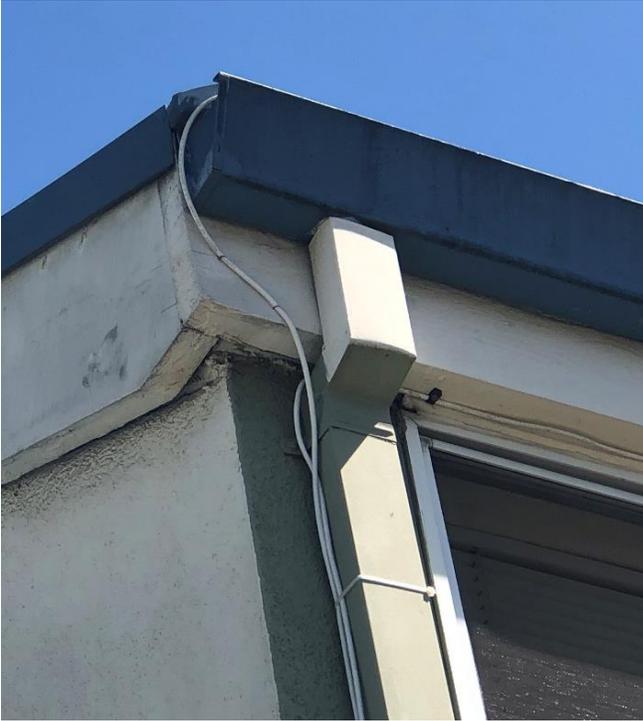
Figure 535: Slim Jenkins Cabling

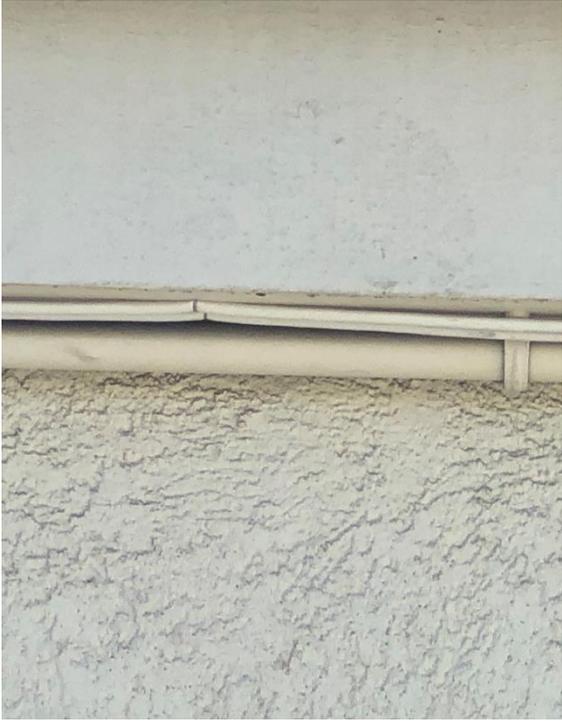
Figure 546: Slim Jenkins Cabling

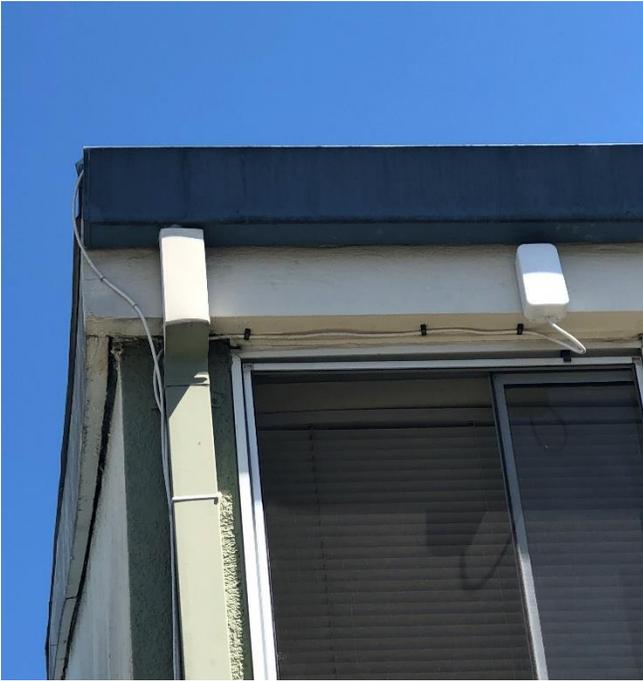
Figure 557: Slim Jenkins WAP

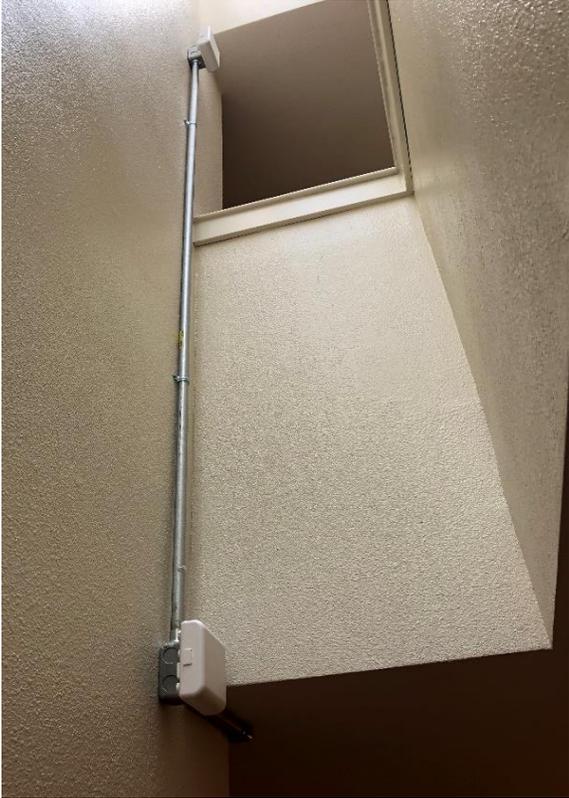
Figure 90: Swan's Market WAP

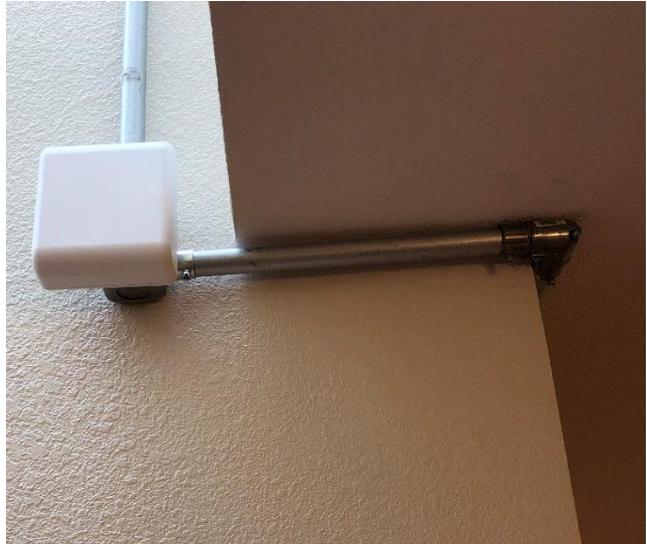
Figure 91: Swan's Market WAP and Cabling

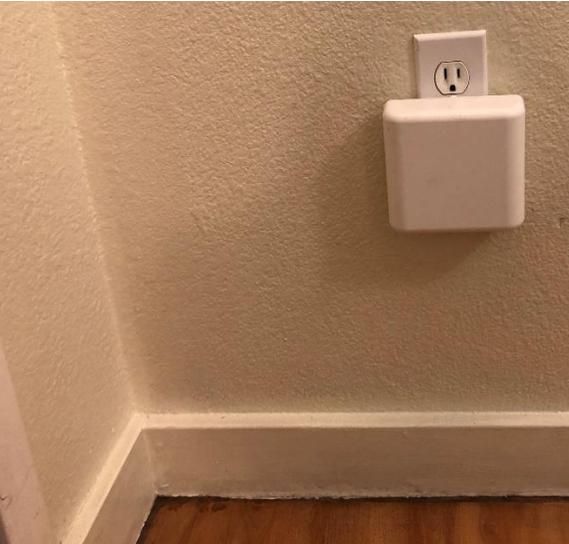
- Some Repeaters and WAPs were installed and plugged on to the wall plug in the hallways, which can be easily tampered
- ISP bandwidth subscribed are not adequate to meet grants minimum speed requirement and the design calculation used by the network vendor was not correct

Figure 582: Swan's Market WAP in the hallway

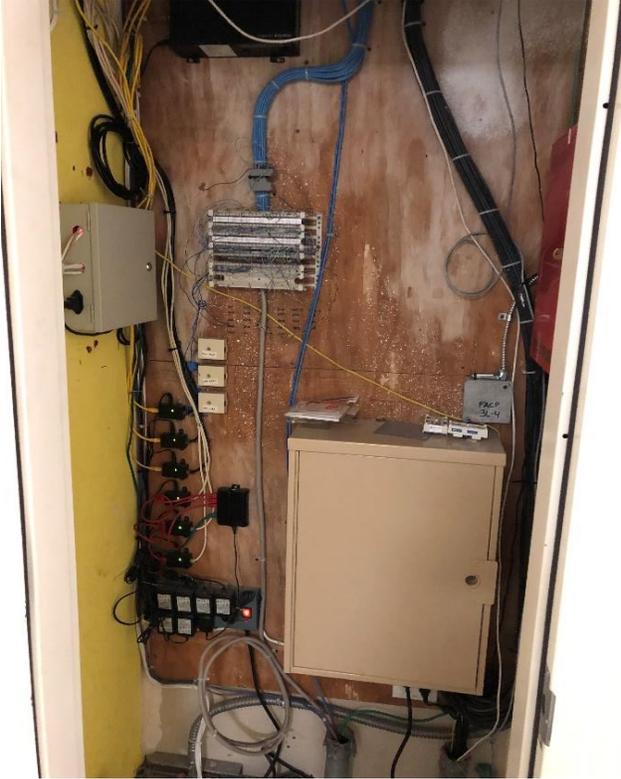
Figure 593: Seven Directions MPOE

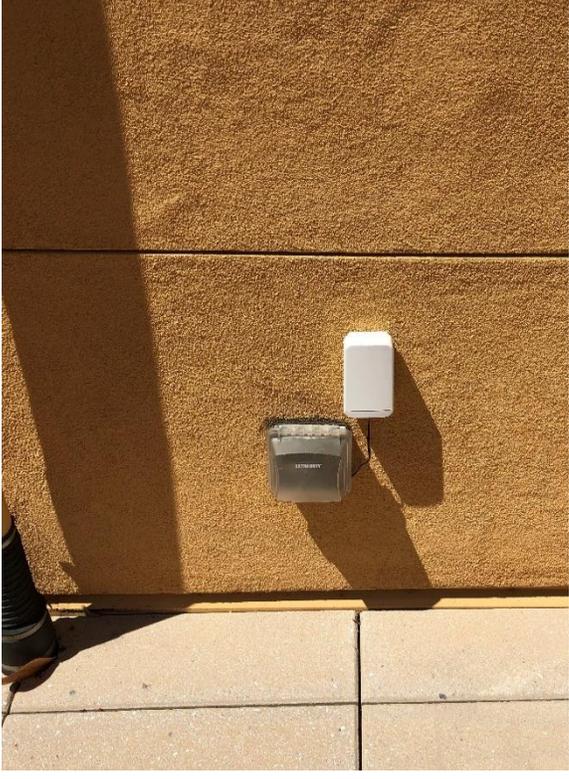
Figure 604: Seven Directions WAP in the walkway

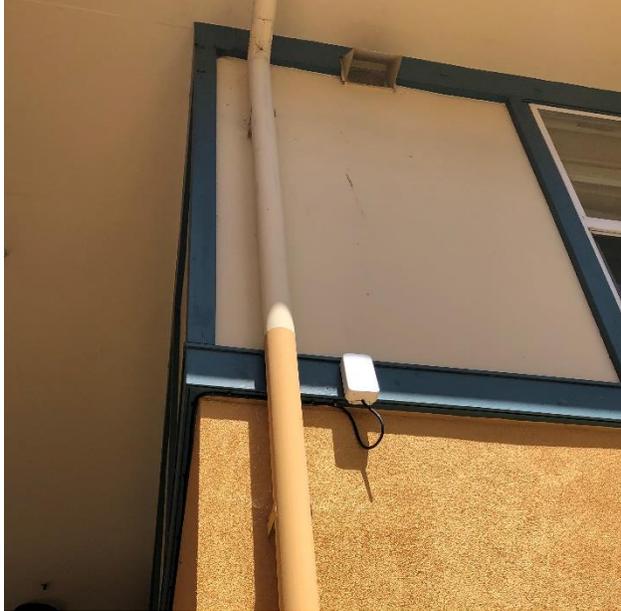
Figure 615: Seven Directions WAP

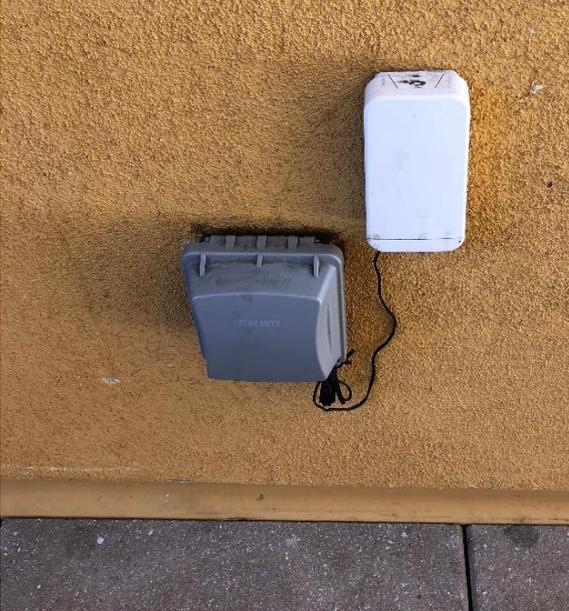
Figure 626: Seven Directions WAP in the walkway
